# Solution of machinery problems by field investigation

F. KUNZ, B.A., C.Eng., F.I.Mar.E., M.I.Mech.E.  
Lloyd's Register of Shipping

## SYNOPSIS

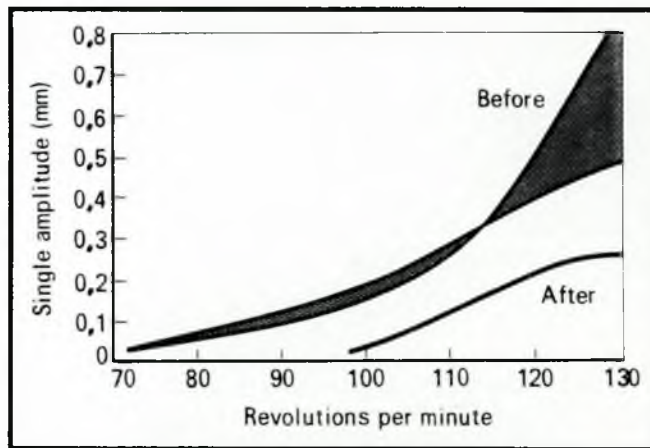
Fig. 1. Effect of bearing change on tailshaft vibration at stern seal

lateral vibration critical was closer to the service speed than calculated and that instability of the shaft within the bearing caused the leakage. An increase of effective bearing stiffness, to raise the natural frequency of the shaft system and a reduction of bearing clearance to increase damping were proposed. To effect these changes the stern tube bearing, which was of a resin-impregnated asbestos type with a fairly large diametral clearance, was replaced with a conventional white metal bearing of smaller diametral clearance, but without further alignment changes. This resulted in a considerable reduction of shaft vibration and the seal leakage rate was reduced from 200 litres per day to negligible amounts.

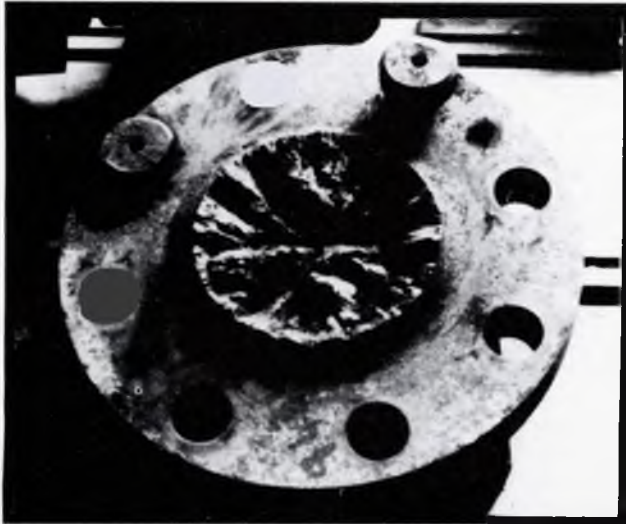
Fig. 2. Multi-origin intermediate shaft fracture

also near service speed under conditions of simulated poor combustion balance. It was concluded that the failures were due to the combination of high cyclic torsional stress and the deleterious effect on fatigue strength of the corrosion in the stress concentration areas of the tailshaft-to-intermediate shaft couplings. The multi-origin nature of the cracks was thought to reflect the detrimental effects of corrosion.

Excessive wear down on one of the vessels is considered to have been a contributory factor. In repairs these factors were taken into account. Alignment of all ships was checked and adjusted as necessary. The coupling flanges and fillets were machined on the remaining original shafts to remove the stress concentration effects of pits and to restore good surface finish. The fractured or cracked shafts were renewed.

A recommendation was made to coat the affected portion of the shafts and couplings to inhibit further corrosion. Further recommendations covered maximum allowable wear down and operation to restrict exposure to high torsional vibration.

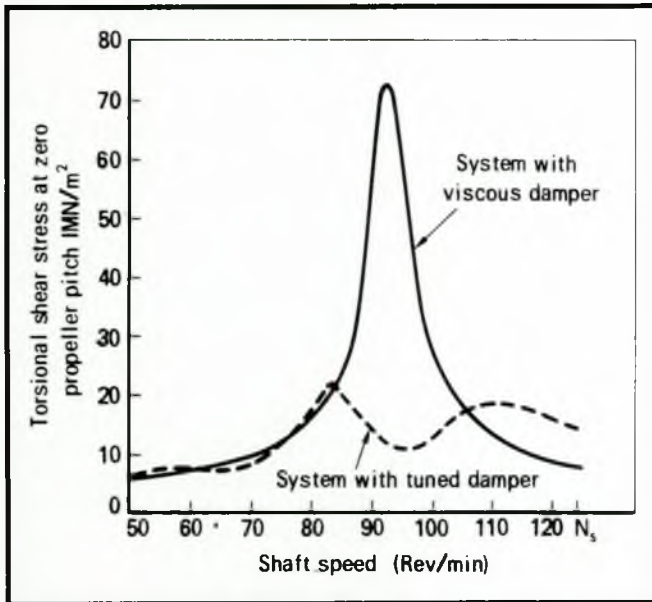
Metallurgical tests were conducted on the failed shaft and extensive torsional vibration and bending moment measurements were made. It was concluded that the shaft had failed in the areas of maximum stress concentration under torsional fatigue stress, produced either by repeated traversing of the torsional critical with no pitch on the propeller or inadvertent no-load idling at too low a speed, possibly in the presence of governor hunting or a combination of the two. Alignment was found not to have been of significance in the failure. In view of the findings it was considered that a sister ship was also at risk.

Fig. 3. Effect of changing damper on torsional vibration stresses

Options to deal with the problem included raising of the idling speed and traversing the critical with pitch on the propeller as this had been found to inhibit high transient vibration torques. The alternative finally selected for both vessels was to modify the torsional vibration system with a damper/detuner and after some fine adjustments of the damping this proved satisfactory. A summary of the principal results of this investigation which involved a considerable number of torsional calculations is given in Fig. 3.

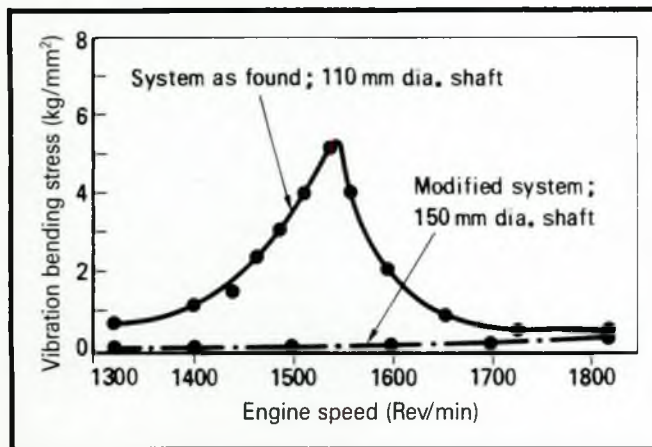
Fig. 4. Whirling-induced bending stress in intermediate shaft

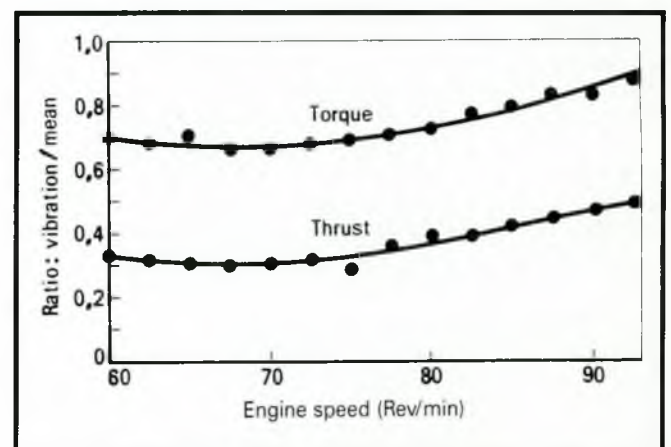
Fig. 5. Fifth-order torque and thrust vibrations

of higher-order resonances, firing order excited torsional and axial line shafting criticals were deduced to be present some 30 % above operating speed and consequently they involved only minor dynamic magnification within the running speed. These forced firing order torque variations in the intermediate shaft were within normal allowable limits, although approaching the mean torque at service speed, and the corresponding thrust variations in the intermediate shaft were approximately half of the mean thrust. The phase relationship of the torsional and thrust vibrations was consistent with excitation of the thrust vibration by vibratory torque-induced speed variations of the propeller. These results, which were confirmed later also on other vessels of the class, are summarized on Fig. 5.

Prior to the bracing of the main engine the thrust variation, which is reacted at the engine thrust bearing, must have induced dynamically magnified longitudinal and pitching motion of the engine which gave rise to the problems in the accommodation. It was recognized at the time that the problem could have been solved in other ways. For example repositioning of the 1-node torsional critical below the service speed by the use of a reduced-diameter high tensile strength intermediate shaft was considered, but thought unnecessary at the time in view of the scale of the modifications involved and the simplicity of fitting the axial stays to the engine.

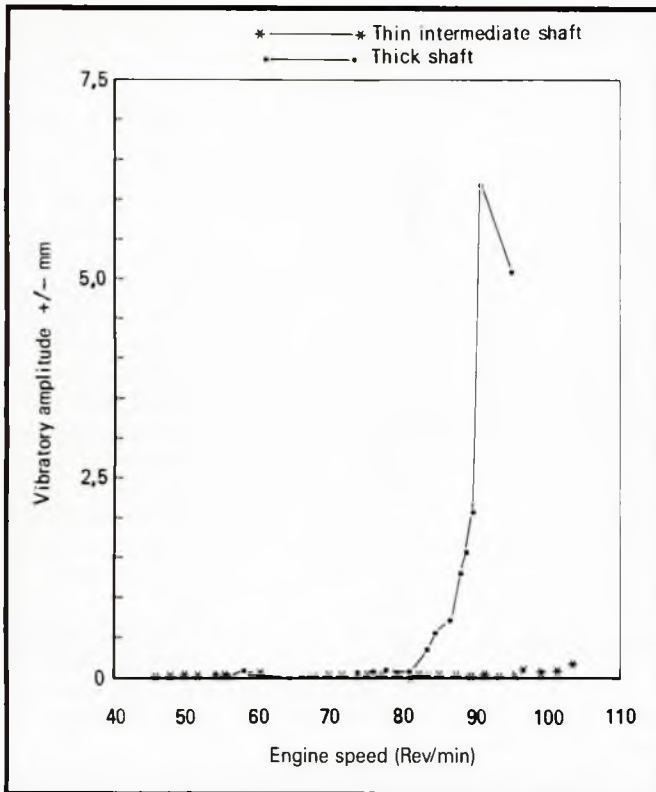
Fig. 6. Vibration of bottom transverse members

Some time later extensive cracking at the boundary welds of the bottom transverse members was found in the cargo tanks of a number of ships of the class and was identified by measurements as having been caused by longitudinal vibration of the bottom transverses when the tanks were full, due to excitation from the thrust fluctuations. Exploratory stiffening of the bottom transverses and provision of an axial crankshaft damper failed to deal with the problem and it was finally decided to resort to redesign of the shafting system which entailed fitting of a reduced-diameter intermediate shaft and torsional damper. This modification reduced vibrations in the

cargo tanks to negligible amounts (Fig. 6).

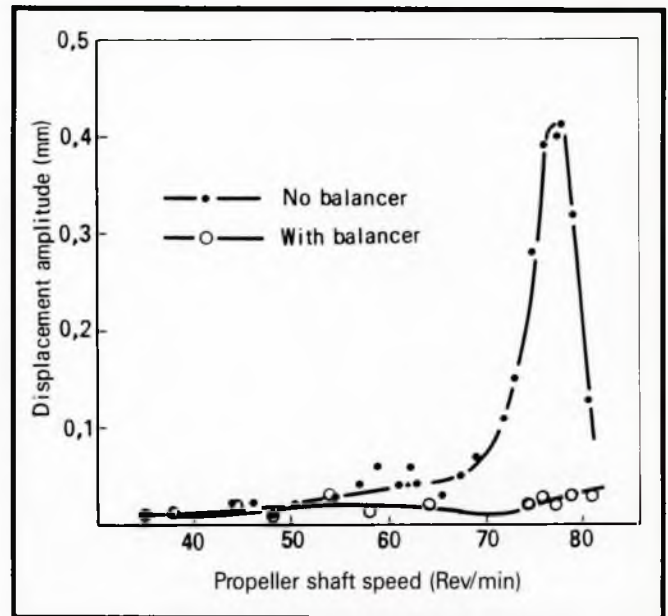
Fig. 7. Effect of fitting secondary balancer

At the cost of added complication an engine-driven balancer can alleviate such problems. A typical example concerns a 26,000 ton chemical tanker fitted with a 2-stroke engine developing 11,000 bhp at 81 rev./min. By fitting a secondary

balancer, troublesome accommodation vibrations were eliminated (Fig. 7), and main engine vibrations were greatly reduced. In another case, involving secondary unbalance of the main engine on a small vessel propelled by a high-speed engine, the accommodation above the engine room vibrated excessively at second engine order in diaphragm fashion, but was rendered acceptable by fitting pillars from the tank top to the accommodation (Fig. 8). In this particular case stiffening provided a more efficient solution than a reduction of excitation by the provision of a secondary balancer. Engine-driven secondary balancers are not entirely free of mechanical problems and in many cases may be difficult to retrofit after a ship has been completed. In several cases, involving secondary unbalance, electrically driven Lanchester-type balancers have been provided. They are usually placed in the steering gear flat which is a suitable antinode to counteract hull girder vibrations with opposing mass forces.

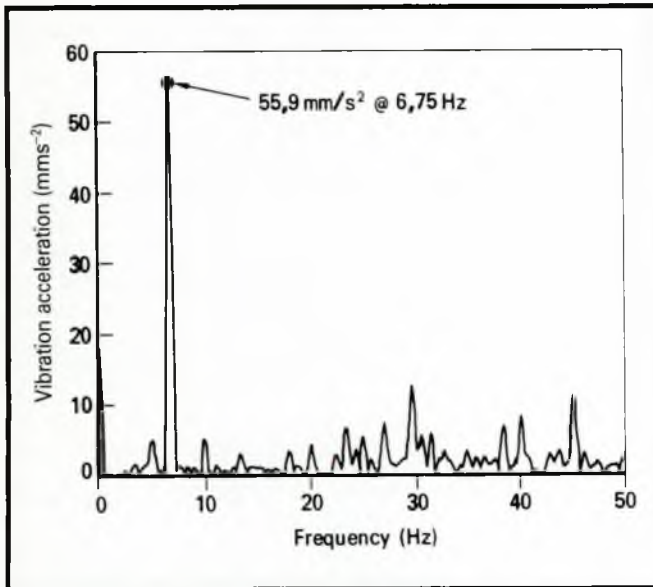
Fig. 10. Transverse vibration at deck 10 before balancing engine no. 3

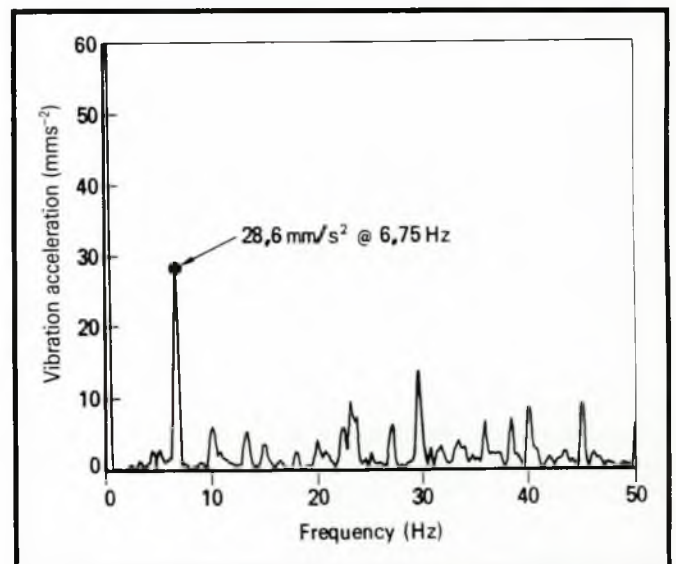
Fig. 11. Transverse vibration at deck 10 after balancing engine no. 3

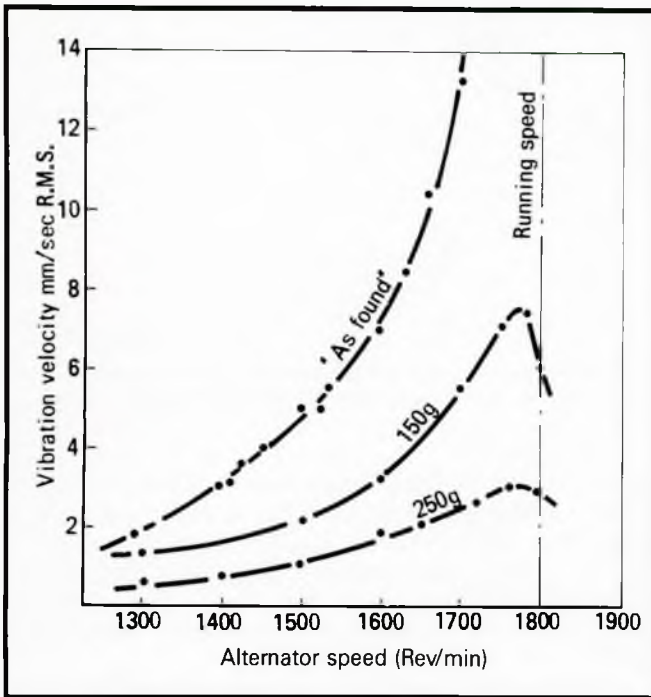
Fig. 12. Field balancing of turbo-alternator electrical rotor

A recent case concerns a replacement turbo-alternator fitted on a VLCC. The machine vibrated excessively despite numerous attempts at rectification which included realignment and low-speed balancing ashore. Using field balancing techniques it was found possible to get the machine to operate smoothly (Fig. 12). It was also found that the synchronous speed was close to a first-order lateral vibration critical of the alternator shaft line and thus was sensitive to unbalance excitation. To render the machine less sensitive to unbalance the lateral critical frequency of the system was displaced above the operating speed by removing a spool piece which had been introduced to accommodate the alternator on the existing seating.

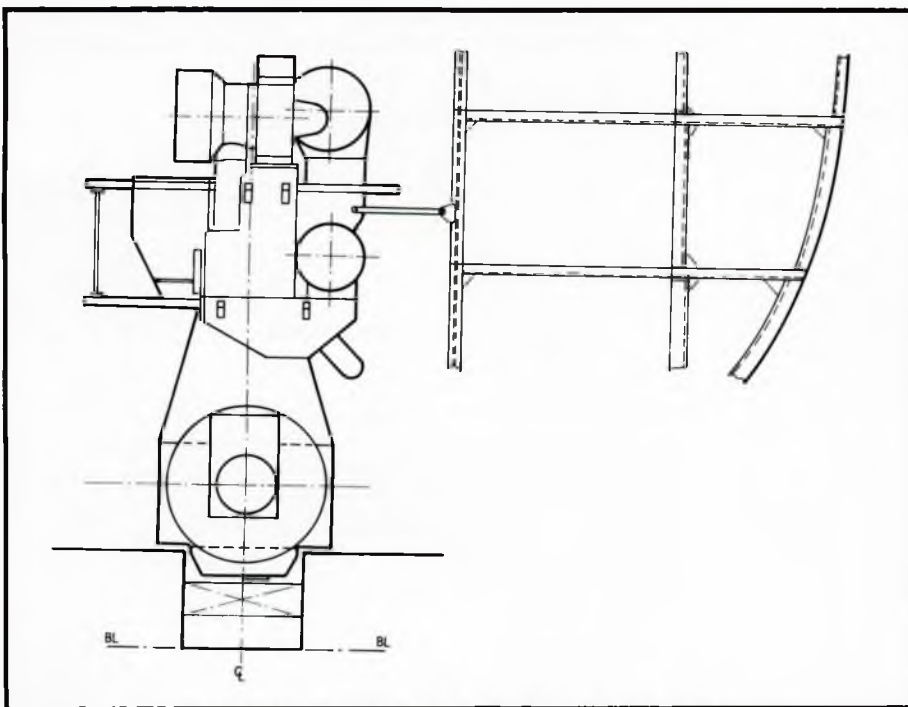
Fig. 13. Undesirable engine stay arrangement

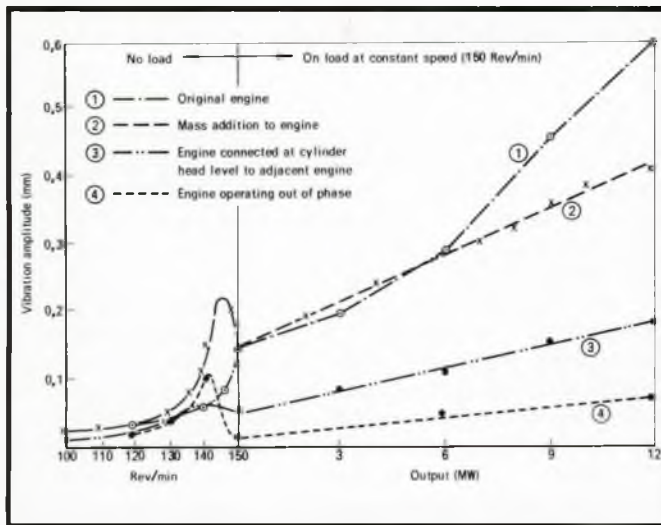
Fig. 17. Free end transverse vibrations at cylinder head level (fifth-order)

machines and their attachments. Measurements showed that fifth-order transverse vibration in the X-mode was involved with a critical close to, but above, the synchronous speed. As the engines are operated at a constant speed the engine builder added mass to the engines at the cylinder head level, thus reducing the critical to below the synchronous speed. The modification reduced the transverse vibrations at cylinder head level by about one-third. While this was considered satisfactory from the point of view of the engines and attachments, complaints of ground-borne vibrations were then being received from the neighbourhood making further reductions of vibrations desirable. At this stage the engines were connected with braces at the cylinder head level and in twin operation arranged to be mechanically out of phase with respect to the major fifth-order vibration frequency. In this configuration the vibration amplitude at cylinder head level was reduced to approx. one-third of the original value, but further improvements were effected by rephasing the engines relative to each other to put the two dominant vibration components (fifth- and third-order) into antiphase thus reducing the allowed relative angular phase relationship of the two crank shafts to only one.

It was recommended that future engines on the site should be medium-speed types mounted on resiliently supported concrete blocks.
