Marine Machinery Failures

H. N. PEMBERTON (Member of Council)*

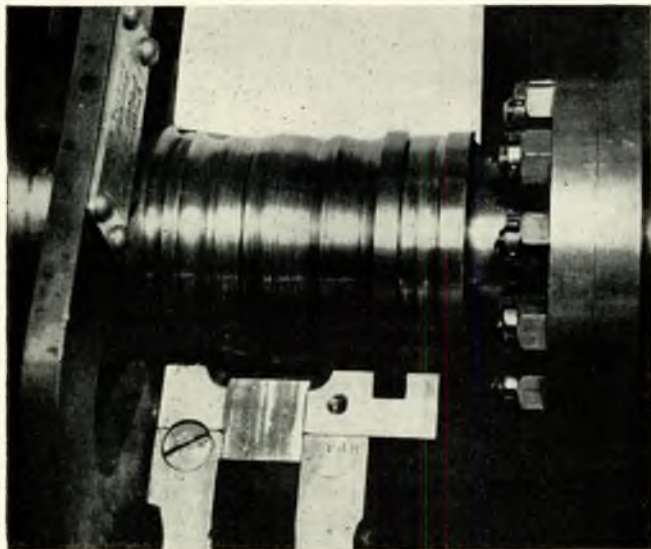
Defects in lubrication systems have been responsible for other serious failures of turbine rotors. Fig. 1 shows an h.p. rotor that was badly grooved during the maiden voyage of the ship, the grooving being caused by foreign matter that had been left in the lubricating oil system. Steel cuttings, weld spatter, bolts, and even a steel wedge, were found in the oil passages.

FIG. 1—Grooving of an h.p. rotor shaft

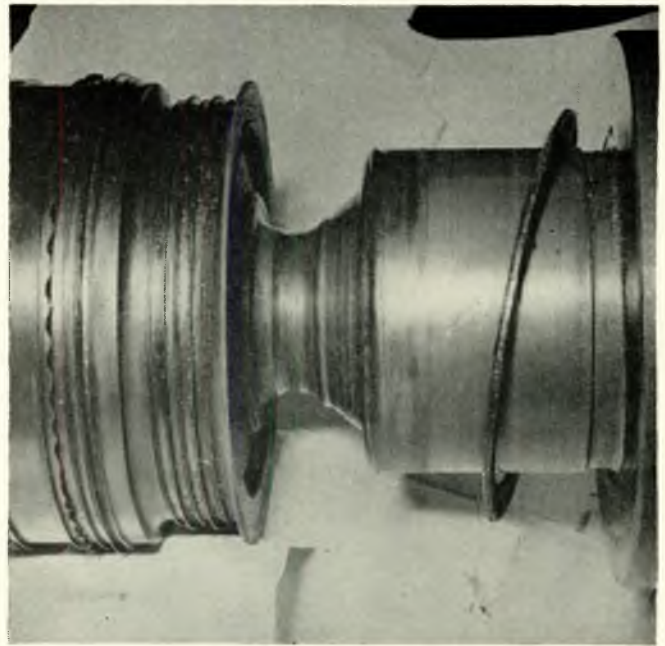
A more serious case is shown in Fig. 2 where the rotor shaft of an h.p. turbine had been almost completely severed by the grinding action of an accumulation of carbon in the oil labyrinth box. The carbonization had initially clogged up the drain holes in the labyrinth box and in consequence carbon build-up steadily increased. The maximum operating temperature at the oil gland was measured as about 275 deg. C. Laboratory experiments with the turbine lubricating oil revealed that in small quantities it would carbonize very rapidly at a temperature of about 230 deg. C. The primary cause of failure appeared to be paucity of oil circulation through the gland. Small quantities of oil passing through the drain holes at 275 deg. C. would carbonize rapidly and restrict the oil flow and a build-up of carbonaceous matter was then inevitable.

FIG. 2—H.P. rotor shaft worn through carbonization in labyrinth box

Enlarging the holes and using an oil that carbonized less rapidly at high temperature have prevented a recurrence of this trouble. A similar failure occurred in a sister ship where the thrust end of the shaft with its two journals was completely severed from the turbine rotor body, and when the installation was shut down the shaft was seen to be red hot. At least two other cases of this trouble are known to have occurred.

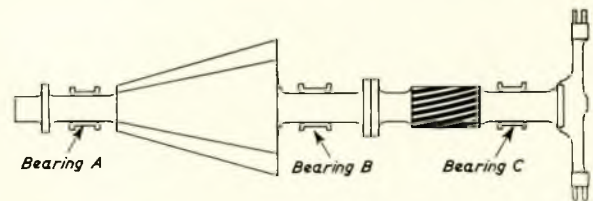
Occasionally an undesirable operating condition is discovered during trials or in service when this might have been avoided at the design stage. An example concerns the heavy vibration of an h.p. turbine due to the critical whirling of the ahead and astern rotors (Fig. 3). Subsequent calculations

FIG. 3—Configuration of whirling h.p. rotor assembly

showed that the critical whirling frequencies of the ahead and overhung astern rotors were practically identical and occurred near the service speed. Remarkable improvement was obtained by reducing the length of the bearing carrying the astern rotor (Bearing C) and lowering the frequency of the overhung system, which was now detuned in respect of the ahead rotor. Bearing loads remained within the permissible limits and the damping in the system produced by the pinion and bearings was sufficient to limit the whirling of the astern rotor to insignificant proportions.

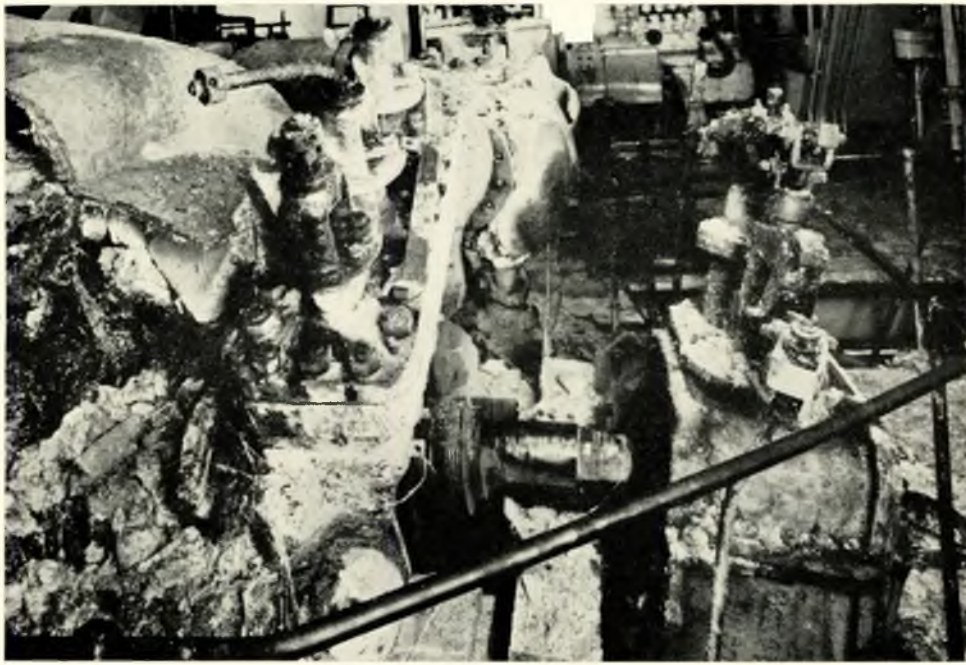
A spectacular failure occurred to the main turbo-alternator set of a tanker. During a dock trial when the speed was being gradually increased to check the overspeed trips of the turbine, increasing vibration was observed at the forward pedestal bearing. With the set operating at about 4,000 r.p.m., sparks were thrown from this bearing and the unit disintegrated (Fig. 4). The turbine and generator shafts were broken and

FIG. 4—*Main turbo-alternator failure*

Examination of the damaged parts showed that the shafts had bent to fracture. The bolts in the coupling between the shafts had also failed either under combined tension and bending or by shear. It appeared that bending about the coupling had been responsible for the failure of some of these bolts, the remainder being sheared as a result of torsional overload. When a shaft having a high angular velocity starts to bow, the deflexion increases as the shaft continues to rotate and retains its position and sense of direction. Although confirmed by metallurgical examination, the deformation suffered by the

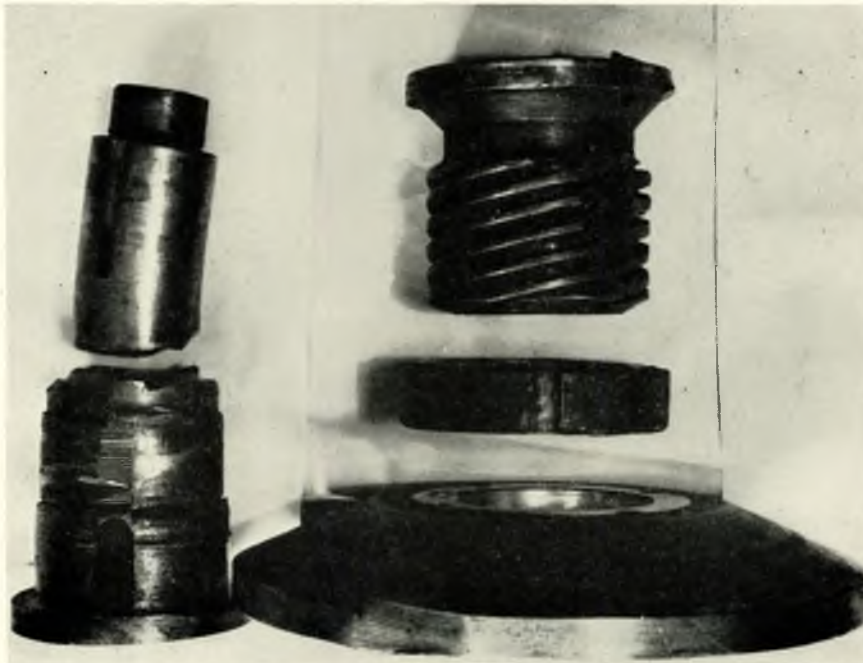
There was no evidence that the set failed as a result of gross overspeeding. Most of the components of the thrust and governor drive were recovered from the debris. It was noted that the security of the thrust assembly had depended upon a tab washer which locked the retaining nut (Fig. 5). The conditions of the threads in this nut and on the shaft indicated that the nut had slackened back before the shaft was damaged (Fig. 6). It was considered that this was the primary cause of the breakdown. As the tab washer was not found, despite a careful search of the wreckage, it could not be

FIG. 5—*Damaged governor drive of turbo-alternator*

established whether this washer had failed during service. It is interesting to note that different locking arrangements for the thrust retaining nut were used on some similar sets. As a result of this accident steps were taken to check the security of the thrust assemblies on all sets of this type.

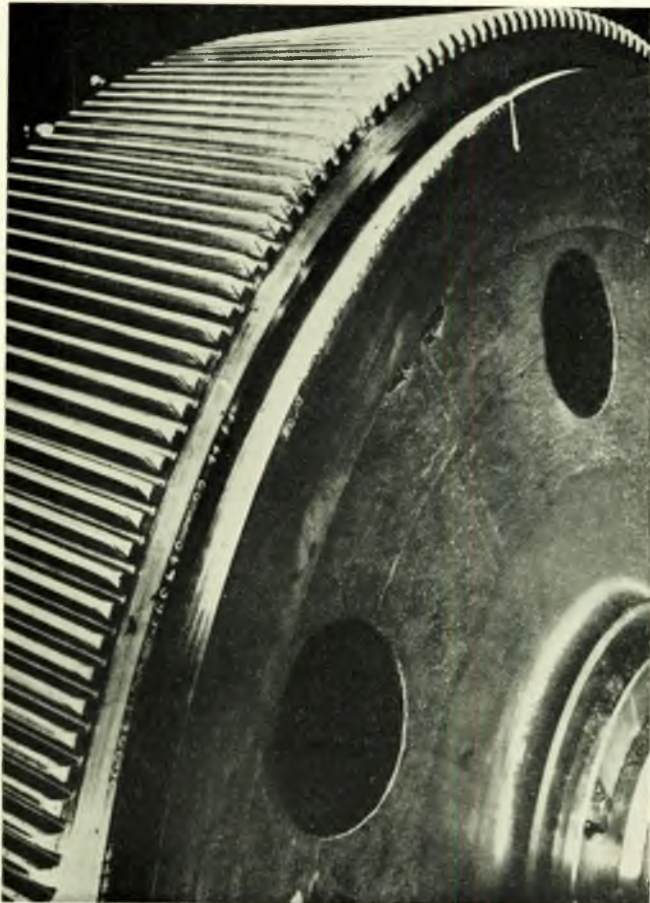
FIG. 7—Slipped main gear wheel rim

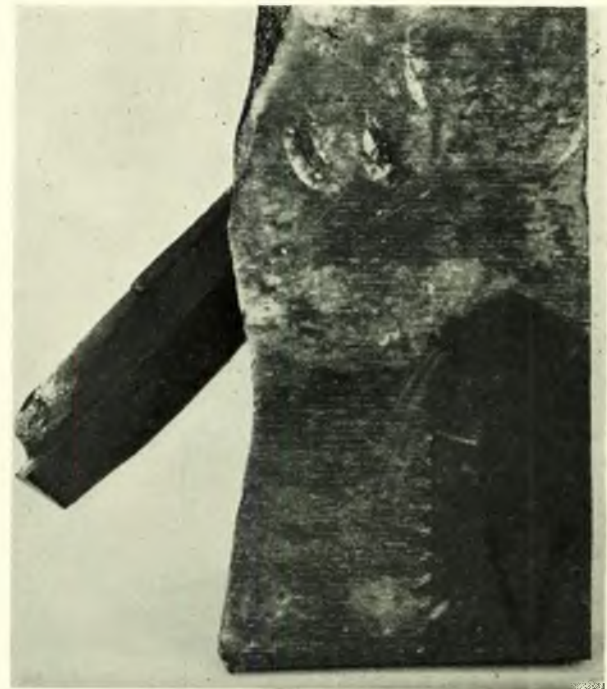
FIG. 8—Rim marking from un-filled dowel hole

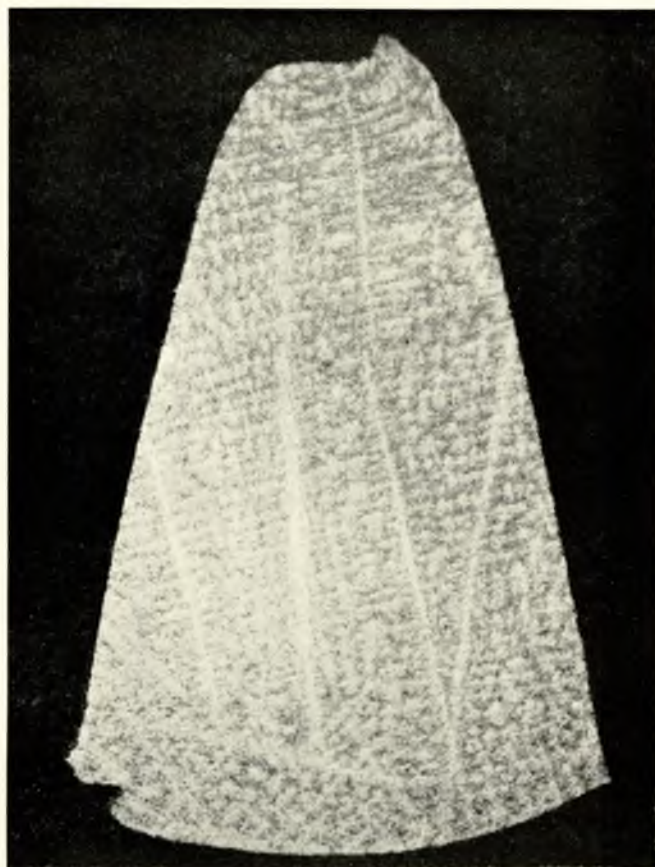
FIG. 10—Gear tooth showing dendritic structure

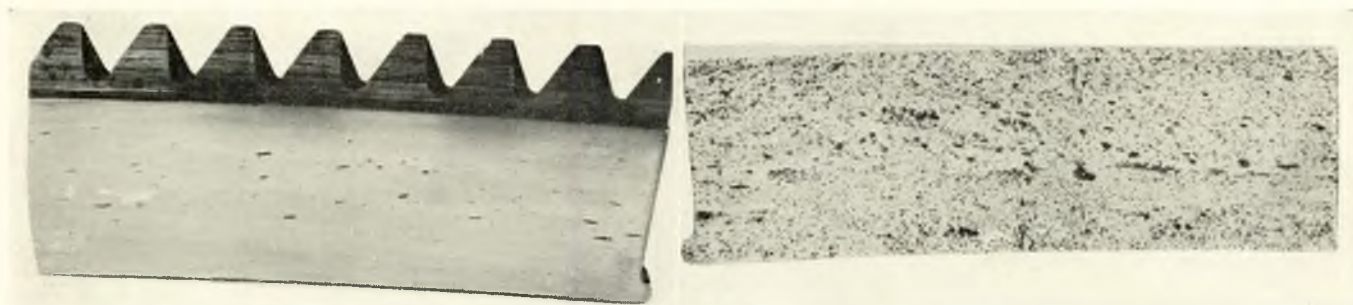
Large ingots of this manganese silicon basic open hearth steel are susceptible to segregations which are detrimental to rim forgings made therefrom. To avoid further failures, sulphur printing the ends of the wheel rims as well as pinions is now a Rule requirement of Lloyd's Register of Shipping. In doubtful cases magnaflux tests are also carried out after hobbing.

FIG. 11—Segregation in gear wheel rim

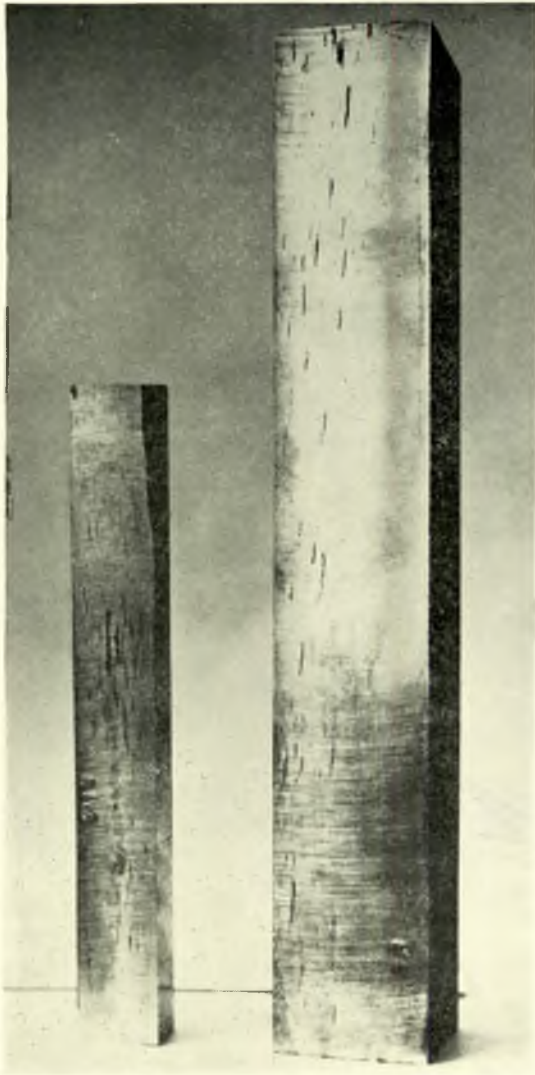
Comprehensive tests were carried out on two of these rims. They showed that the steel had a U.T.S. of 41-45 tons per sq. in. in the circumferential direction, with a yield of 26-28 tons per sq. in. Bend tests showed about 30 per cent failure. Fig. 11 shows a magnetic crack test taken on a section of a rim, with an associated sulphur print showing extensive segregations in way of the cracks. Fig. 12 shows a magnetic crack test on a prepared bend specimen.

FIG. 12—Magnetic crack test on pieces cut from gear rim

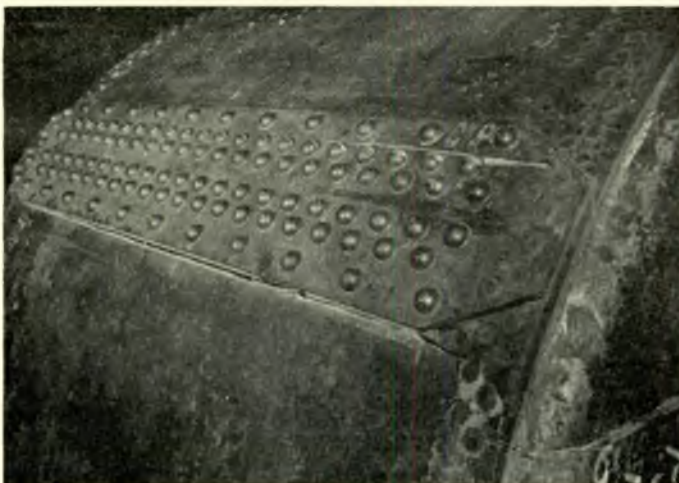
FIG. 13—Cracking of boiler shell due to welding

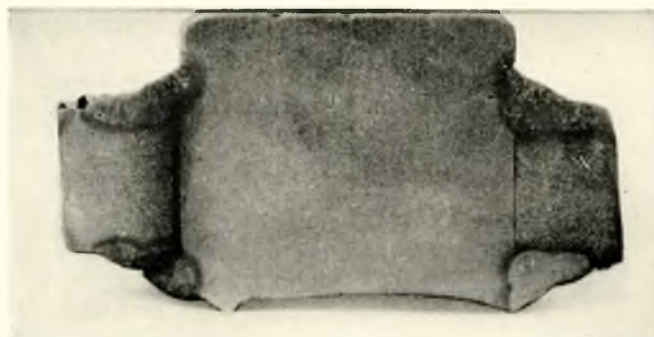
FIG. 16—Welded boiler stay

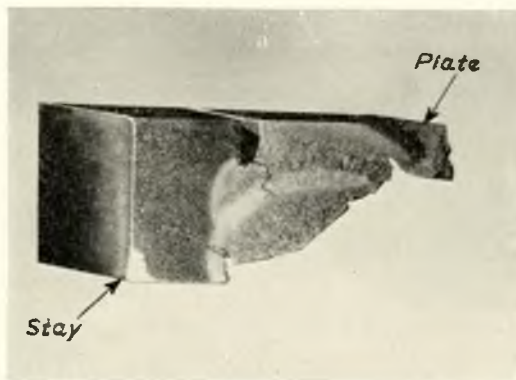
An example of unsatisfactory welding, this time on new construction, concerns the longitudinal stays in the auxiliary boilers of a 10,000-ton tanker. These stays in the steam space were welded, inside and out, to the front and back end plates. All the stays in the port boiler and four in the starboard boiler fractured in way of these welds. Mechanical tests and sulphur prints taken from the parent material showed it to be of satisfactory quality. It will be seen from Fig. 16 that the clearance between the stay and the hole in the shell plate was almost completely on one side of the hole. In all cases the fillet welds showed a considerable amount of undercutting and contained root cracks (Fig. 17). There is no doubt that the unsatisfactory quality of the welds was responsible for the failures.

FIG. 17—Undercutting at boiler stay fillet weld

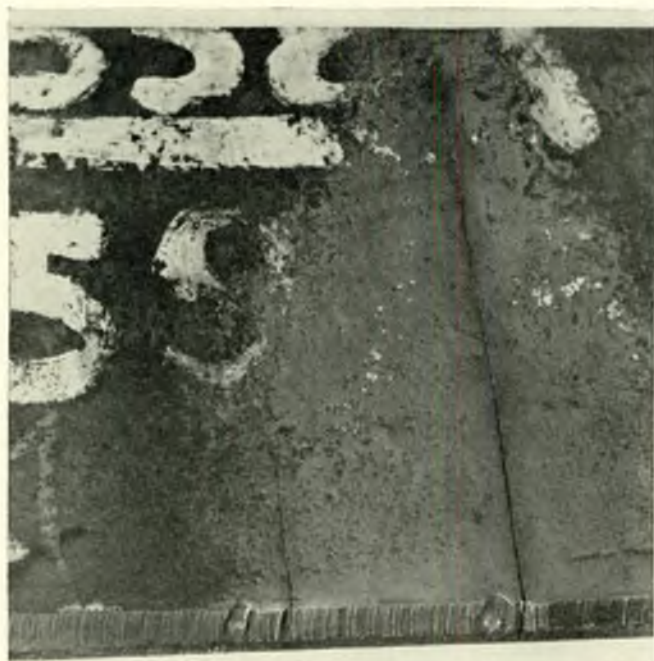
The chief danger arising from flame cutting of plates prior to welding is that notches or cracks are frequently left in the overheated zone. Fig. 18 shows a section of plate 1-in. thick that had been flame cut and which fractured along its free edge whilst being welded along its opposite edge to another plate. Two cracks can be seen originating at irregularities on the flame cut edge. Similar cracks have occurred during the bending of plates having flame cut edges.

The effect of the process is to increase surface hardness and induce residual stresses which aggravate the possibility of cracking due to stress concentration at the notches in the flame cut edges.

FIG. 18—Cracking of flame cut plate

For plates which have low notch toughness at ambient temperatures, the tendency for small cracks to propagate is greatly increased. It is essential that plates and slabs that have been flame cut to size should not be either cold formed or put into service before the damage is rectified. This also applies to flame cut openings, etc., in plates and slabs. Lack of attention to rectification has resulted in the failures of crankwebs, transverse beams of oil engines and boiler shells. The extent of the damage by flame cutting depends on the thickness of the section and the type of steel. For thin mild steel plates the removal of $\frac{1}{8}$ -in. from the flame cut edge by either machining or careful grinding is usually sufficient. For thick slabs, at least $\frac{3}{8}$ -in. should be removed by machining. However, to avoid cracking between flame cutting and machining operations, thick slabs and alloy steel plates should be heat treated immediately after the cutting operation. The best practice is to charge the flame cut component while still hot into the furnace.

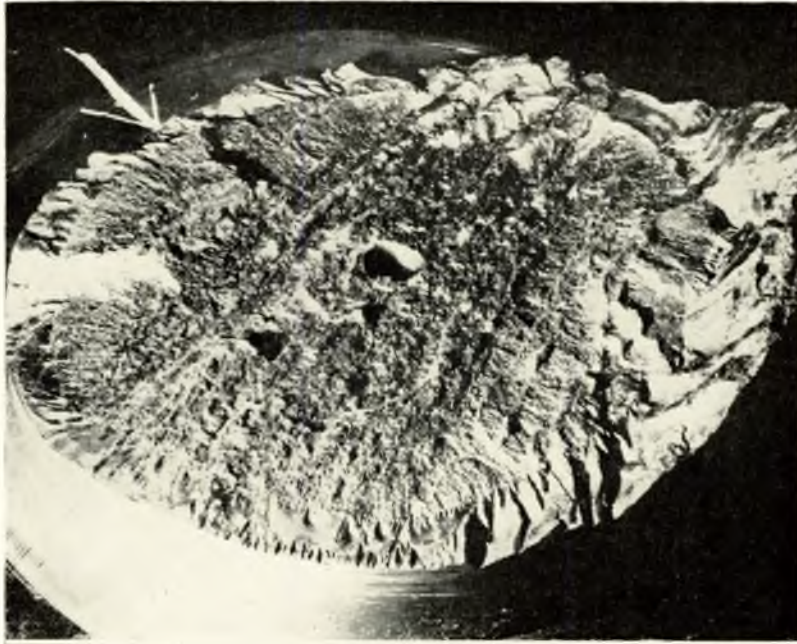
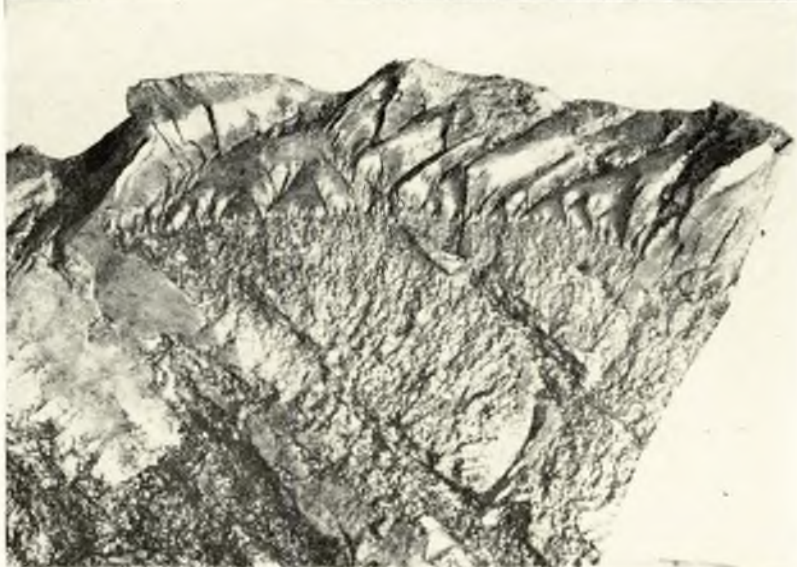
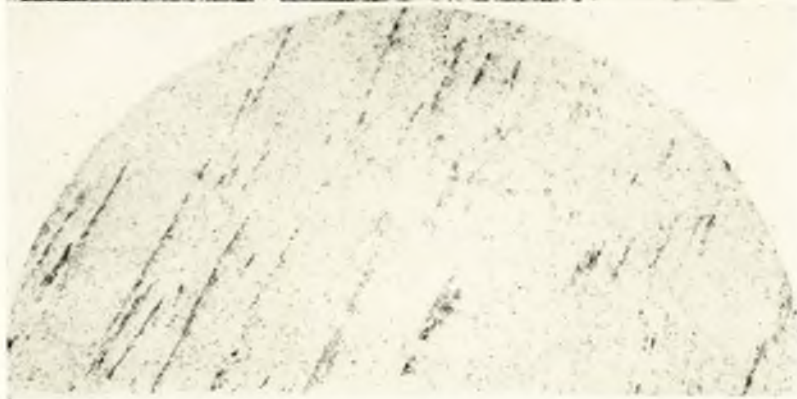
The occasional case does arise where a failure is entirely due to defective material which could not be detected by normal inspection of the finished machined shaft. A defect of this kind occurred in the crankshaft of an 8,500-h.p. oil engine. The shaft failed through a crankpin during the maiden voyage and the fracture (Fig. 19) contained multiple origin fatigue cracks extending round the entire periphery of the crankpin to a maximum depth of about 2 inches. The major portion of the fracture was coarsely crystalline with pronounced directional features (Fig. 20). A sulphur print through a section of the pin (Fig. 21) showed severe bands of segregation which outcropped on to the working surface of the crankpin. Tests also showed that the pin had poor mechanical properties. The steel was generally dirty, containing numerous globular oxides, complex slag inclusions and sulphide particles. These undesirable features were the primary cause of the failure of this crankshaft.

FIGS. 19 and 20—*Fractured crankpin, showing crystalline nature of central area*
FIG. 21—*Sulphur print from crankpin*

Unfortunately this is not an isolated case and the Society has experienced others in which poor quality forgings have proved to be the cause of failure. Faulty material cannot be tolerated in such a component, and ultrasonic testing is strongly recommended to ensure that forgings with major internal defects do not go into service.

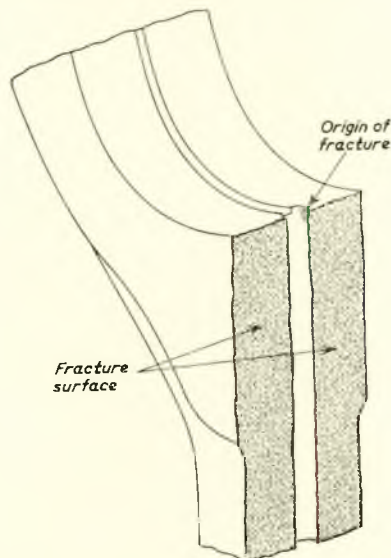
There have been several cases in which the connecting rods of some oil engines have fractured longitudinally from the edges of oil holes in either the top or bottom forked ends. Investigations have shown that these fractures were due to fatigue and were not associated with defects in the steel. Fig. 22 is a sketch showing a fracture at the top end of a rod. In this and in the other cases the fatigue cracks originated at sharp notches, represented by either unradiused oil holes and/or an adjacent tapped hole on the transverse axis of the fork.

FIG. 22—Typical connecting rod failures

The roots of the forks are subject to fairly high levels of alternating stress. Sharp notches and large diameter oil holes are undesirable features at these positions. Where possible, oil holes should stop short of the fork at the bottom of a rod. This practice eliminates the stress concentration. When it is essential to drill the oil hole through into the root

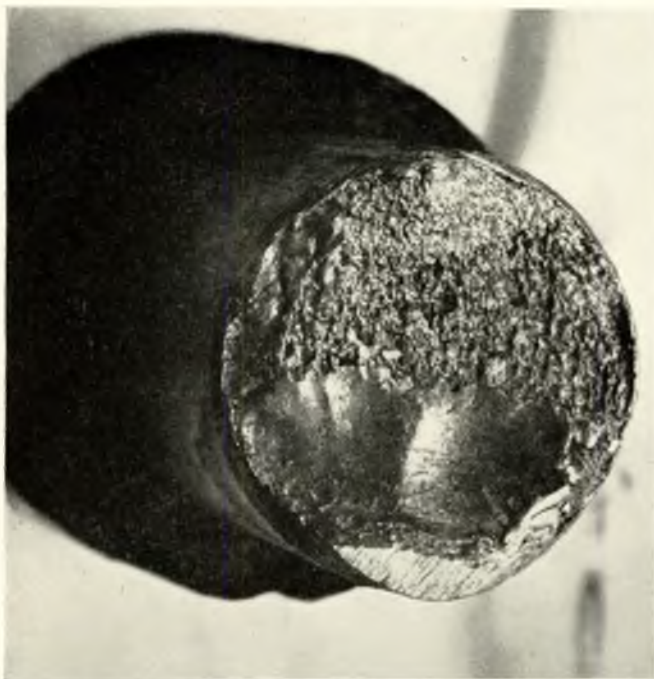
Coupling bolt failures are often associated with fretting corrosion. In one recent case a failure occurred in the coupling bolts between the intermediate and screwshaft when the oil engine governor failed to function in heavy weather and the engine overspeeded. The shaft coupling faces were badly fretted and torn in way of the bolt holes. Examination of the bolts showed evidence of fretting and corrosion on the surface of the shank and the bolts had fractured inside the screwshaft flange. Fig. 23 shows a typical fracture surface in which the origin of fracture had occurred at one point at the surface of the shank. It is considered that failure of the bolts was due to fretting corrosion fatigue. The fatigue crack had probably been present for some time and the breakdown of the governor

FIG. 23—Coupling bolt failure

control of the engine led to a sudden increase of stress in the bolts.

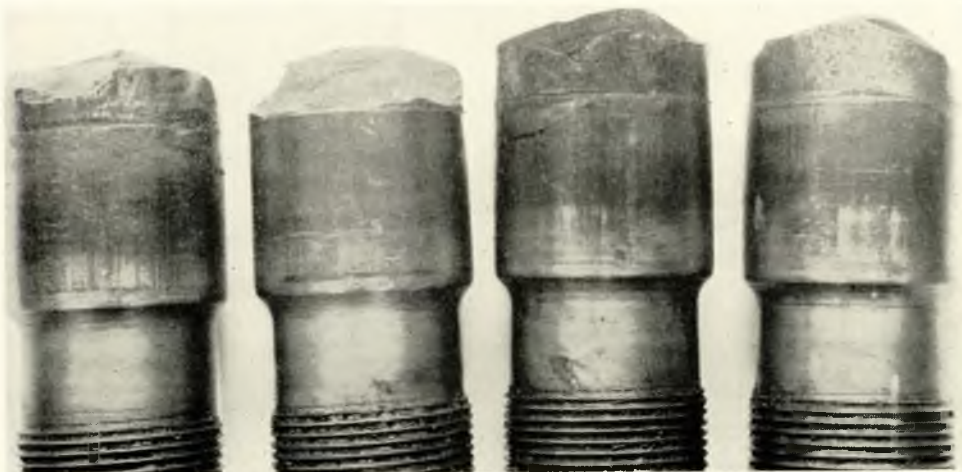
FIG. 24—Fretting corrosion failure of coupling bolts

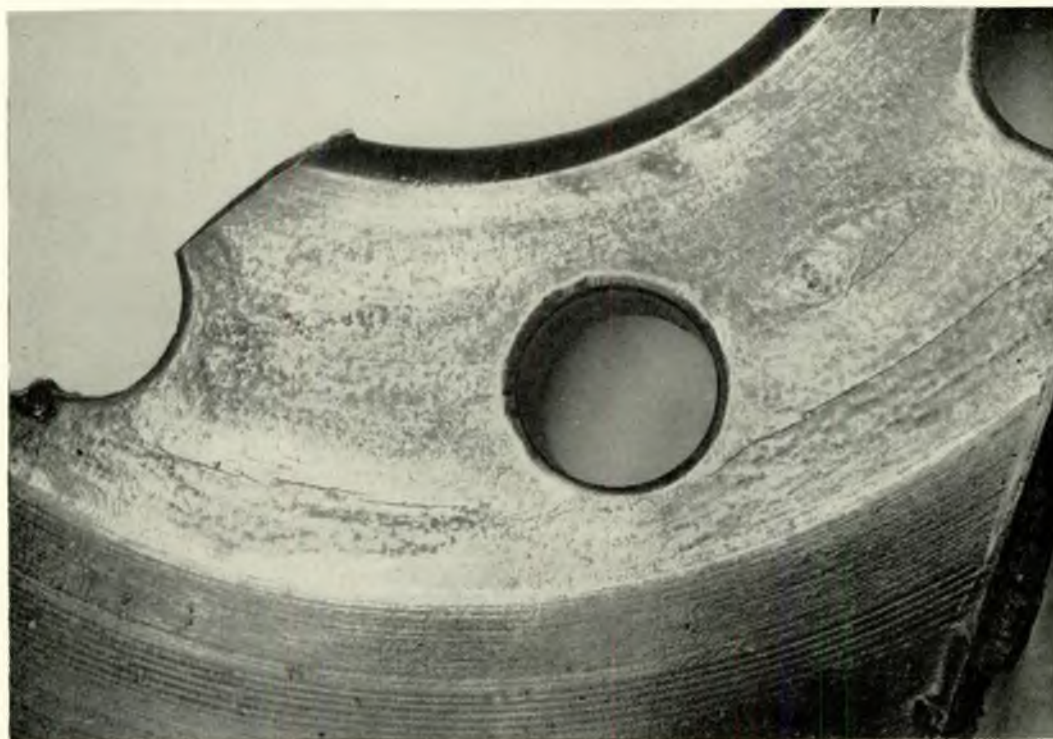
FIG. 25—Cracked scavenge pump piston

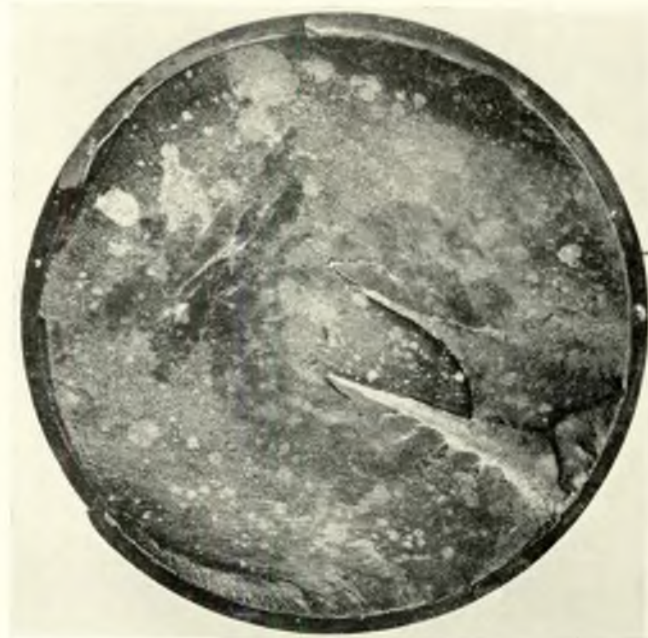
FIG. 26—Corrosion fatigue failure of tie rod

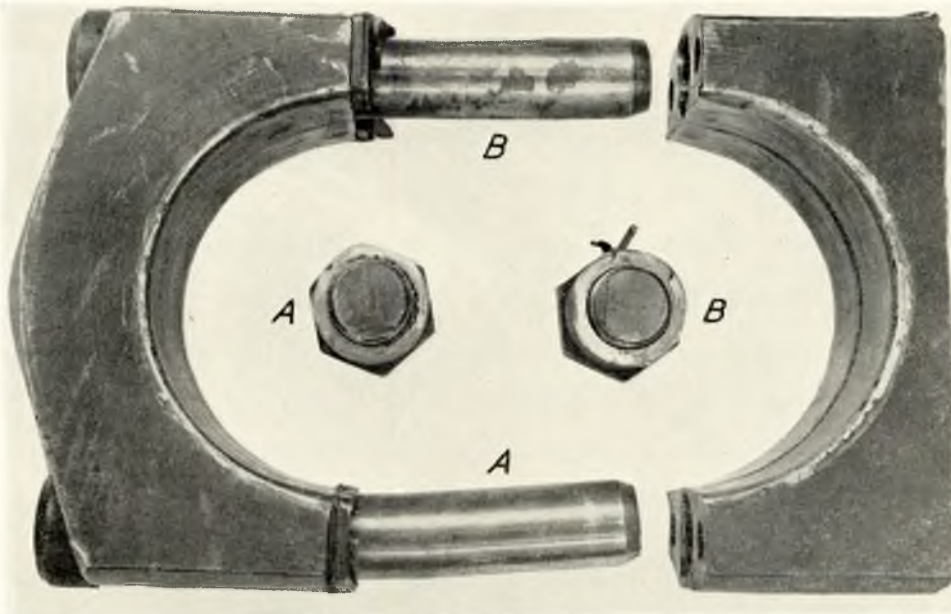
FIG. 27—Fractured auxiliary bottom end bearing

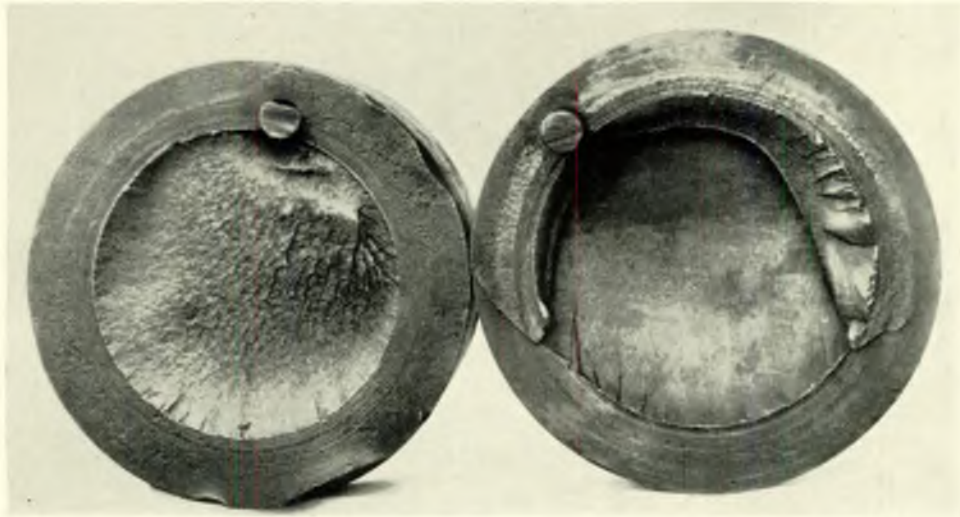
FIG. 28—Top end bearing bolts

bolts had fractured due to fatigue, two of which are shown in Fig. 28. Examination of the fracture surface showed that the cracks originated not in way of the dowel pin but all round the root of the fillet between the head and shank. This type of failure was indicative of a sharp stress concentration, and this was borne out by the very sharp fillet radii at the roots of the heads of the bolts. The importance of an adequate radius at sudden changes of section subjected to high fluctuating loads cannot be over-emphasized, since the stress concentration factor of a sharp notch is remarkably high. This has also arisen in other recent cases in which fractures originated at the roots of badly cut threads. The radii at the roots of these threads were negligible and the fatigue cracks followed these stress concentrations for several complete turns. Three breakdowns which were attributed to this fault caused serious damage to the machinery.

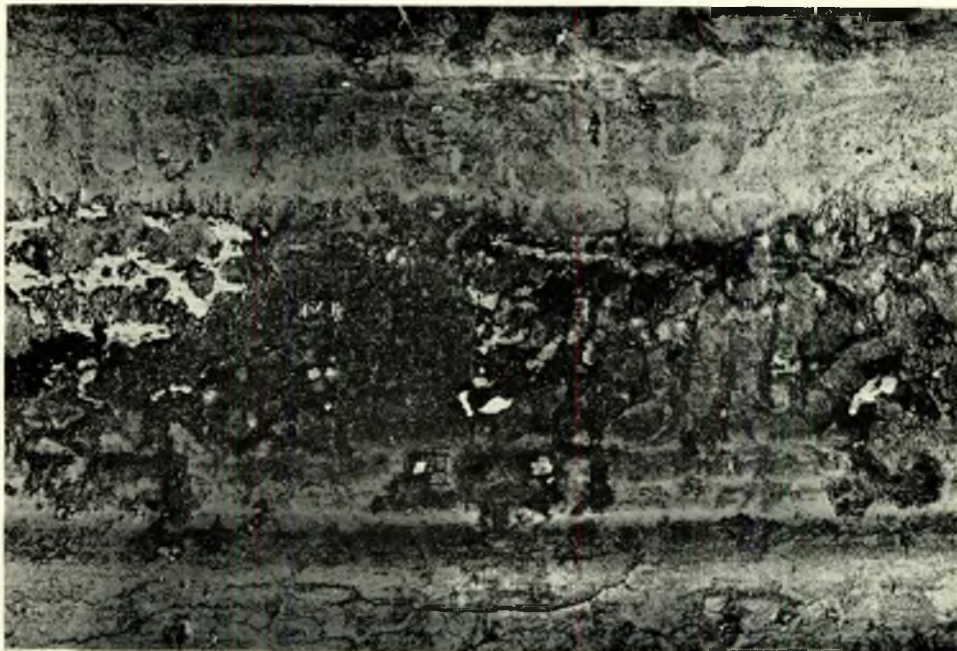
FIG. 29—Furnace cracking due to oil contamination

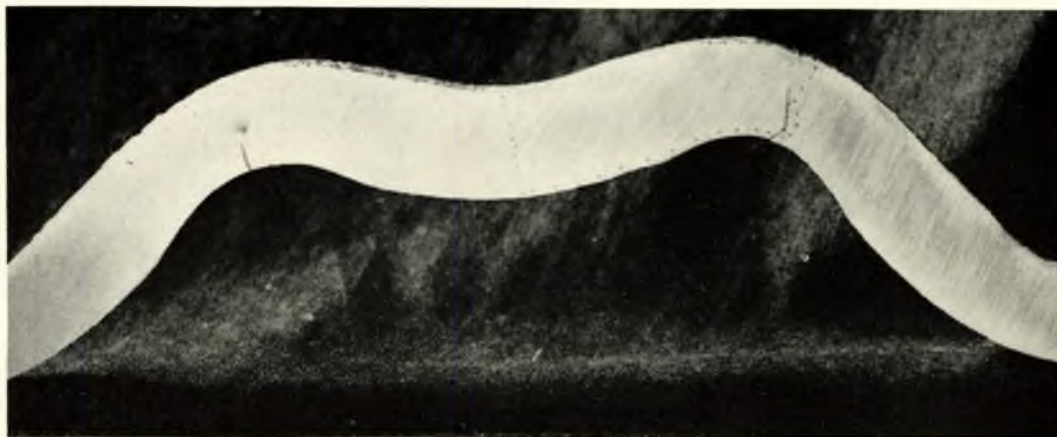
FIG. 30—Cracks in the furnace corrugations

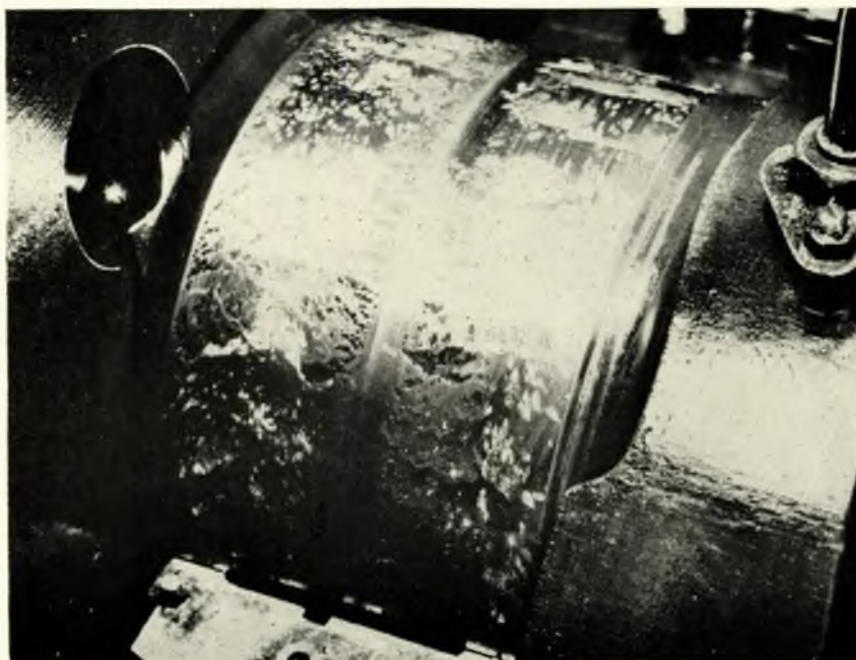
FIG. 31(a)—Damage to journal and crank pin due to contaminated lubricating oil

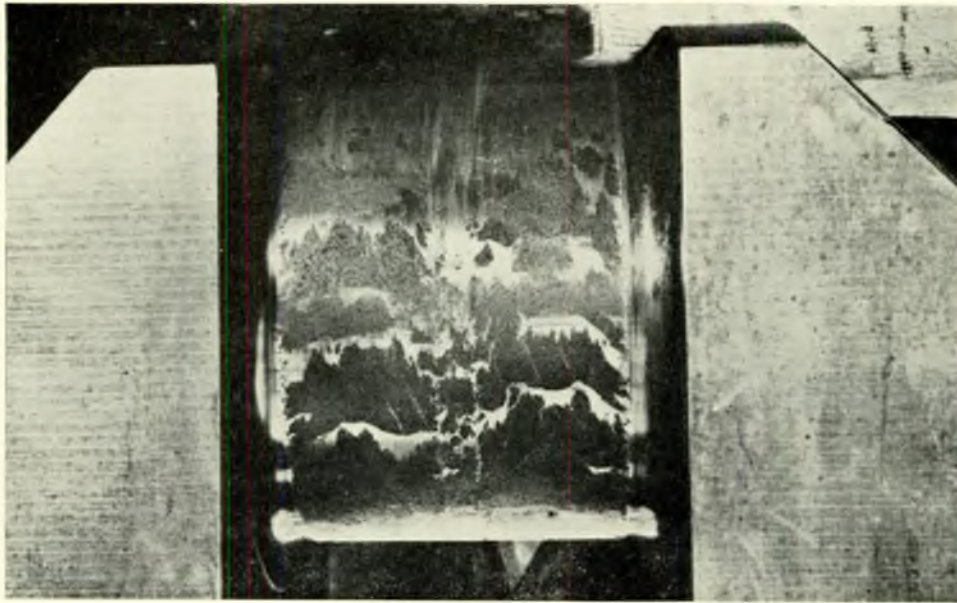
FIG. 31(b)—*Damage to journal and crank pin due to contaminated lubricating oil*

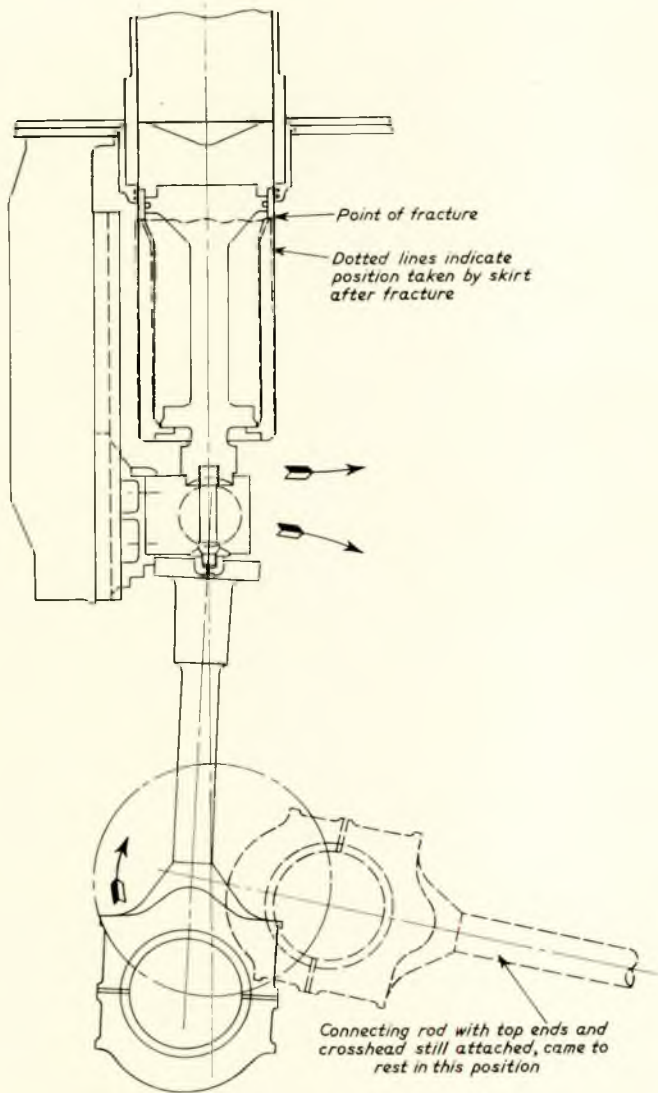
FIG. 33—Sketch illustrating sequence of events after piston skirt had fractured

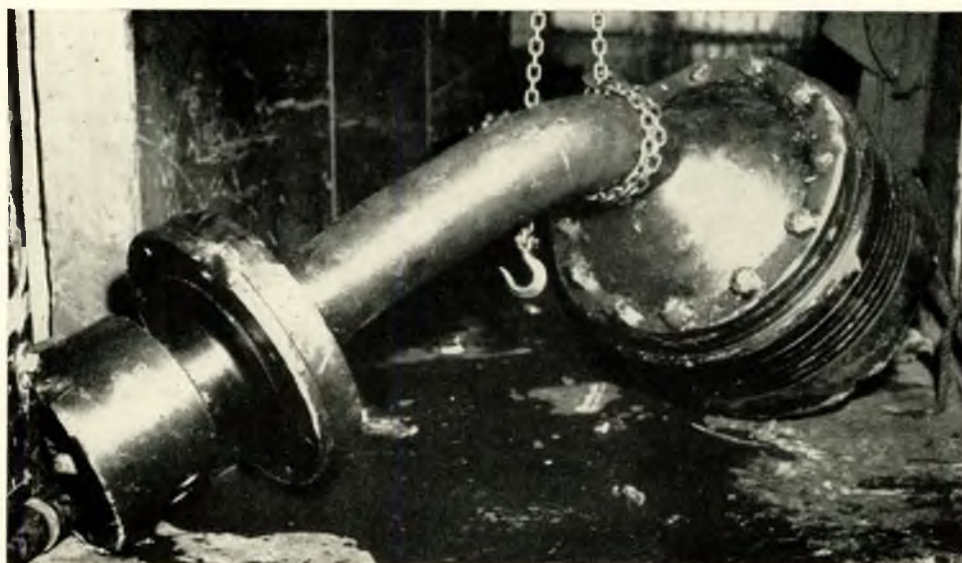
FIG. 35—Damaged piston 2nd rod
