Operating Experience with Large Modern Turbocharged Heavy Oil Engines

G. McNEE, B.Sc., C.Eng. (Member)* and J. McNAUGHT, C.Eng. (Member)†

The paper is generally confined to the experience acquired in vessels owned by the authors' company and propelled by Sulzer RD76 or RD90 engines operating on heavy fuel. After an historical introduction, the paper continues with sections on the design aspect of the engines and operational experience, and concludes with some reflections on the future of slow-running Diesel engines with particular regard to supporting services for their operation and maintenance.

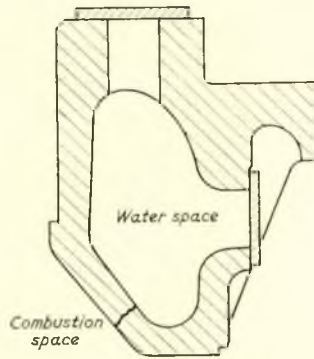
FIG. 2—Section of cylinder cover showing position of typical crack

These gave no trouble at all until April 1965 when a cracked cover occurred at sea on one vessel. Investigations revealed that the crack started from the water space and progressed towards the combustion space. Fig. 2 shows a typical example of a fracture and Fig. 3 the extent of the cracks in one vessel. In all there have been 36 cracked covers in a total of eight ships. The majority of the defects was found by inspection when the basic cause and mechanism were realized. Briefly, it can be stated that the surface finish of the castings was not of a sufficiently high quality for the service required.

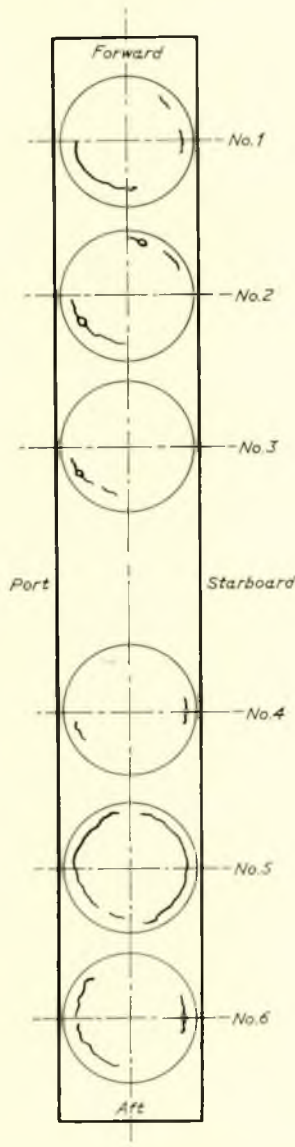
FIG. 3—Plan of engine top showing position of cracks in the cylinder covers of one engine

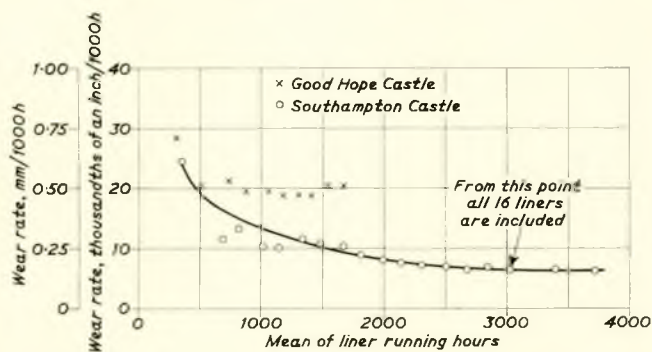
The graph in Fig. 4 is the record of wear based on cumulative hours operation in order to allow comparison between the ships which entered service eight months apart. It also shows the trend in the wear.

FIG. 4—Cylinder liner wear rate
