MARINE MACHINERY FAILURES

B. K. Batten, M.Sc., C.Eng., M.I.Mar.E.*

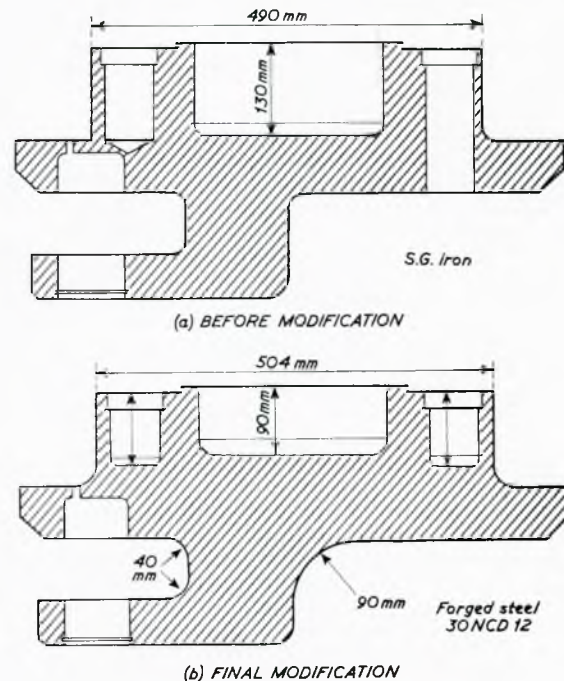
Two interesting cases investigated concerned failure of a propeller blade pivot and of a control system. Examination of a broken blade pivot on one vessel led to the examination of similar rings on other vessels which were also found cracked (Fig. 1). The rings were made from S.G. cast iron, and the cracks originating from the fillet between the boss and the

FIG. 1—Variable pitch propeller blade pivot rings

flange had fatigue characteristics. Metallurgical examination showed that while there was extensive galvanic corrosion pitting in the fillets, the fatigue cracks had not originated from these points, but from apparently notch-free surfaces. The structure of the cast iron contained numerous zones where inoculation had not been effective and, while this is normal in fairly large castings, their incidence in this pivot was higher than normal. Changing these pivots to a carbon steel of 0.32ton/in² U.T.S. and increasing the fillet radius (Fig. 1b) cured the problem.

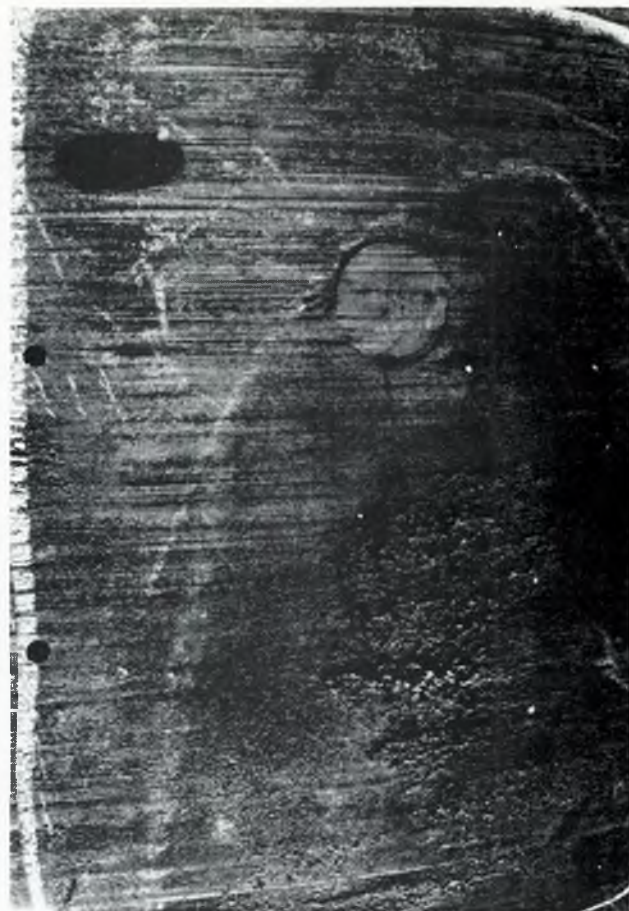
FIG. 2.—Pitted tailshaft liner

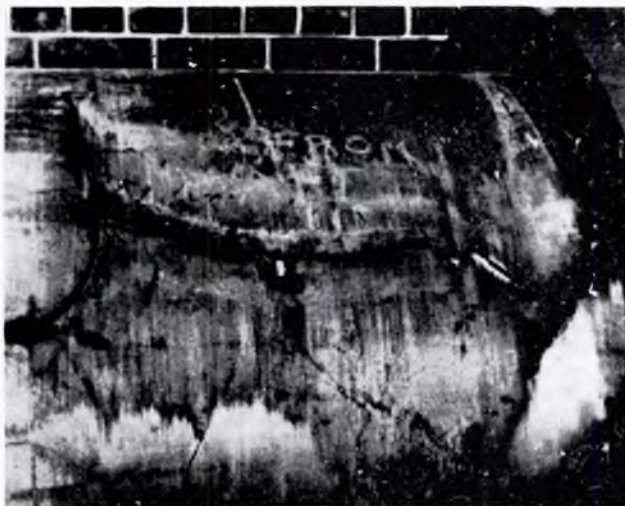
The port tailshaft was drawn. The liner was found fractured in many places in an entirely random pattern, (Fig. 3), and the synthetic resin bush severely overheated and charred thus blocking all water channels. A metallurgical examination showed that the liner had failed under cyclic thermal stressing and that

FIG. 3—Thermal cracking of a liner

the tailshaft itself was fractured under the liner.

The most likely causes of the bush failure were:

- a) Water starvation due to inadvertent shutting of the service stop valve, though both shafts were supplied from a common line, branched through unmistakably clear gauge glasses and any serious water shortage would certainly have damaged the forward end shaft seal;
- b) Hygroscopic swelling of the bush material producing insufficient bearing clearance, though both shafts were stated to have had the same initial clearance.

It is certain that the blockage of the stern bush water channels must have occurred early in the ship's life. The continual stopping and starting characteristic of a cruise ship could have induced severe thermal cycling requisite to cause cracking of the liner. If the correct cause is obscure, the moral is obvious; gauge glasses and thermometers etc., however remote from the hub of activity in the comfort of the control room, are not there just for amusement; they are meant to be used intelligently.

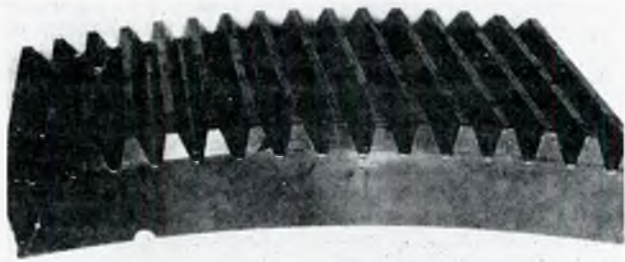
Fractured teeth in the main reduction gear wheels of a 15 000 hp motor cargo ship, leading to axial slip of the

rim under the helical tooth forces, inspired a detailed investigation (Fig. 4). Alignment of the main wheel to the shafting was satisfactory and local malalignment between the main wheel and the two engine pinions was suspected. In particular, interest was directed toward the movement of the pinions under clutch plate forces. In this case, phased readings

FIG. 4—Cracked main wheel rim

of the tooth bending stresses showed the pinion to be “tumbling” under the action of a radial clutch force generated by a slight displacement of the clutch plates when engaging. This could in fact be stopped by de-clutching one pinion, and then re-engaging when both pinions were running at the same speed. Measurements taken at the main wheel tooth roots showed superimposed stresses due to this movement. Re-design of the clutch-pinion bearing supports eliminated the clutch engagement effect and allowed greater control of pinion alignment and hence more uniform tooth loading.

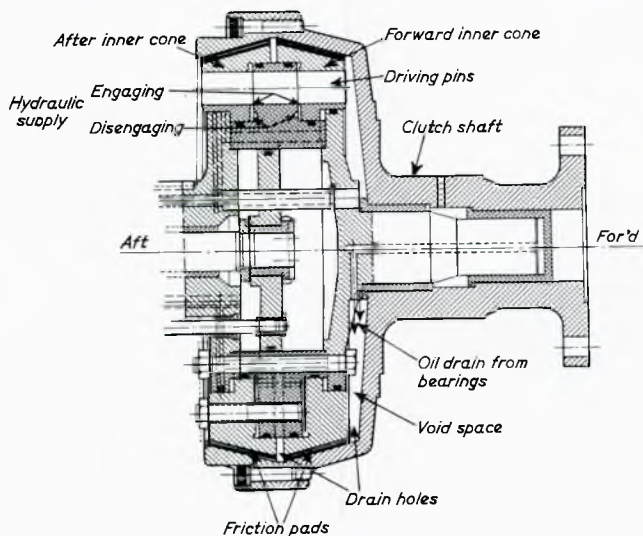
A clutch failure leading to a train of other troubles occurred on a roll-on/roll-off container vessel having a 14000 bhp 8 cylinder non-reversing oil engine running at 375 rev/min and driving a 3-bladed c.p. propeller through an hydraulically operated friction clutch. The vessel was not to Lloyd’s Register Class. See Fig. 5.

main lubricating oil filters, mainly with fine particles, and the whole oil charge contaminated. This trouble recurred, when the main engine crankshaft was found to have moved forward damaging the locating bearing and the timing gear train. The aftermost friction lining of the clutch was worn, while the forward lining was in good condition.

FIG. 5—Clutch arrangement

When changing from manoeuvring to passage alternators, the blackout was long enough to cause a marked drop in clutch oil engaging pressure, and automatic re-starting of the oil pump could bring a sudden application of full load torque on the clutch. Since the design was such that any residue of drain oil in the void space in the clutch was at this point thrown out between the forward lining and the clutch shaft, it was apparent that full load torque could be thrown suddenly on the aftermost lining after every blackout. It was apparent that a major re-appraisal both of clutch design and of the electrical system was required.

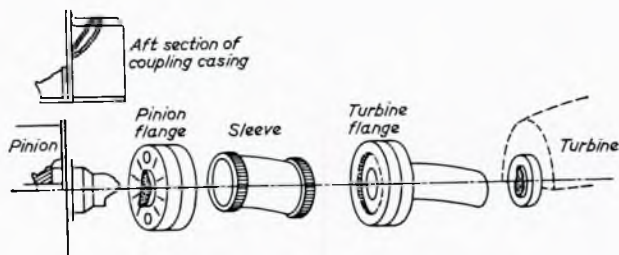
From the outset it was clear that the engine room fire was consequential on the flexible coupling failures, which allowed lubricating oil to spray on the H.P. turbine. The remainder of the significant damage in way of the H.P. turbine and pinion unit was confined to five components. See Fig. 6.

FIG. 6—Flexible coupling failure

flange, events would have moved rapidly. It seems likely that as failure of the pinion shaft occurred across the final holding area, which was offset from the central axis of the pinion, the pinion flange turned out from the centre axis still restrained by the stiffness of the now distorting flexible coupling. It must be remembered that the fore and aft float of the pinion was restrained by it being a double helical gear, and the float of the H.P. rotor restrained by its thrust pads. Therefore, the pinion flange and coupling sleeve would be prevented from flying out until the rim of the flange had cleared the end of the pinion shaft, and this would account for this shaft end and the pinion flange back-face being hammered. How long this took one cannot say, probably no more than seconds, during which much of the energy of the turbine would have been absorbed in belling out the after turbine bearing.

The pinion flange finally broke on upward swing, coming out and carrying with it the flexible coupling cover. The coupling sleeve appeared to have worked itself out of the turbine coupling ring in two or three revolutions, heavily distorting the teeth on its way. The H.P. rotor was undoubtedly still turning at this moment but must have seized shortly after, causing the whirling coupling flange and shaft to break. On opening the H.P. turbine later, it was seen that at the moment of failure of the rotor shaft, it must have been nearly at standstill as the damage was confined to a small part of the shrouding of the aft two rows of blades.

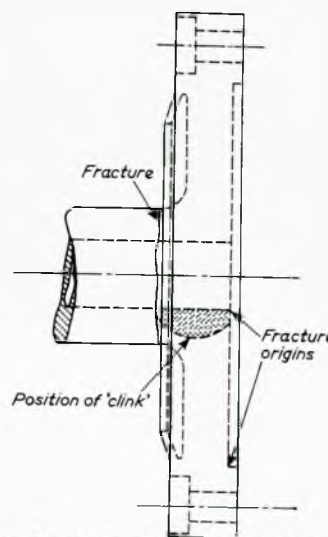
The metallurgical examination showed not one, but three distinct origins of failure. See Fig. 7:

FIG. 7—Pinion shaft forward flange

- i) Through a point on the lip of the bore and on the face of the flange, that had propagated round the shaft so as to sever it completely;
- ii) A second crack having an origin adjacent to a sharp step forming the rim of the flange;
- iii) A longitudinal crack extending from the bore surface of the central hole and penetrating the flange radially for a distance of 1.2in. This was a brittle fracture having the appearance of a clink in the original forging, most of which had been removed in the boring operation.

It was concluded that the initial crack propagation probably emanated from this large latent defect in the bore, possibly formed during heat treatment of the pinion forging.

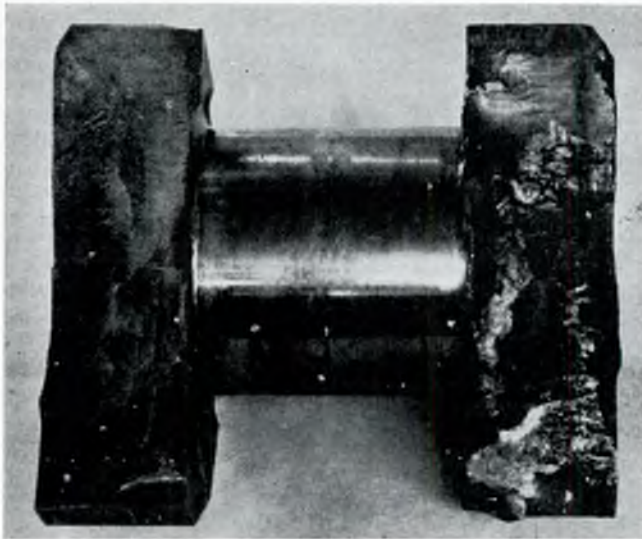
A major breakdown concerned the starboard oil engine of a twin, 14-cylinder, V-engine installation, developing a total of 11 480 bhp. The crankshaft failed without prior warning during normal service, though two weeks earlier oil mist detectors had operated the alarm but no signs of overheating had been found. Damage was confined to cranks 4-11 and 5-12 (from aft), crank 4-11 being fractured across both webs—a most unusual feature. See Fig. 8. Several balance weights were subsequently

FIG. 8—Failure across two webs

found slack, and the crankshaft was seen to have been contacting the top halves of bearings Nos. 1, 2, 3 and 4 (from aft). This suggested misalignment, probably between engine and gearcase. Checking of the port engine showed a lateral discrepancy of 1/32 in due to an error in a coupling aligning jig, and crankshaft deflexions on both engines, had apparently been considerably greater than normal.

The appearance of the surfaces, together with the fact that cracks had been found in another fillet radius, suggested that in addition to normal service loadings the crankshaft had been subjected for some time to a bending moment which had been reasonably uniform over four lengths on each side of the centre-line of No. 3 unit; and that the cyclic stresses arising from rotation of the crankshaft under this bending moment were primarily responsible for the fatigue failure.

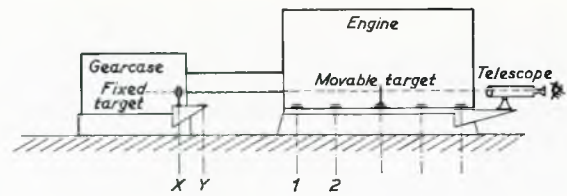
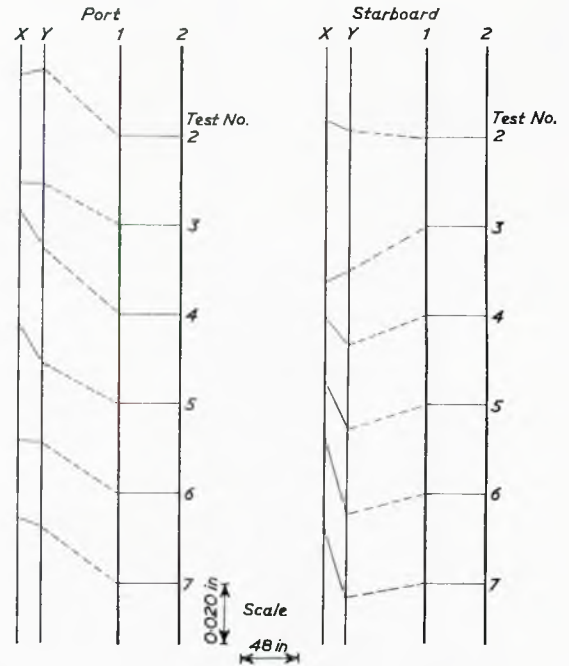
From extensive alignment measurements using telescopic and proximity transducer methods it was concluded that significant changes in alignment took place not only due to temperature changes in the engine, engine seating and double bottom structure in way of the lubricating oil tank, but also due to changes in cargo distribution in holds and deep tanks. Heating of the double bottom lubricating oil tank alone gave engine to gearbox vertical and transverse alignment changes of 0.030 in. Fig. 9 gives some alignment changes under different loading conditions. It was also found that under certain conditions of engine hog, the journals lifted from the bearings and gave spurious crankshaft deflexions. It was concluded that these large alignment changes

FIG. 9—Gearcase alignment changes relative to after end of main engine

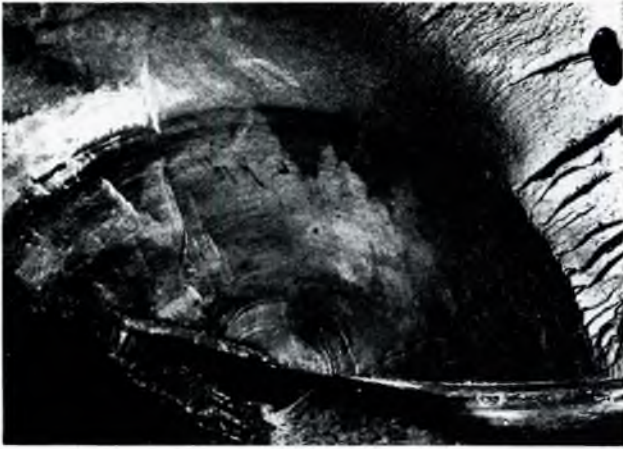
FIG. 10b—Point of origin of fatigue fracture

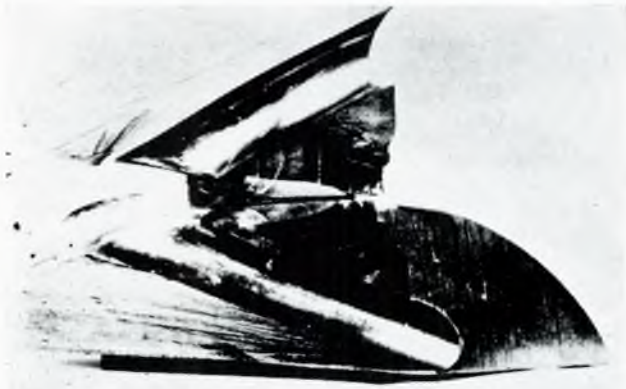
This, and the discovery of further cracks in shafts held in stock, threw new light on the whole problem. The shafts had a U.T.S. of 57.1 tons/in² and, after final machining including total finishing of the oil holes, were induction hardened on the pins and journals to a depth of 0.12in. It was the practice in this process to close the oil hole entry with a copper plug which was then hammered over to fill the radiused area so as to avoid sharp

FIG. 14—Fracture at crankshaft oil hole

thermal gradients. This was clearly not successful, as metallurgical examination of some of the other cracks showed the origin to be at the point where the hardened zone met the oil hole radius.

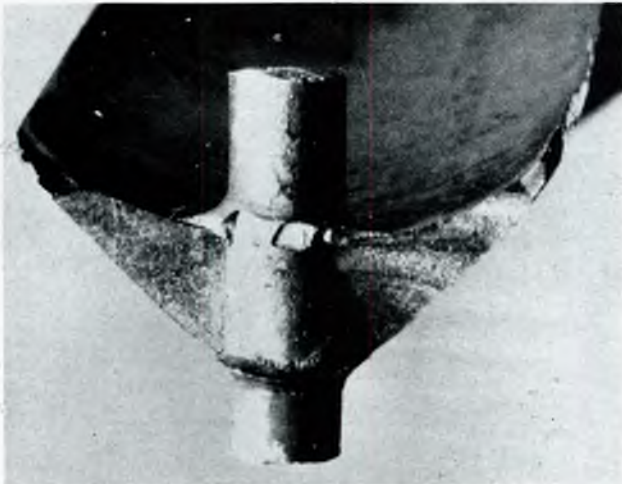
FIG. 15—Blade failure in way of blading wire

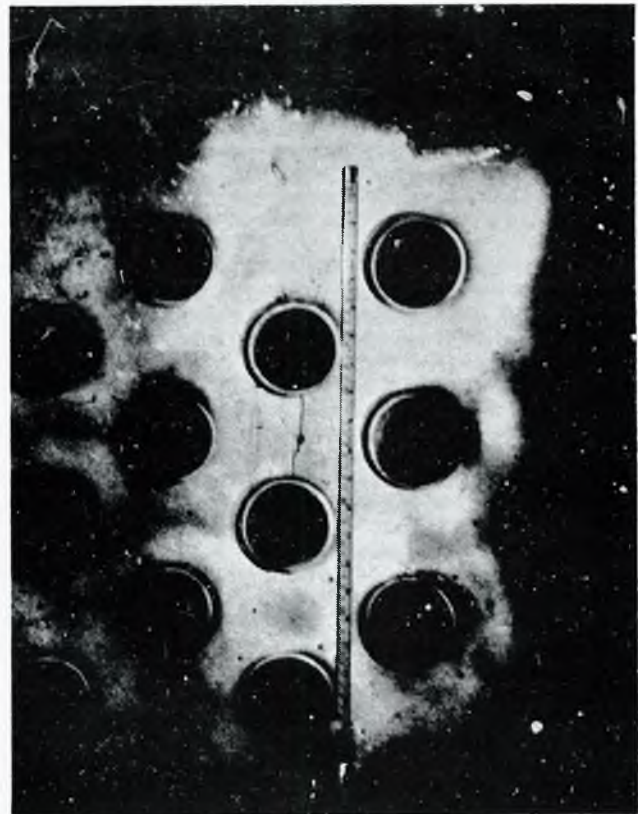
It was seen that the tube had not been fully expanded in the drum, there being a visible clearance on the external surfaces of the drum between the tube and its hole, extending around 50 per cent of the tube. The boiler history showed this tube had been removed some 3 months previously for access purposes, and there was then some difficulty in sealing the new tube. The tube holes were themselves good, though the mid-position groove in the holes had rather sharp corners.

FIG. 16—Ligament crack in a main steam drum

Metallurgical examination of chippings taken out of the drum and containing the crack showed it to be a transcrystalline fatigue crack. It appeared that the failure had been initiated by overstressing of the drum material due to excessive pressure when rolling with the expander. The stress concentration induced at the edge of the holes when combined with the stress due to service conditions and the stress due to the inevitable work-hardening round the holes, could produce total stresses approaching the yield point of the material.

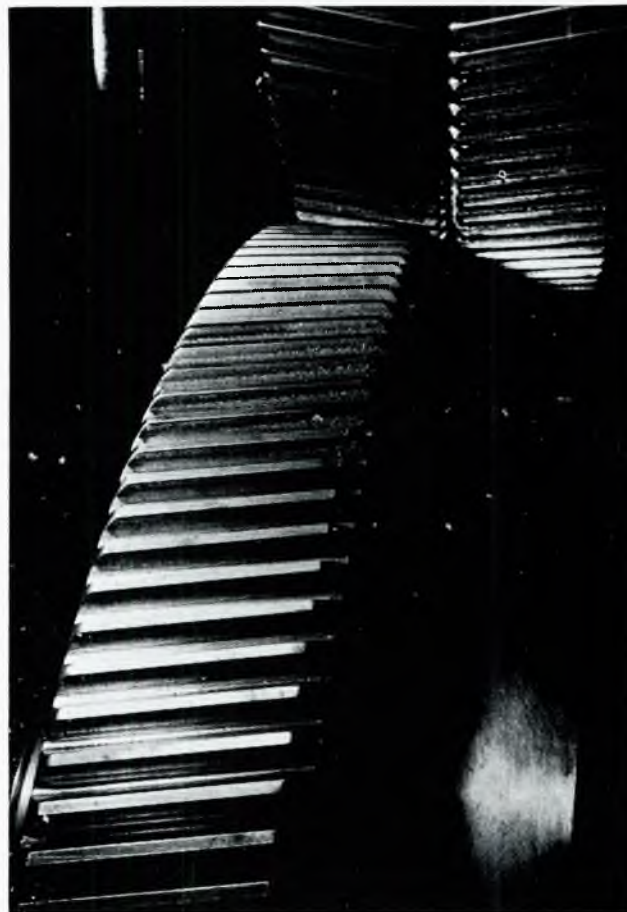
FIG. 17—Selective pitting on camshaft drive gears

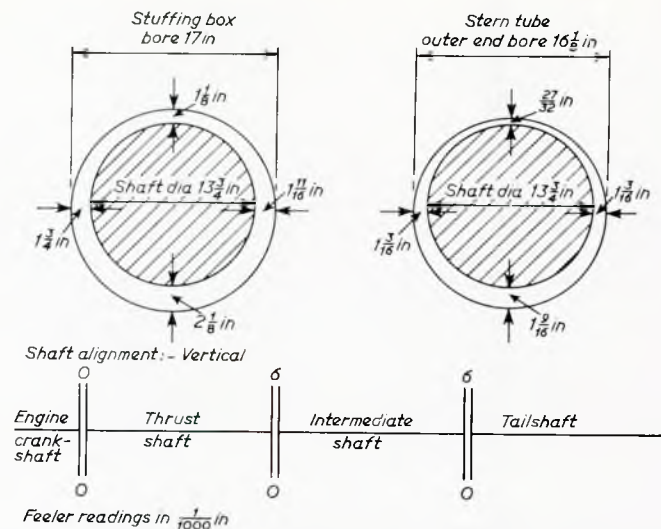
FIG. 18—Starboard shaft alignment—Intermediate shaft and tailshaft lined up on rollers through sterntube

outside of the boss of the A bracket. Fig. 18 illustrated the condition when the shafting had been set up as described. Repairs had consisted of drawing the sterntube, welding in a new piece of plate in the after peak bulkhead, welding up the landing in the eye of the "A" bracket to a sufficient amount to permit correct centring of the tube, and then re-boring all on the correct centre line. Thereafter, the sterntube, tailshaft etc, were all re-fitted.

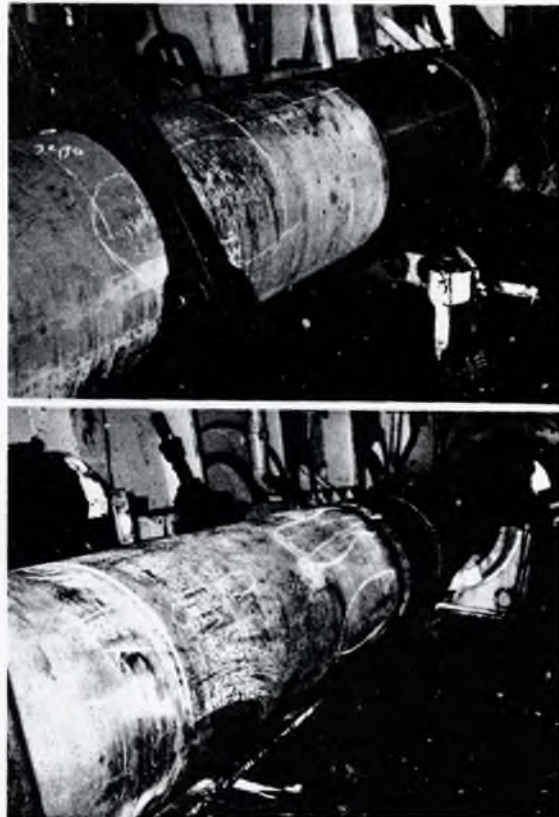
FIG. 21—Erosion-corrosion pitting of propeller shaft liners

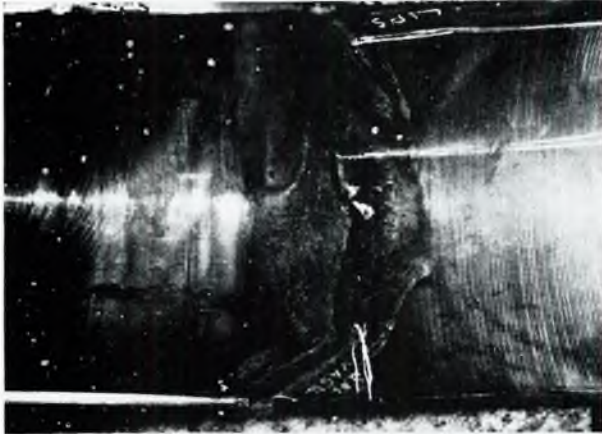
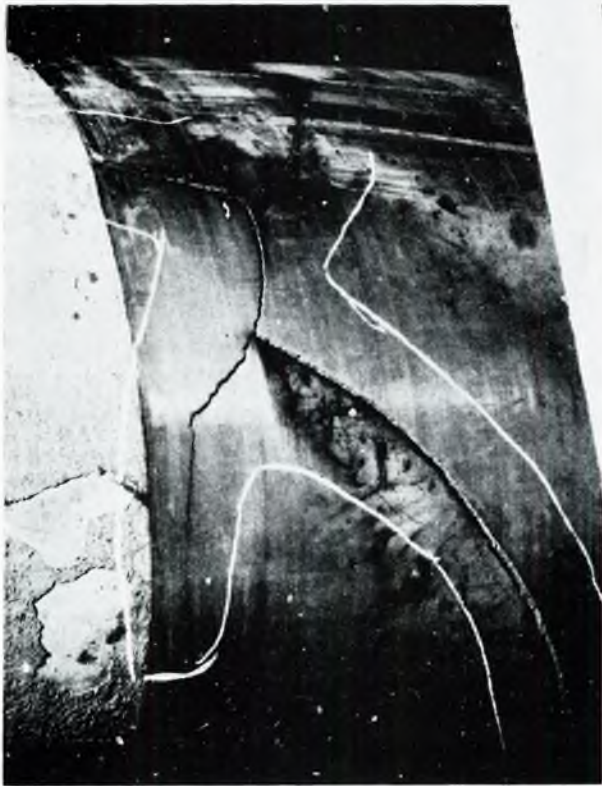
FIG. 22—Fractures of propeller shaft liners

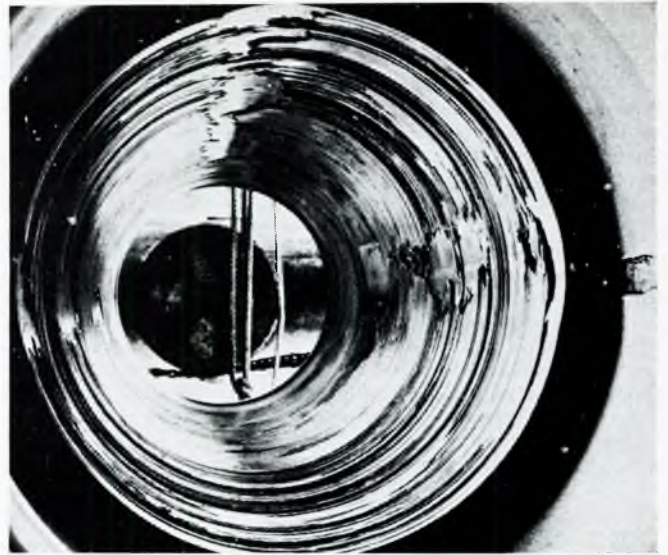
FIG. 23—White metal damage due to loss of contact at bush

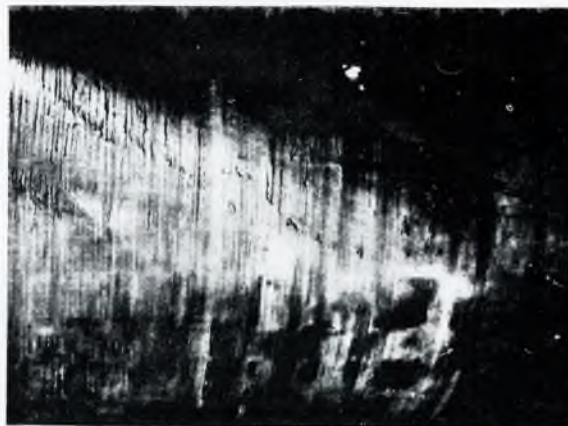
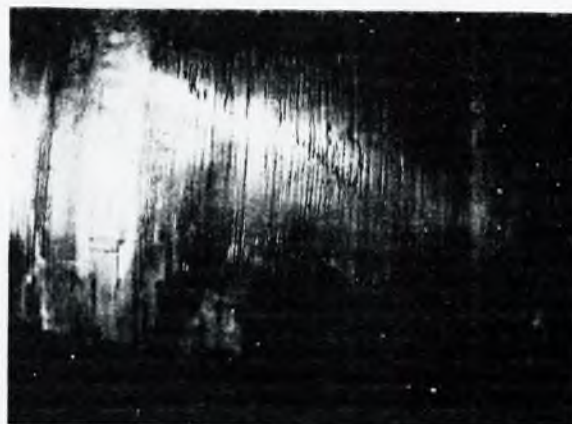
FIG. 25—Erosion-corrosion pitting process of propeller shaft liner arrested by rational alignment

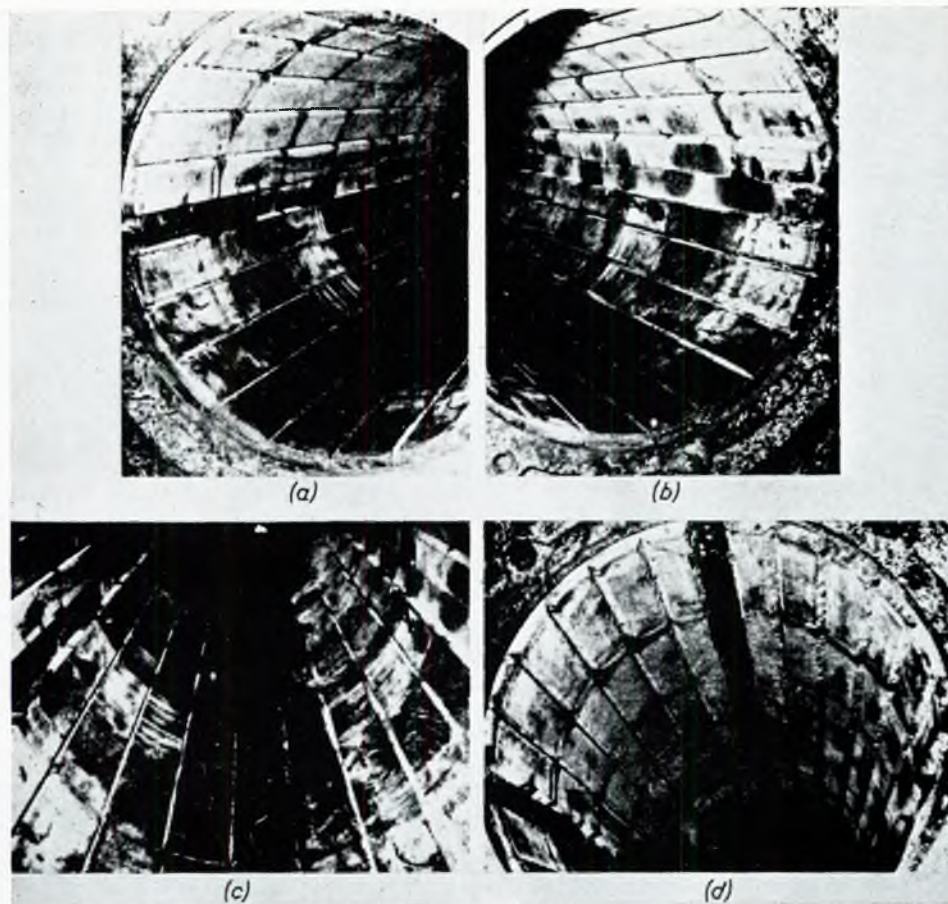
FIG. 26—Slope bored aft stern tube bush (lignum vitae) after a year of operation—(a) aft extremity of bush viewed towards port, (b) aft extremity of bush viewed towards starboard, (c) forward lower portion of bush (slope bored), (d) forward upper portion of bush

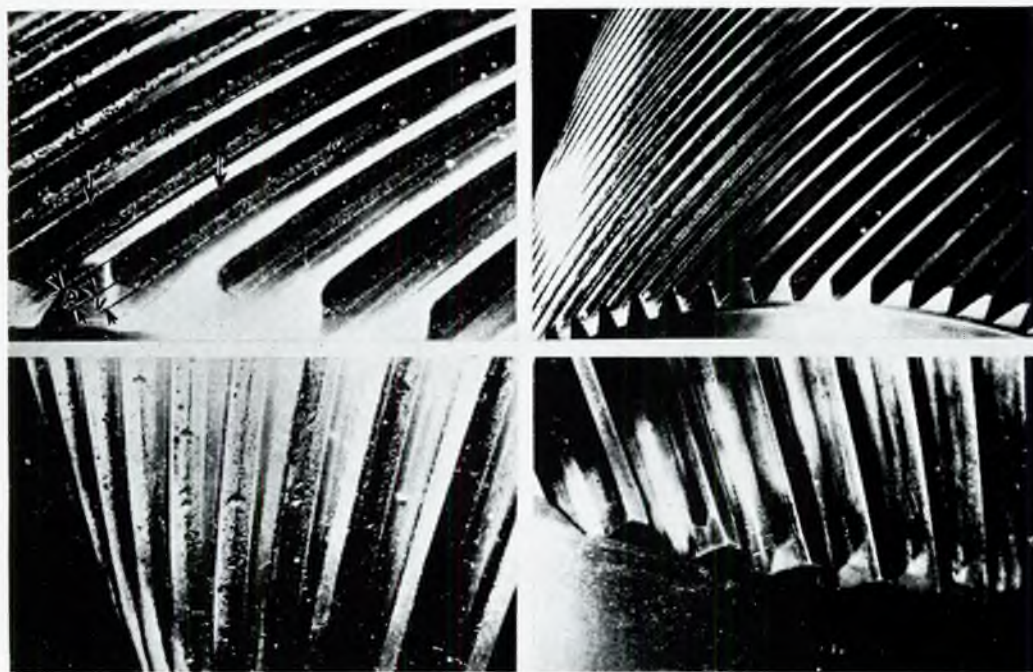
FIG. 27—Pitting, spalling and heavy wear of after helix caused by tilting of thrust block and a non-rational alignment of the shafting supports

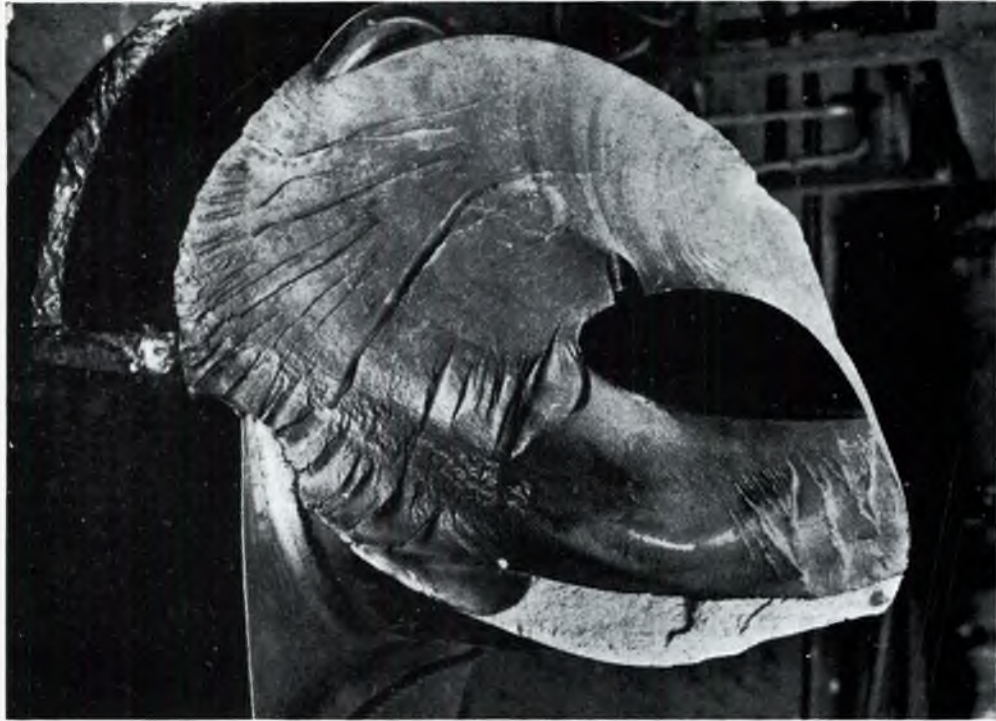
FIG. 29—Fracture caused by torsion bending

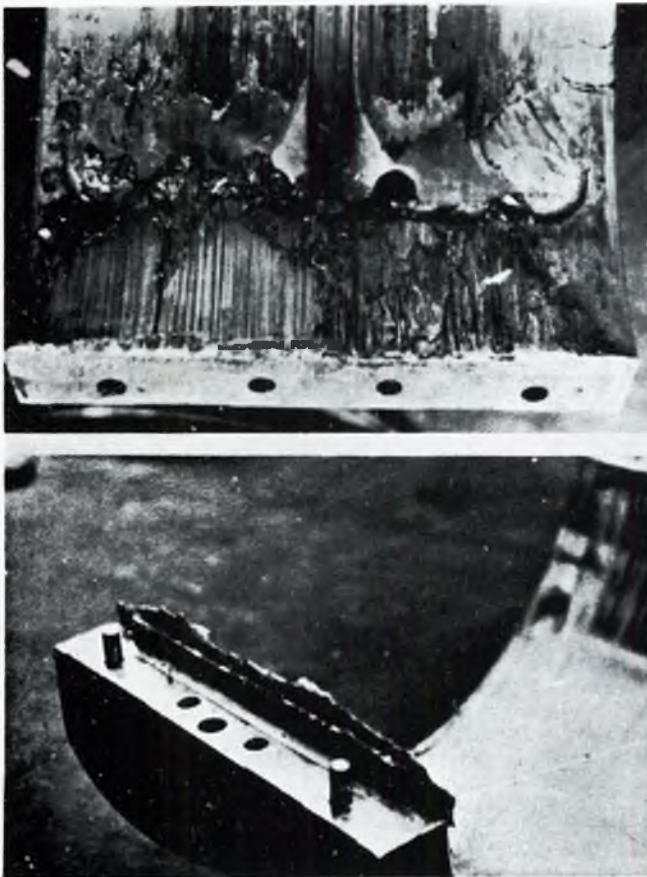
FIG. 30—Damage to shells of seized bearings

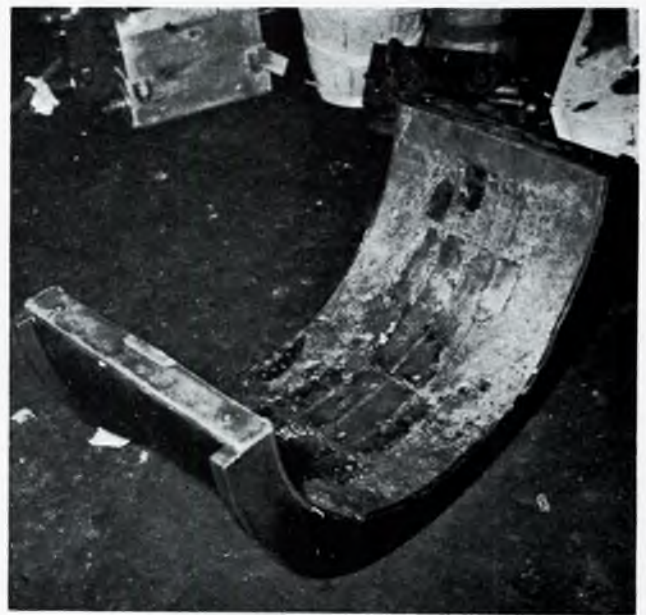
FIG. 31—Bearing shell damaged as a result of hammering

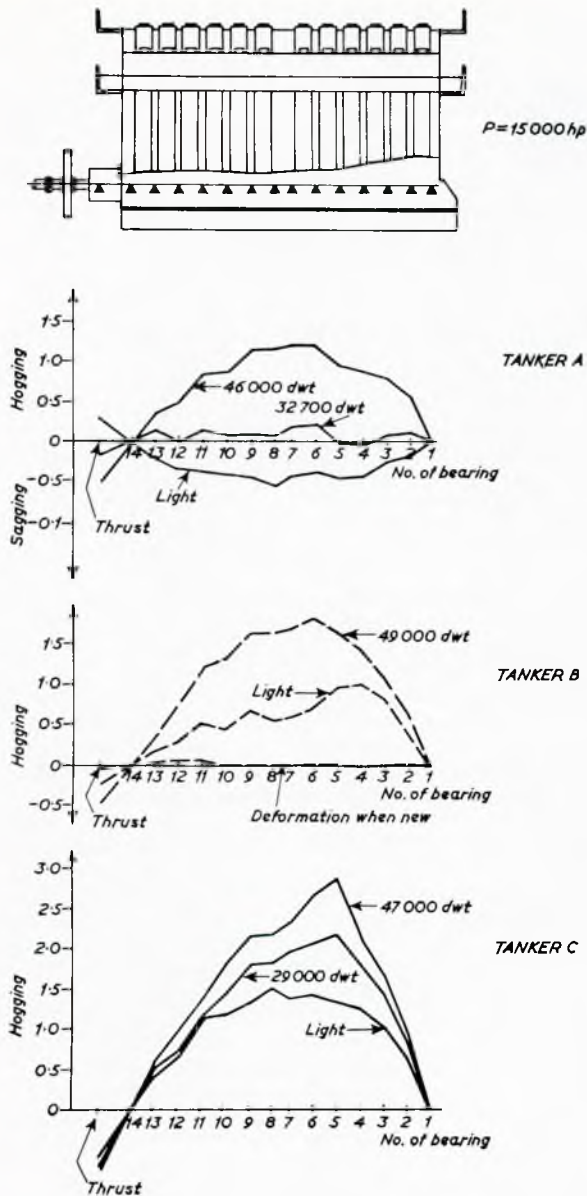
FIG. 32—Deformations of engine bedplates in tankers while loading
