NOTES ON SHIP MAINTENANCE

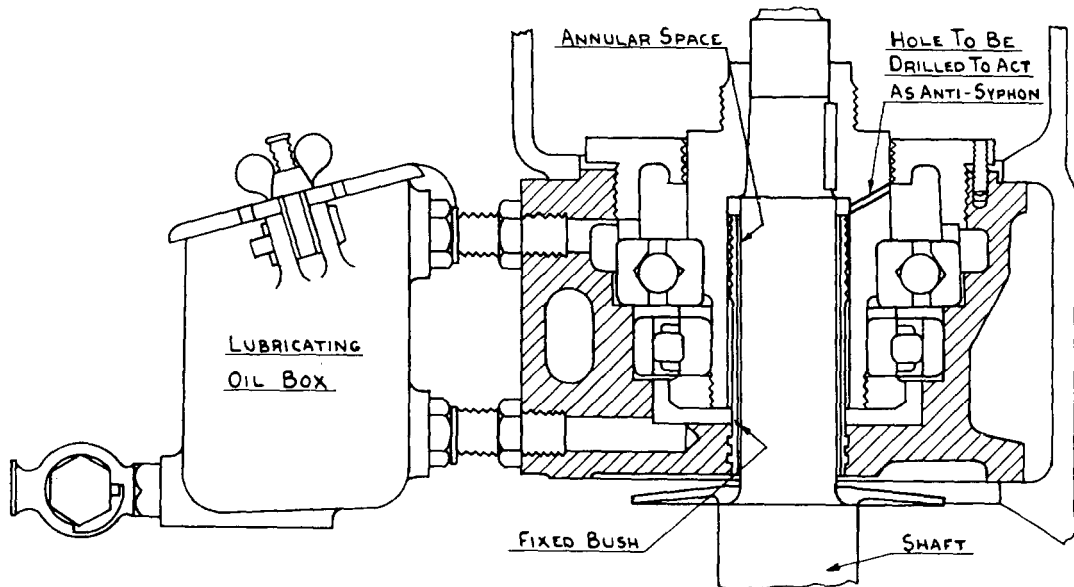
FIG. 1

Weir's Vertical Turbines—Oil Box Leakage

Trouble has been experienced in H.M.S. *Vanguard* due to oil leakage from the oil boxes of certain turbine-driven extraction pumps, fire and bilge pumps, and oil fuel service pumps. The loss of oil amounted to half a box full per hour per pump, the oil seeping away via the annular space between the shaft and the adjacent fixed bush. This effect is believed to be due to syphonic action, the oil being drawn over the top of the bush into the annular space.

The remedy being tried is illustrated in Fig. 1 and consists merely of drilling a hole continuous to the top of the bush, with the upper end as high as practicable, to act as an anti-syphonic device.

This hole was originally provided in Messrs. Weir's earlier designs but was discontinued later, as certain units were found from experience not to need such measures.
