# PROPELLER TIP WELDING BY THE CARBON ARC PROCESS

J. E. BURTON

*Engineering Department, H.M. Dockyard, Rosyth*

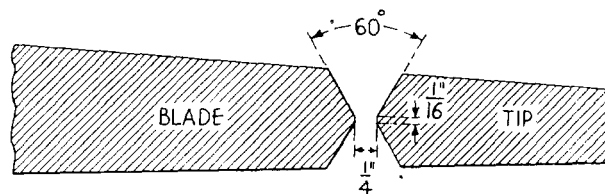
FIG. 1

It was decided to cut off a portion at a depth of 24", which resulted in a chord of 56" and a maximum section of  $2\frac{15}{16}$ " with aerofoil shape. The tip was cast in Stones ingot and being all new metal an additional 1" in depth was allowed to ensure sound metal upon which to weld, and after machining to permit a gap of  $\frac{1}{4}$ ". The edge was chipped to "double vee" preparation of 60 degrees with a root face of  $\frac{1}{16}$ " as shown in Fig. 1. The propeller was similarly prepared,

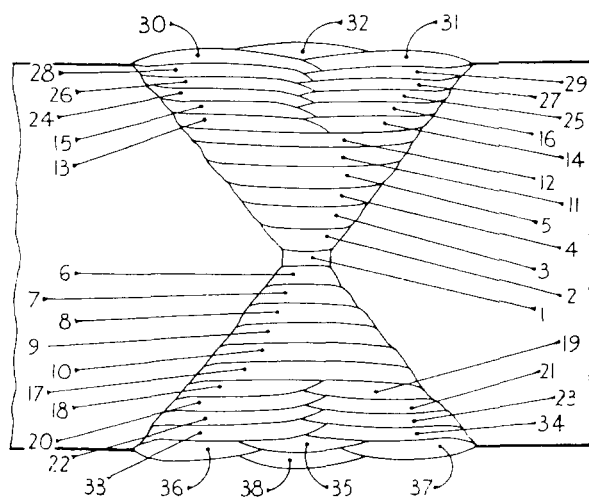
FIG. 3.—SEQUENCE OF RUNS

Another run was then made in the manner just described, after which the block welding was adopted. A sprinkling of flux was applied and the length of the block welded. Still using the  $\frac{1}{4}$ " diameter rod, a slight sideways movement was given to the carbon, while keeping it vertical with the same short arc length. The arc at all times was passed across the end of filler rod, no matter what its diameter, the rod being maintained almost stationary with very little feed-in. The alternate blocks from the centre were then welded in the same manner, after which a further run was laid on the centre block and again on the alternate blocks. At this stage a depth gauge was used to measure the thickness of one run of weld metal; this depth should not exceed  $\frac{1}{8}$ " and was periodically checked throughout the work. Further runs were laid in a similar manner, taking care that each succeeding run of weld metal was slightly shorter than the preceding one so that a ramp-ended block was obtained, making it easy when welding-in the spaces left between the blocks to obtain fusion of the bottom runs. The angular distortion due to weld contraction was measured. Welding was continued on the blocks until the angles shown were reached. As the welding progressed, the size of the filler rod was increased to  $\frac{3}{8}$ ", and subsequently to  $\frac{1}{2}$ " diameter, in order to maintain the  $\frac{1}{8}$ " layer, remembering that the amount of metal deposited is dependent on the size of rod, and this is governed by the width of the vee, because the full width must be welded by traversing across it for every run as far as is possible. A  $1\frac{1}{4}$ " width of run is quite practicable with  $\frac{1}{2}$ " diameter rod. The current was lowered somewhat in accordance with the thickness as the edges were approached, down to 450-500 amps, keeping the original open-circuit voltage and  $\frac{1}{2}$ " diameter carbon, but using one that had been tapered in use. For sequence of runs see Fig. 3.

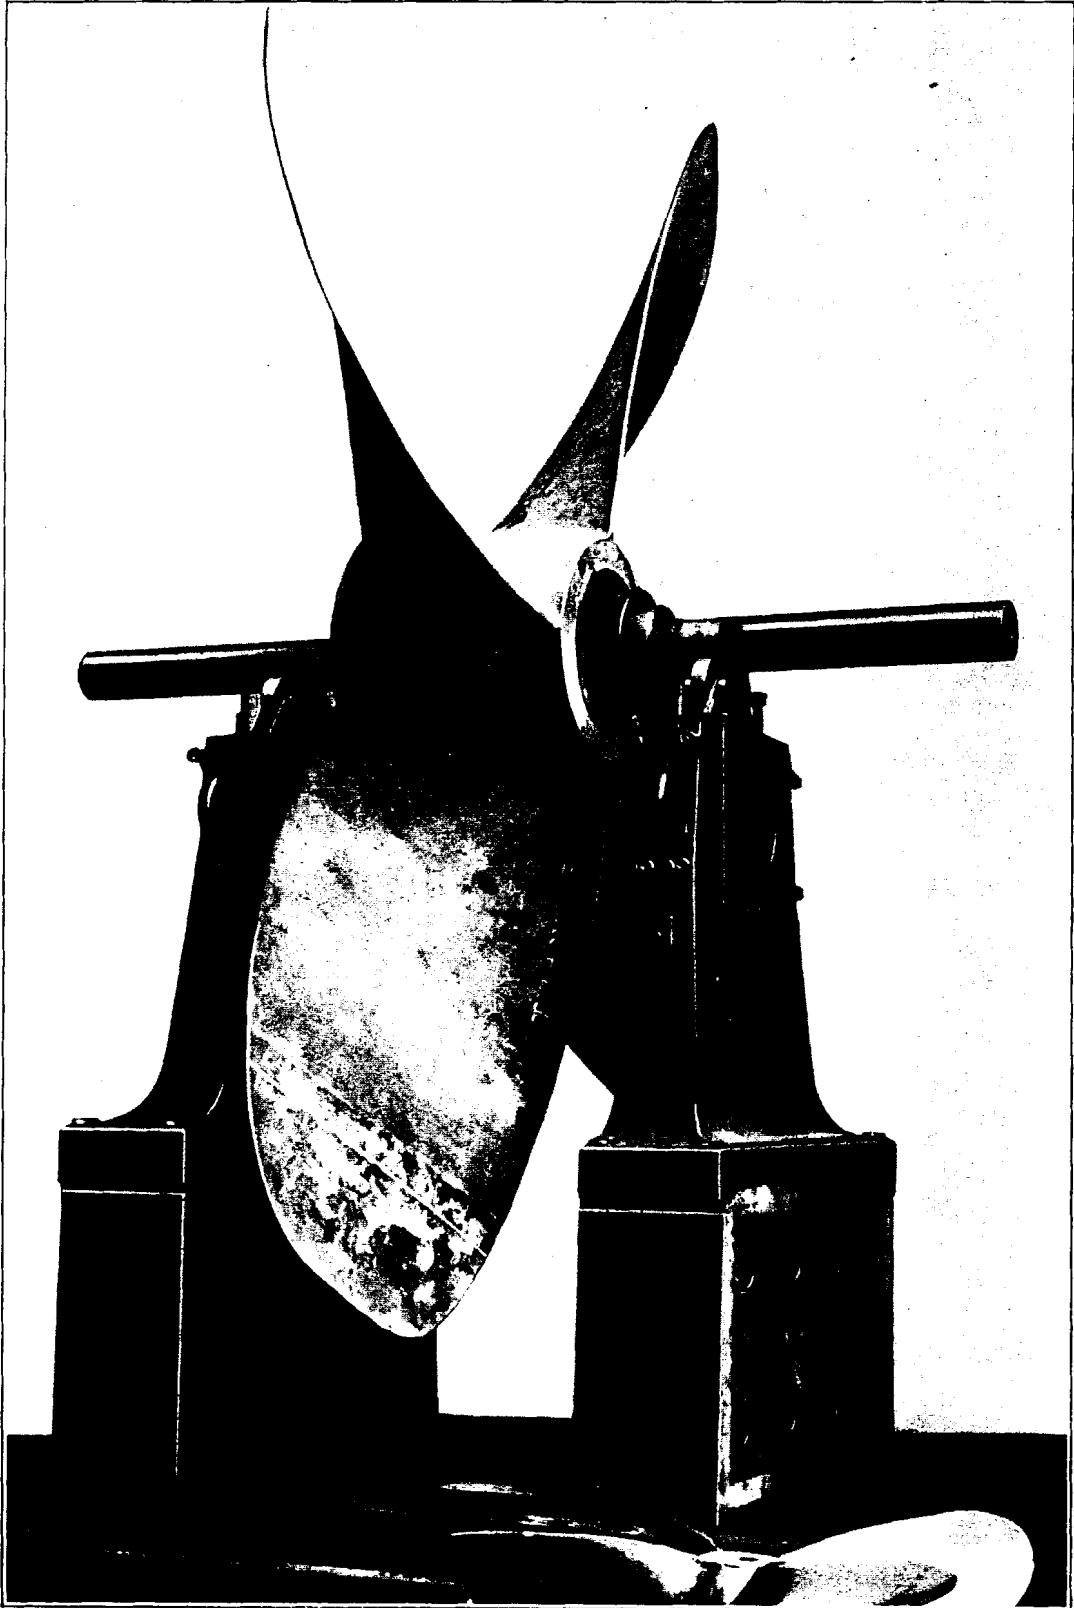
FIG. 4.—GENERAL VIEW OF PROPELLER

The propeller blade was found to be in correct alignment, and it was then erected upon the balancing arrangement as shown in Fig. 4. Stress relief

Fig. 4 shows a general view of the propeller with the re-tipped blade and Fig. 5 shows a close-up after grinding and polishing, the position of the weld being indicated by a chalk line. A typical macro photograph is shown in Fig. 7.

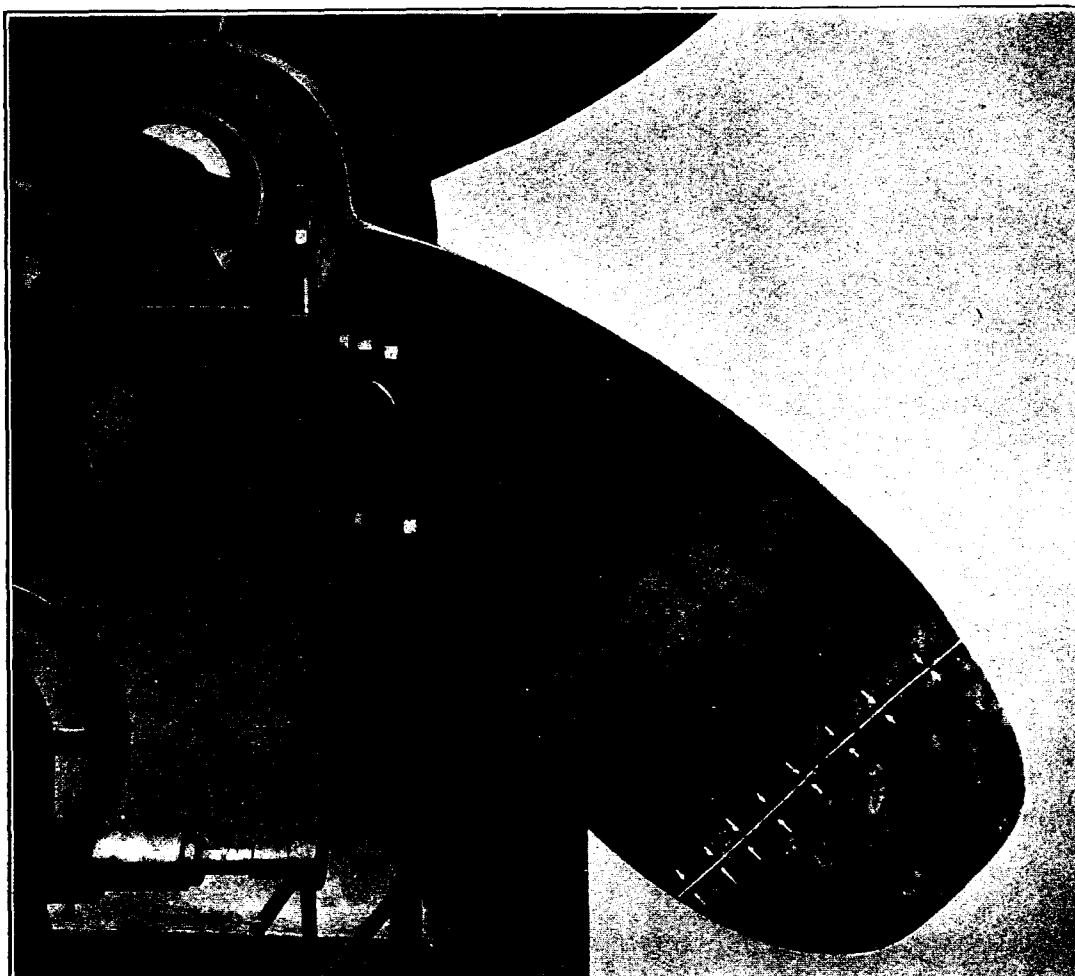
FIG. 5.—CLOSE-UP OF REPAIRED BLADE. MOTTLED EFFECT IS DUE TO REFLECTIONS FROM POLISHED BLADE

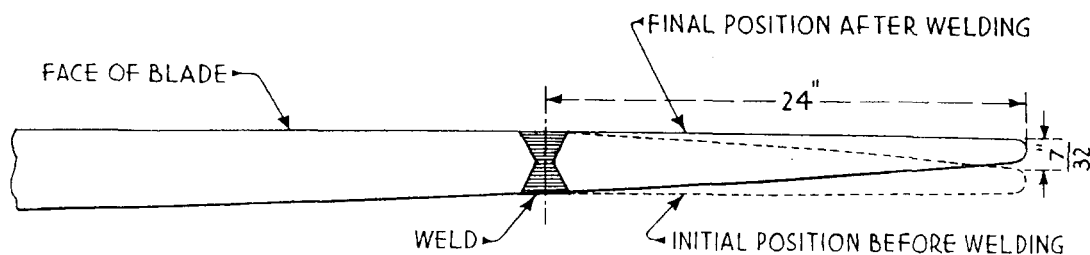
FIG. 6

An initial downset of  $\frac{7}{32}$ " was allowed on the face side (Fig. 6) in order that more welding could be carried out before making the first turn, but since the propeller was turned without difficulty, this idea need not be generally adopted; this downset was corrected by a little extra welding.
