A TURBO-FEED PUMP DEFECT

COMMANDER (E) C. R. HAVERGAL, O.B.E., D.S.C., R.N.

While H.M.N.Z.S. *Bellona* was on passage from the United Kingdom to New Zealand in the last quarter of 1946, the interesting and diverting voyage was punctuated for the Engine Room Department by a series of tiresome defects in a Weir's turbo main feed pump. The defects which took the form of recurrent impeller gland leaks and wiped tail-end bearings are, it is feared, not particularly novel, and of themselves they certainly would not provide the excuse for this article. They and their treatment are only mentioned to provide a "case history" background for the description of an unusual defect that occurred later, and its repair. It is hoped that both of these may perhaps interest other guardians of these, sometimes fickle, machines.

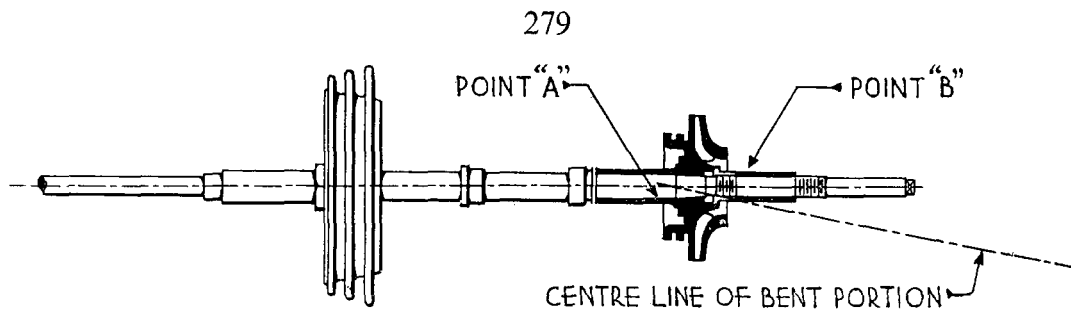
FIG. 1

Clock gauging revealed the bend to be a "dog leg" one, originating about two inches towards the turbine from the blind side of the impeller (point 'A' in Fig. 1), in way of the stainless steel packing sleeve fitted there.

The impeller was remounted on the shaft, and careful readings of the longitudinal dimensions were taken and compared with the maker's drawings. This procedure disclosed that the stainless steel packing sleeve on the blind side (*i.e.*, the 'A' side in the sketch) of the impeller was $\frac{1}{8}$ in. shorter than the designed length, and that the taper in the impeller boss was not mating correctly with the male taper on the shaft, due to a slight divergence between their angles. It was, therefore, considered desirable to machine this sleeve off the shaft, and to substitute a spare of the correct length, lining the impeller boss as necessary, after lapping the two tapers together. It was this process that led to the discovery of the probable cause of the distortion, and consequently suggested a cure.

While machining the sleeve, the portion of it at the origin of the bend in the shaft proved so hard that the lathe tool would not touch it. This zone was

about $\frac{3}{16}$ in. in width, and occupied almost exactly a semi-circumference of the sleeve.

Deduction at once suggested that for some reason the impeller had got out of balance, and the consequent bearing load on the stuffing box neck rings, had locally heated the sleeve and the shaft underneath it beyond a "change point" in their structures. Water leaking from the gland, plus the conduction of the shaft material itself, having acted as quenching agents when the pump was stopped.

A wobble resulting from the unsatisfactory mating of the impeller tapers, generated a vibration of considerable amplitude at the critical speed of the assembly, which seemed to be in the vicinity of the running speed, namely at about 5,000 r.p.m. This, in turn, resulted in a whirling motion of the impeller which was only restricted by the neck rings on the suction and delivery sides, causing very considerable local overheating of the stainless steel gland sleeve and spindle at both points of contact. The fact that the shaft on the suction side did not become so overheated as the other, is probably accounted for by the considerably greater water leakage from that gland at the time. Its neck bush was, however, heavily worn and the sleeve, but not the shaft, was considerably distorted in way of it. (Point 'B' in Fig. 1.) Support for this theory is lent by the fact that both zones of overheating occupied a semi-circumference only.

Working on this theory, it was decided to attempt partially to reverse the process of re-tempering the spindle locally in way of the overheated zone, on the assumption that if it was properly done, the shaft would resume its original structure and alignment.

Heating with a large blow lamp was now started to bring the shaft temperature up to 200 or 300°C . with the object of preventing over-rapid cooling of the hardened zone by conduction. As soon as this general temperature had been attained, direct heat was applied to the hardened zone with a pencilled oxy-acetylene blow-pipe, until the previously determined "colour" temperature was reached. The area was heated twice, heavily coated with borax, and then wrapped up in asbestos cloth and allowed to cool off slowly.

What had been predicted came partially to pass, namely, when the shaft was cold again the tail end had returned $\frac{4}{1000}$ in. towards the normal. This meant that the total throw was now reduced to $\frac{9}{1000}$ in. ($\frac{4\frac{1}{2}}{1000}$ in. on the radius), and this was further reduced to $\frac{4\frac{1}{2}}{1000}$ in. total ($\frac{2\frac{1}{4}}{1000}$ in. on the radius) by lightly peening the now softened re-tempered and annealed zone.

The final correction which reduced the throw to 2/1000 in. was effected by carefully fitting the impeller securing nuts prior to "pulling them up."
