HMS FEARLESS RESTORING CONFIDENCE

LIEUTENANT COMMANDER R.D. RANDALL, CENG, MIMECHE, RN
(WSA – DSUPC/SO)

ABSTRACT

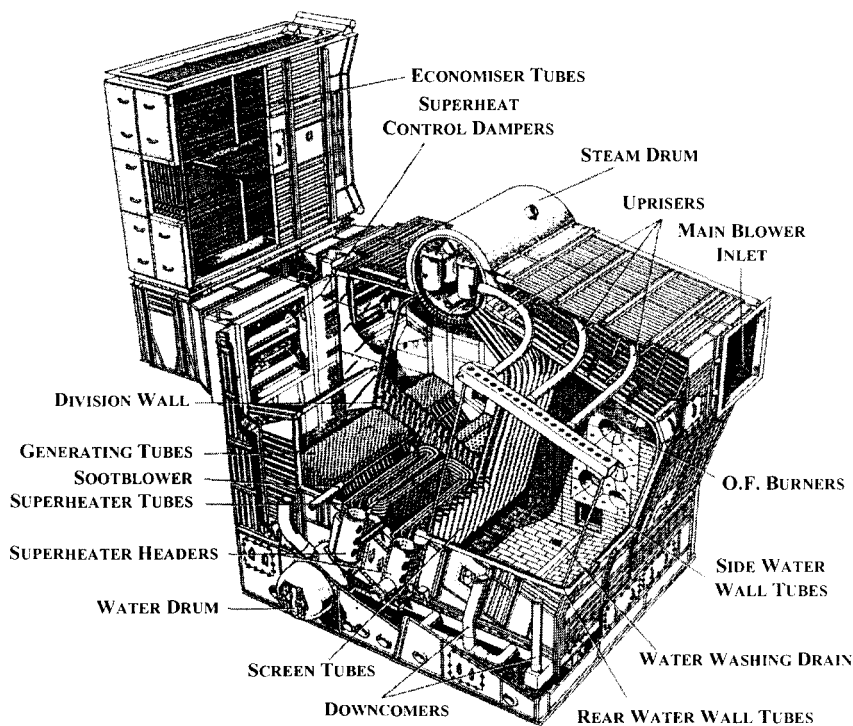
FIG.1 – GENERAL VIEW OF AMS BOILER

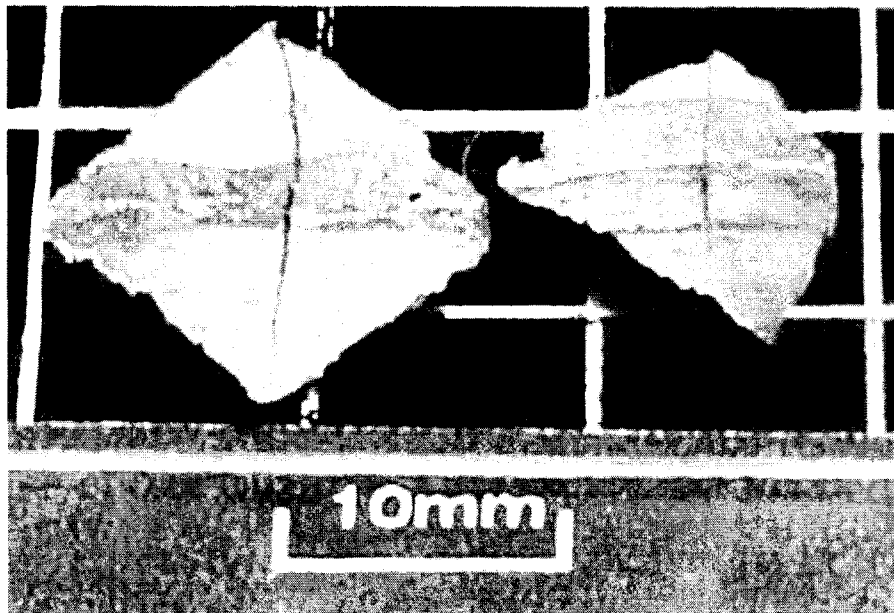
- (g) The cracks at ligament holes G14 and SR2 were cut out and subjected to analysis by Mitsui Babcock, Lloyds Register and DERA, (FIG.2). This group also concluded that the tube rolling had imposed high tensile stresses on the ligament hole walls, which may have caused the formation of small cracks in the heat affected zones, and that these cracks had subsequently grown by a Stress Corrosion Cracking (SCC) process. They also concluded that the residual ligament stress alone was sufficient to cause SCC, although, in their opinion, they thought that crack propagation by this method was unlikely without the existence of an initiating crack or surface defect.***

FIG.2 – CRACKS CUT OUT FROM AMS WATER DRUM SR2 TUBE PLATE LIGAMENT

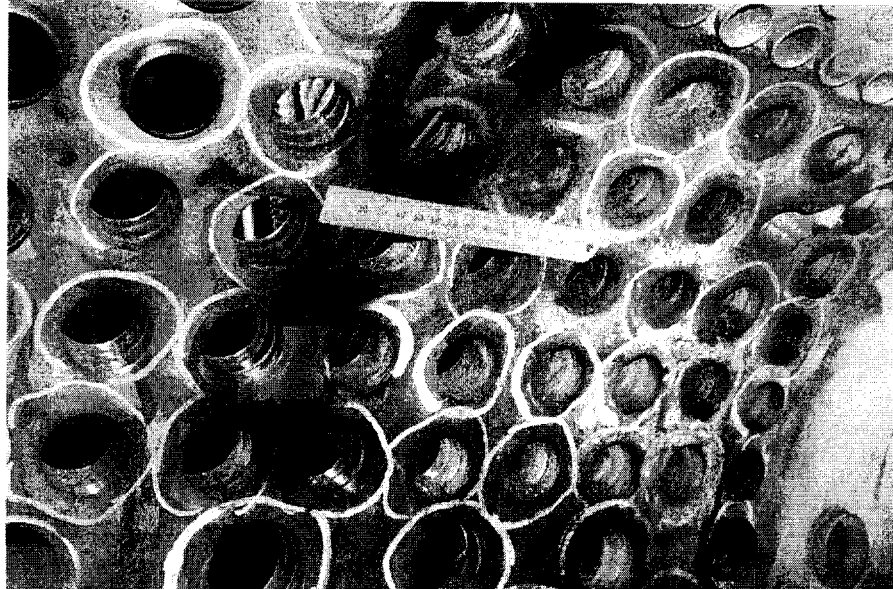
The above analysis however, did not explain the existence of the 24mm crack at water drum ligament hole G14. In the majority of cases, the Martensitic layer around the affected tube holes was around 5-8mm (with a single exception of 14mm at one hole). This was in most cases confined to the waterside of the boiler, although small amounts of Martensite were also apparent on the furnace side of the boiler shell at some ligament holes. The clear extension of the crack at G14 into the parent metal implied that either the rolling process had, in this case, been sufficiently large to crack the relatively ductile parent metal (unlikely), or that a different mechanism had existed. Despite much debate, and the removal of one side of the crack (excluding the tip) for metallurgical analysis, no satisfactory explanation for the existence of this crack was obtained. The depth of the boiler chemical deposit on the crack face implied that the crack had existed for some time but, the absence of a reported leak during the boiler pressure test at the end of CSP00 implied that it had probably not existed through-wall prior to this point. The inability to remove the crack tip for analysis (due to its proximity to the next ligament hole (FIGs.3 & 4) and the need to leave some material for the weld repair to bond to) prevented confirmation of whether the crack was stable or active. A consensus of opinion, however, was that the crack was stable.

FIG.3 – VIEW INSIDE AMS WATER DRUM SHOWING HEAT AFFECTED 'HALF-MOON ZONES,' G14 CRACK CUT OUT (TOP RIGHT) AND 'BELLING ON TUBES'

These concerns were further compounded by the possibility that a very small crack may have been invisible to the available NDE techniques due to the 3mm (approx) 'belling' overhang of the tubes on the water side of the ligament plate (FIGs.3&4).

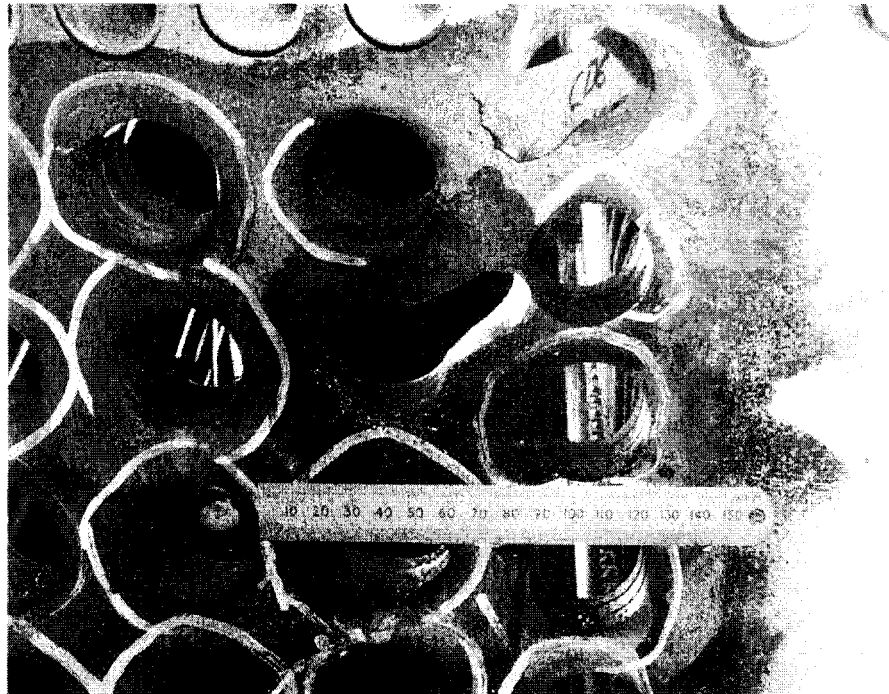
FIG.4 – VIEW INSIDE AMS WATER DRUM SHOWING CLOSE UP OF G14 CRACK CUT OUT
