HMS NOTTINGHAM

FROM WOLF ROCK TO PORTSMOUTH

This is an edited version of the paper that was presented at The Royal Institution of Naval Architects on 6 November 2004

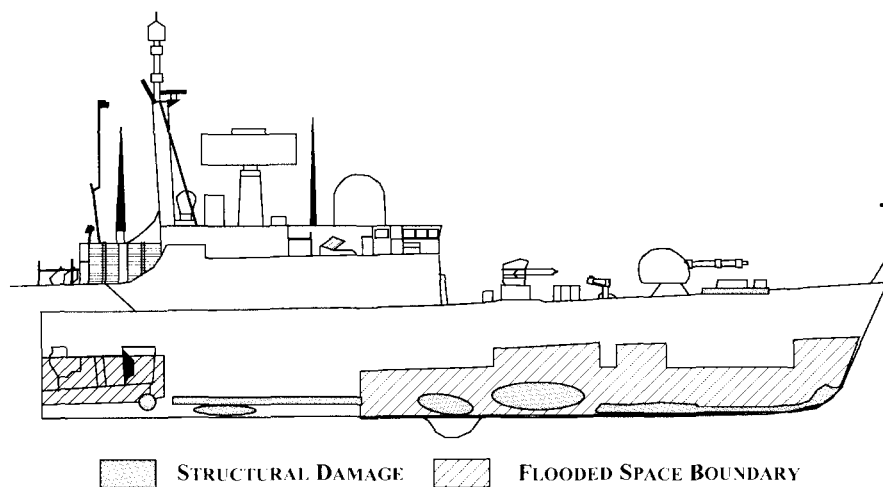
FIG.3 - EXTENT OF COLLISION DAMAGE

- Almost complete loss of the bow structure below the 6 foot draught mark, for the first 7 metres of the vessel from the bow. In this area much of the structure was unrecognizable.

- Extensive damage to the keel and surrounding structure on the starboard side in Zones C and D.
- Possible loss of solid ballast in Zones B and C indicated by disturbed ballast blocks at the mouth of the damaged plate.

- A major penetration into the SEA DART Spray Compartment.
- Limited distortion to the keel in Zones E-G.
- Many plate perforations, tears and major plate deformation in Zones E-G.

- Complete removal of the forward half of the Sonar Dome. Many Hydrophones were hanging.
- Aft of the Dome the keel was completely untouched but with damage to the turn of bilge.

- The Bilge Keel was heavily distorted and it was uncertain whether there was a leak into adjacent compensated tanks.
- The leaking, distorted and damaged stabilizer.

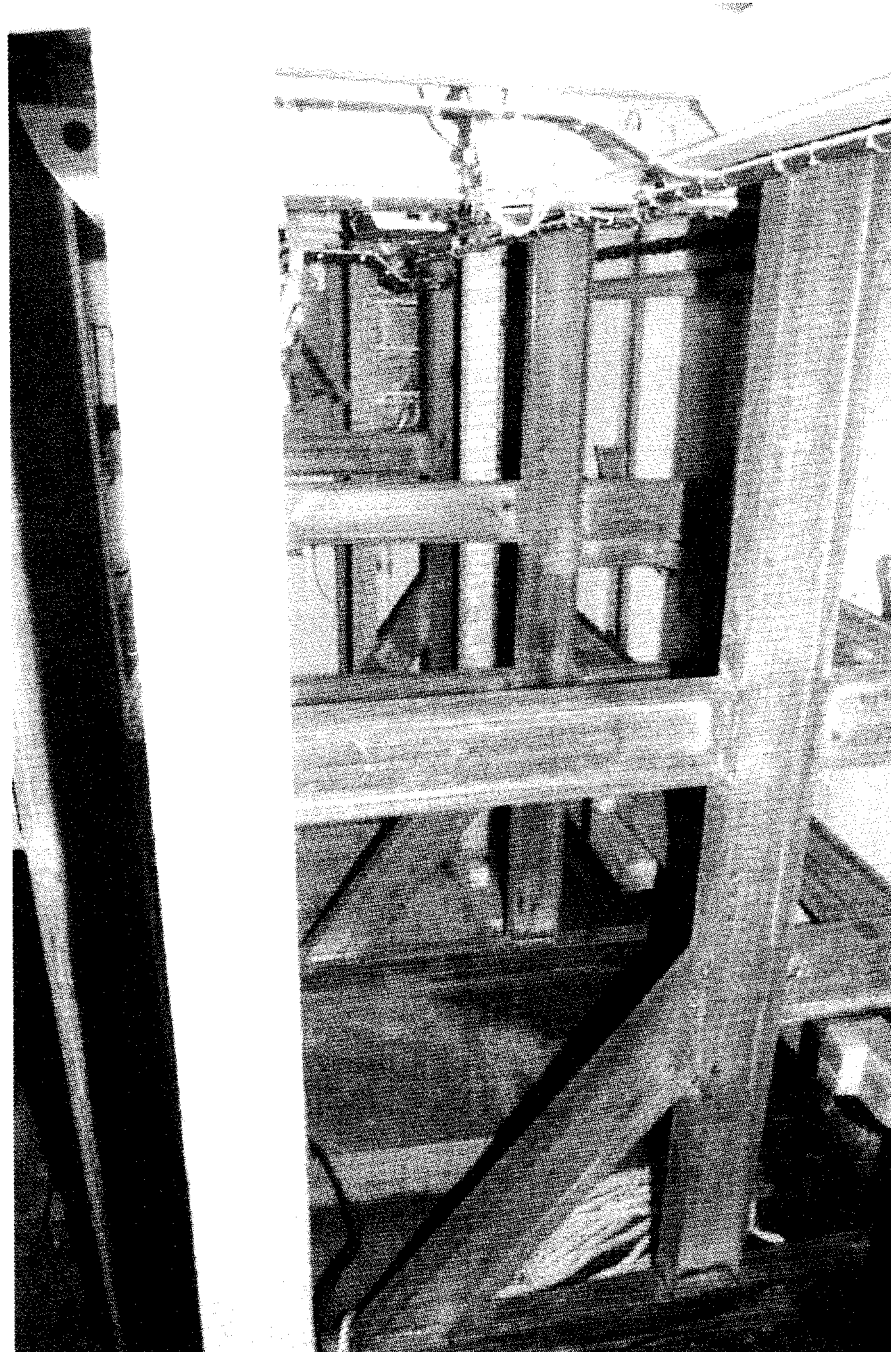
3F's shoring was designed to fix the deck and bulkhead stiffeners in place using welded steel I beam shores. The design that evolved also had to consider the difficulties of fabricating a structure in a seaway such as the risk of flooding a dry compartment by accidentally burning through plating. The final design only allowed welding onto stiffeners or plating that did not form part of the flood-boundary

FIG.4 3F STEEL SHORES

Seven Steel shores (FIG.4) were later introduced consisting of I beams laid longitudinally onto the deck, over a potentially damaged under-deck stiffener. Each beam was stiffened by two vertical steel pillars welded to the deckhead stiffening and angle connecting beams. Four pillars were connected to the forward bulkhead stiffening. Additional transverse beams linked the four shores and the forward bulkhead stiffeners to allow the shoring of bulkhead plate by wooden wedges.

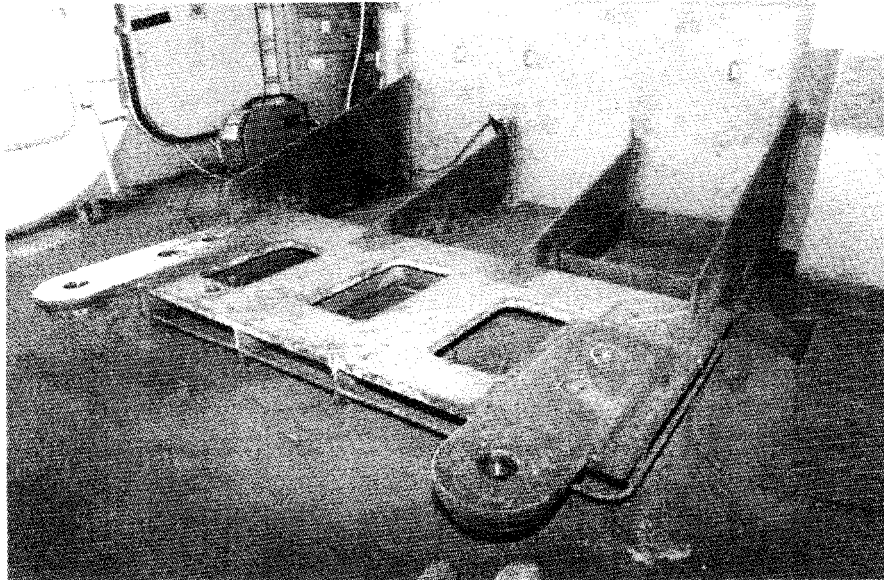
FIG.5 PORT TOWING CLENCH

The towing plan evolved in response to the availability of equipment and tugs. A port side towing clench was intended for the quarterdeck, along with the standard fit Starboard towing clench, to allow a bridle tow rig. The Sonar 2070 towed array decoy bedplate was cannibalized for this purpose (FIG.5). A Panama fairlead was removed from forward of the bridge, flected down the vessel, and welded into position on the aft end of the quarterdeck for the port tow cable. Substantial additional stiffening was designed to assist load transmission into the deck structure.

The towing arrangement was based on a 35 Tonne predicted load in Sea State 6. The port side of the main towing bridle had a second bridle and fishplate to avoid the quarterdeck bollard and was connected to the Sonar 2070 bedplate via two shackles and in-situ fabricated towing arms. A load cell was installed. The tow safety case was predicated on a tow in conditions of up to Sea State 4 at about 5 knots.

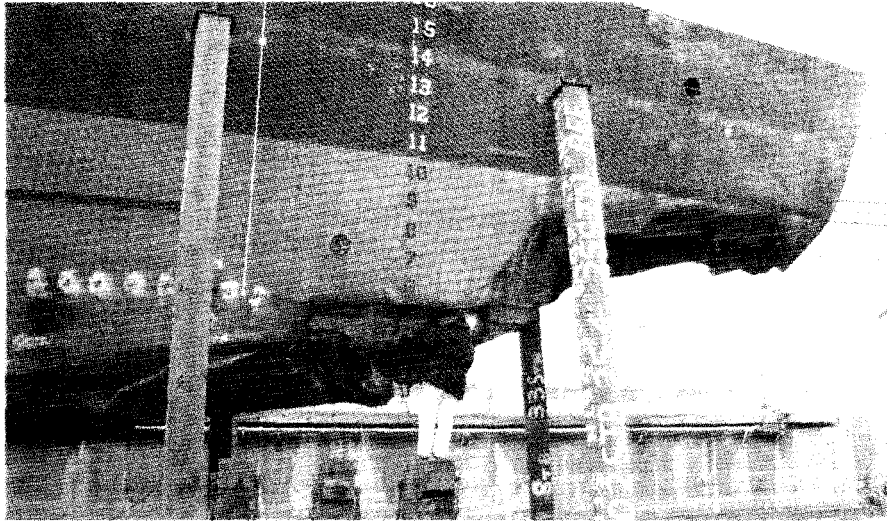
FIG.14 REPAIR IN PORTSMOUTH

The repair period has been undertaken in two stages, the first mainly concerned with repairing the structural (FIG.14) and major systems damage while in the Dry-dock. This has been achieved by fabrication of replacement structural modules, based on original drawings, for the major areas of structural damage. All major systems were inserted into these modules prior to undocking. A replacement forward port stabilizer mounting was installed in place of that wrecked during the grounding, using both stock items and major new construction. The sonar system and dome have been completely replaced. Solid ballast lost during the initial grounding has been replaced.
