THE FAILURE INVESTIGATION AND REPLACEMENT OF A LARGE MARINE GEAR

ABSTRACT

Following a routine inspection of HMS *Invincible's* main propulsion gearboxes, cracking was identified on the starboard main wheel teeth. This article presents a summary of the subsequent work, including: the palliative repair, inspection regime, risk reduction measures, failure investigation, the design and manufacture of replacement gears and the permanent repair.

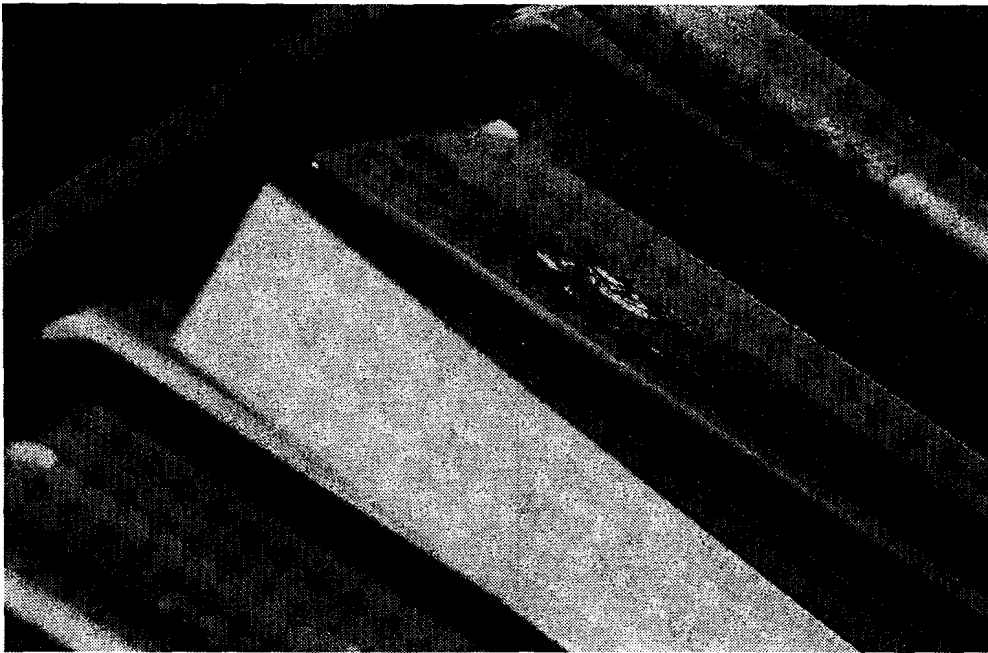
In December 1999, during the Commander (E)'s supercession inspection of HMS *Invincible*'s starboard gearbox, ship's staff identified damage to a number of teeth on the main wheel. A full dye penetrant Non-Destructive Examination (NDE) of the main wheel by David Brown revealed cracks originating from surface pits in 11 teeth. These varied in length up to a maximum of 30cm (FIG.3).

FIG.3 – FLANK PITTING ON A CRACKED TOOTH.

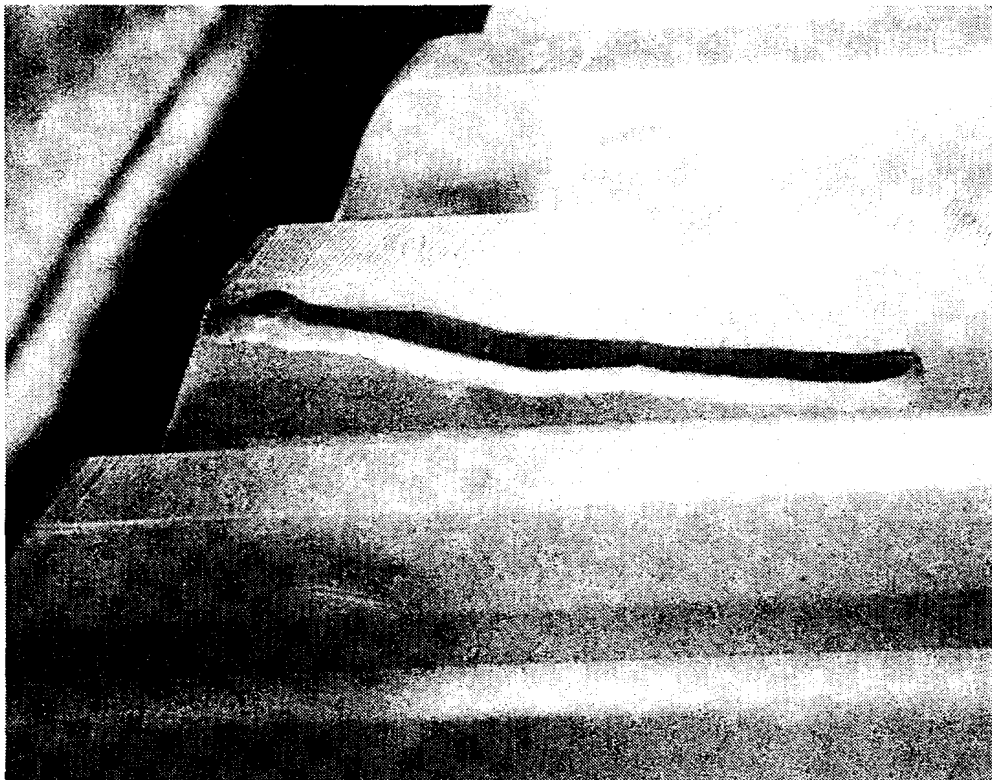
FIG.4 – NDE WHILST REMOVING A CRACK

Following an initial assessment it was decided to remove the cracks by in-situ dressing, to establish the full extent of the problem and to prevent any further crack growth. An iterative process of grinding and NDE was undertaken, to ensure that no crack indications remained (FIG.4).

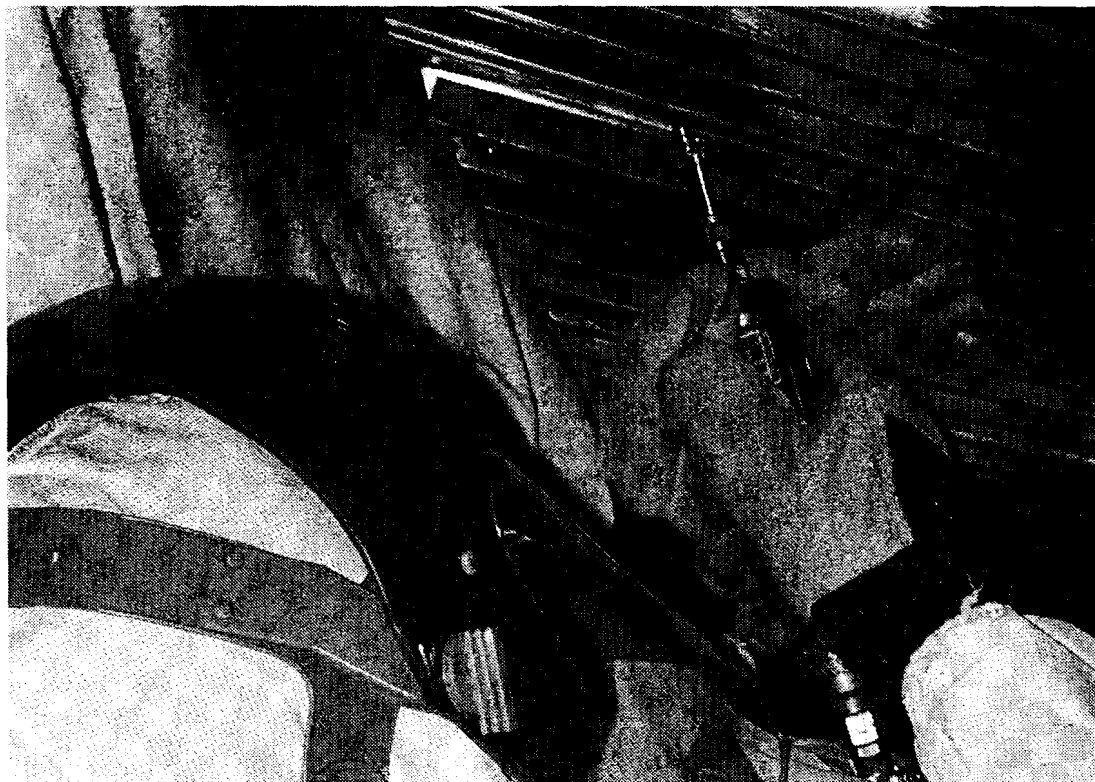
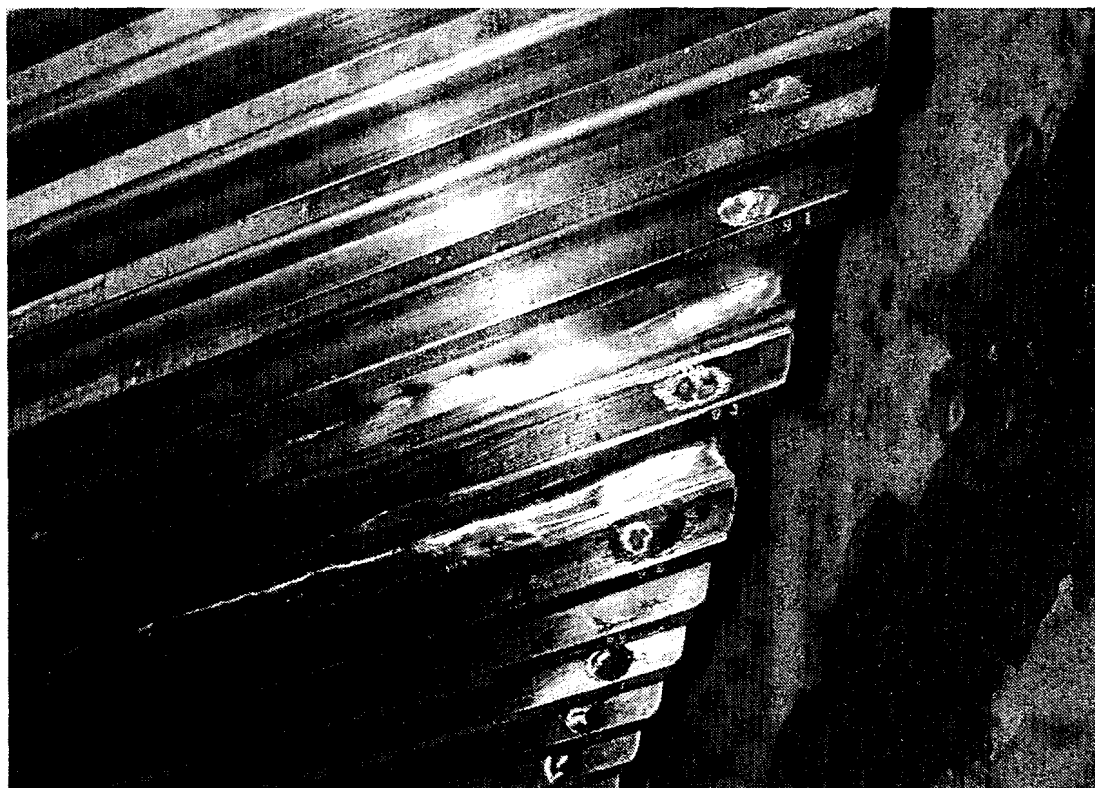
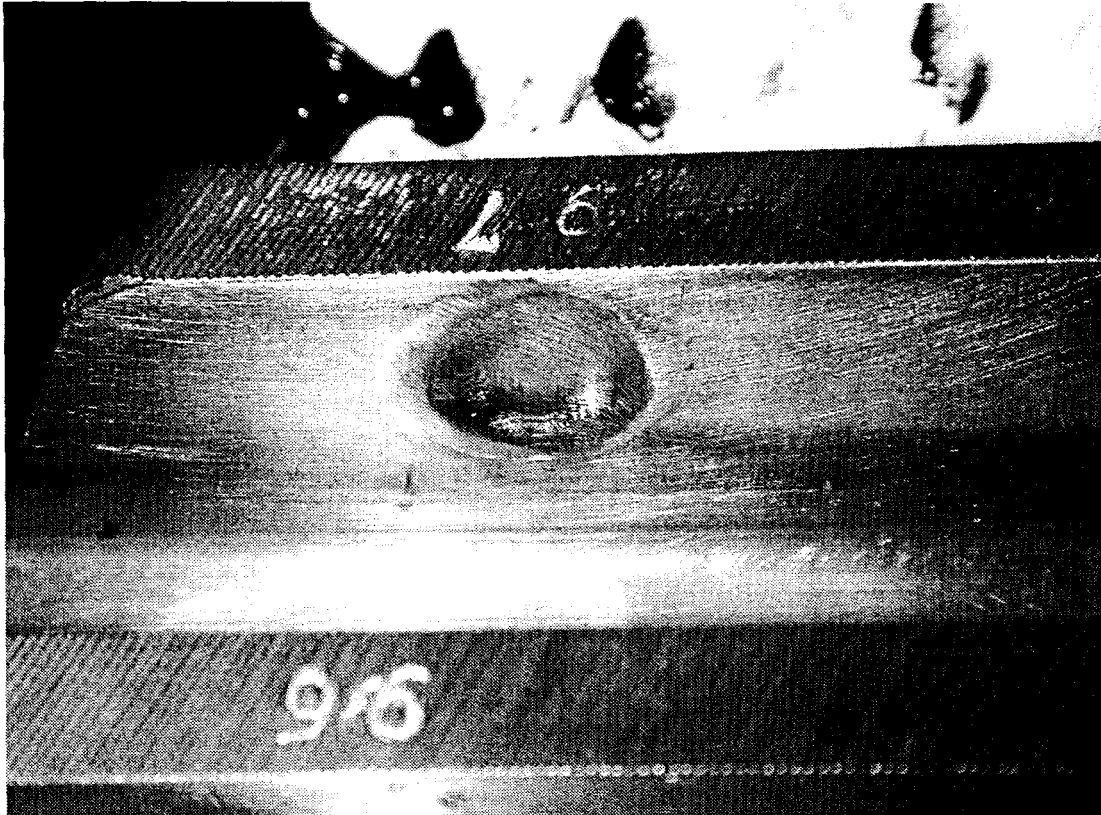
This resulted in the removal of 9 complete teeth and parts of 2 teeth (FIG.5).

FIG.5 – DRESSING TO REMOVE TOOTH SECTIONS AND AREAS OF PITTING.

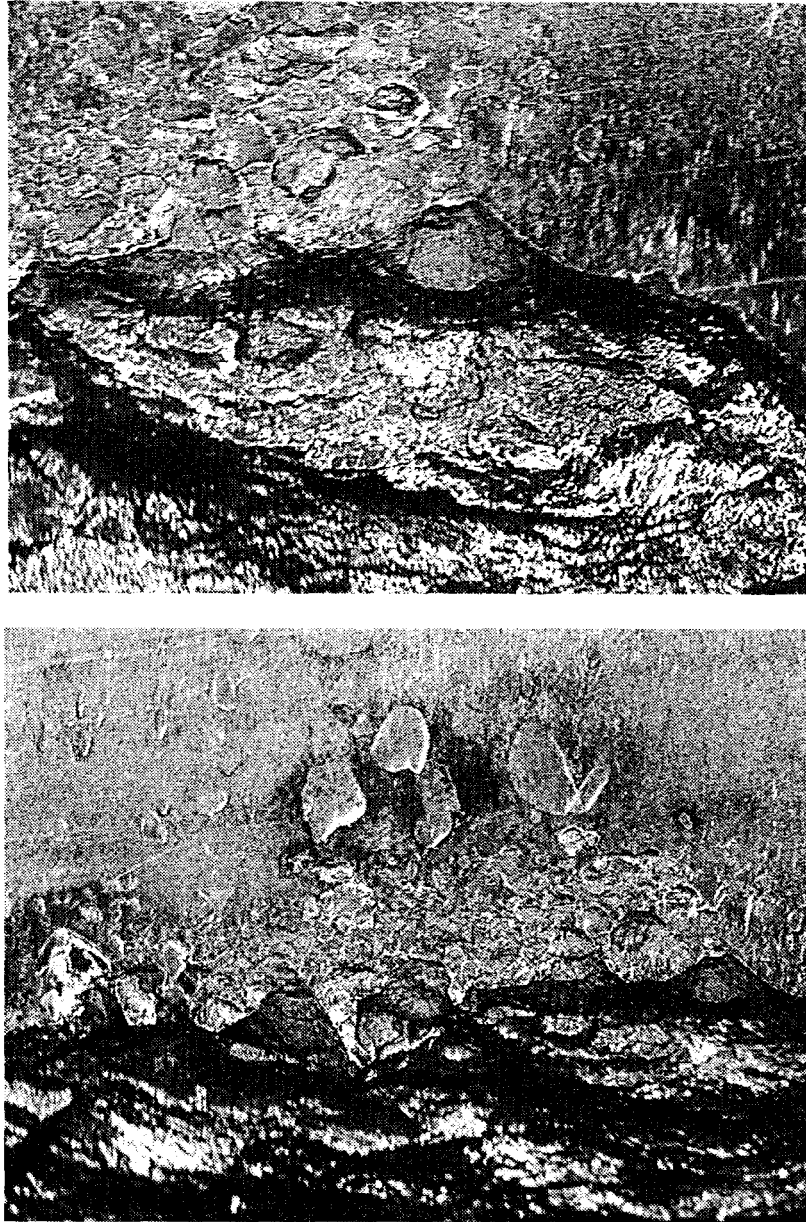
Examination of the fracture surfaces showed clear indications of fatigue crack growth indicating that the crack had taken sometime to initiate and propagate to give the final failures. The main bending crack that led to failure was found to initiate from below the surface and this was tracked to the presence of flank surface initiated pitting that was seen fairly widespread in the regions of tooth cracking (FIG.6).

FIG.6 – FLANK INITIATED PITTING LEADING TO BENDING FATIGUE CRACK GROWTH.

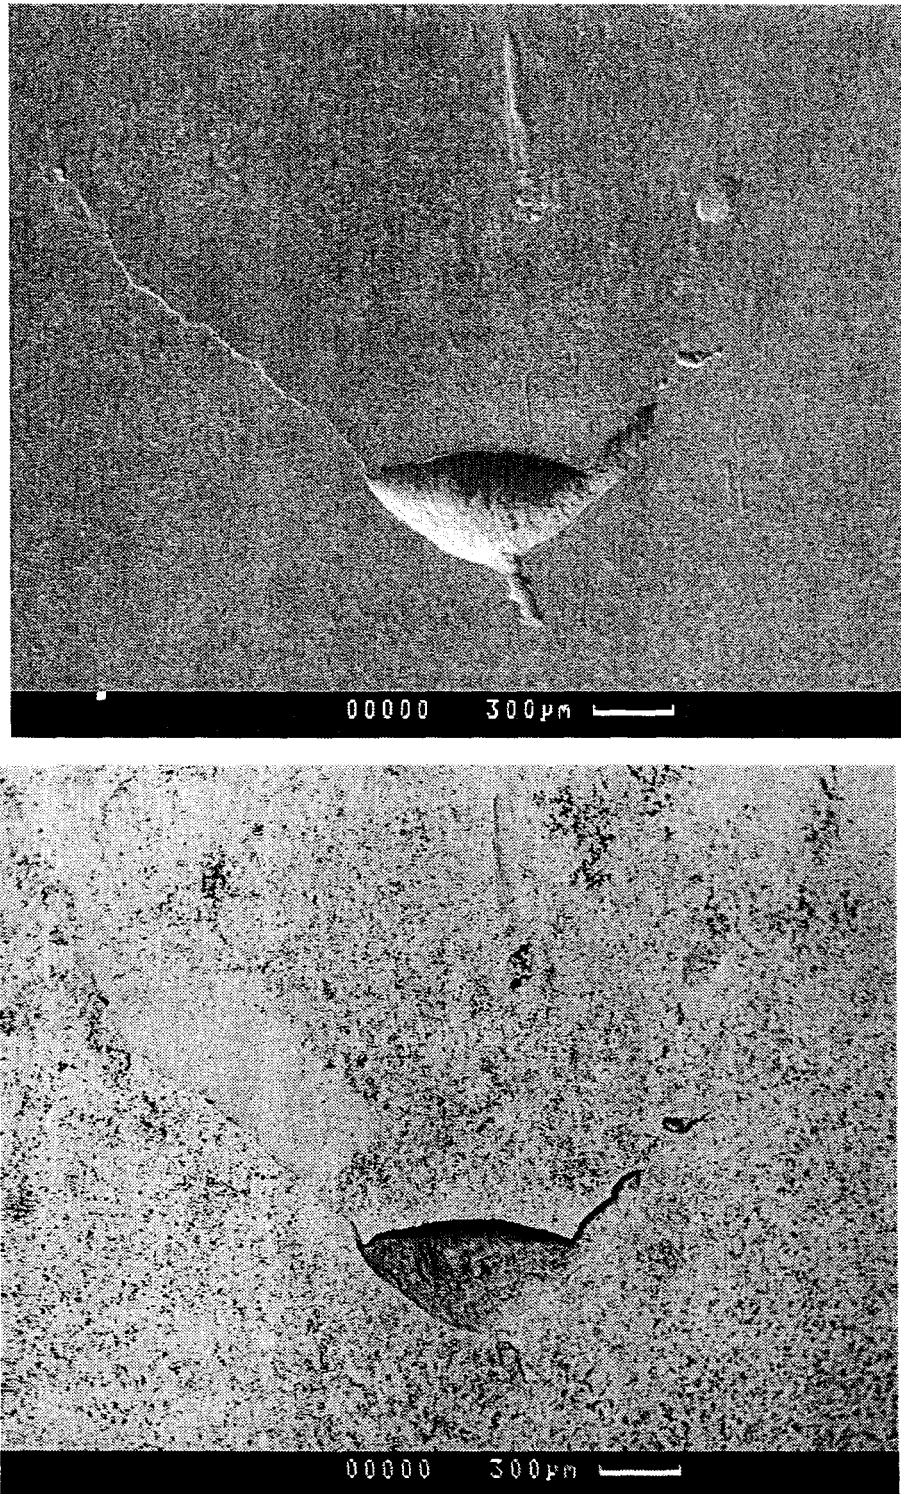
Examination of the fracture surfaces was undertaken by using a Scanning Electronic Microscope (SEM) with Energy Dispersive analysis by X-ray (EDX) for chemical analysis. This confirmed the visual and optical microscopy observations of fatigue initiated from below surface flank pitting. Close examination of the pitting and the main fatigue crack initiation sites did not reveal the presence of any unusual material defects such as large oxide inclusions that could account for the failure (FIGs 7 and 8).

In Figures 7 and 8, the lower image compares backscattered imaging with the normal secondary imaging in the upper image. In this imaging mode oxides would appear black.

FIG.7 – SEM IMAGES SHOWING FLANK PITTING LEADING WITH ASSOCIATED CRACK GROWTH (TOP IMAGE IS SECONDARY ELECTRON IMAGING AND THE LOWER IS BACKSCATTERED ELECTRON IMAGING)

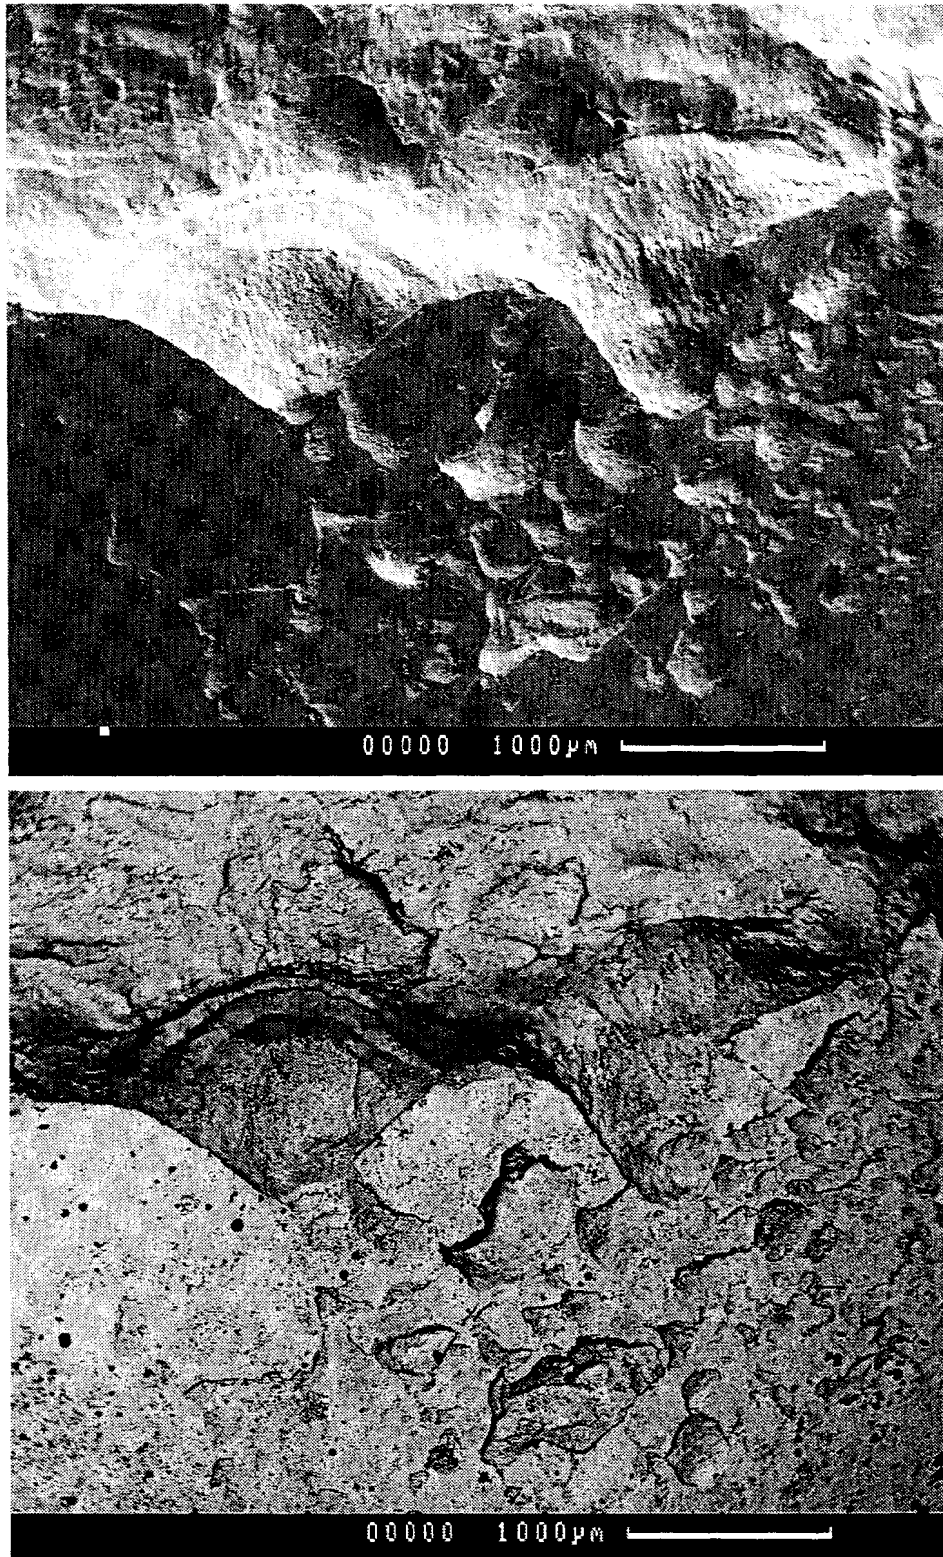
FIG.8 – SEM IMAGES SHOWING FATIGUE CRACKS GROWING FROM FLANK PITTING

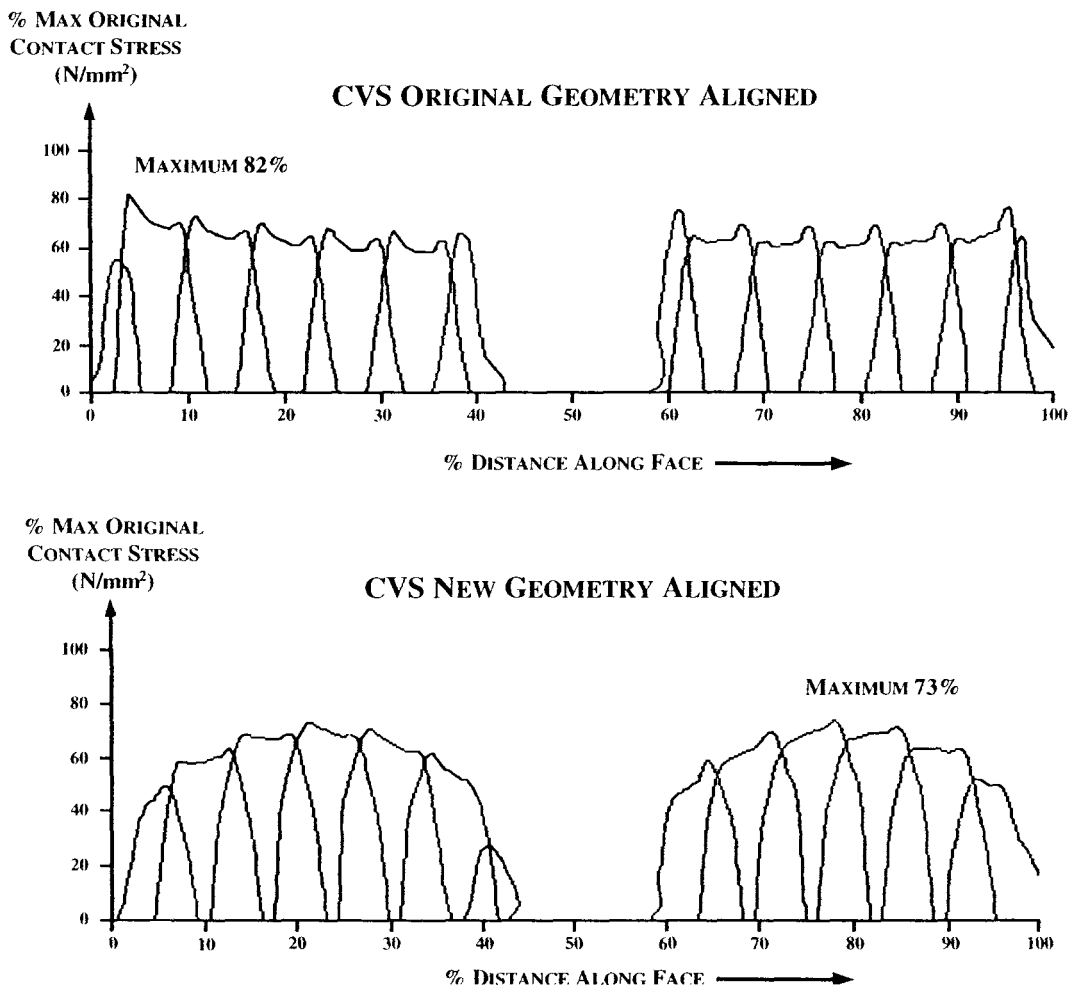
The pinion teeth were also crowned to decrease stressing at the ends of the gear meshes and reduce the sensitivity to misalignment. Improved helix corrections assisted the crowning to give an improved load distribution along the full length of the face width. Revised tip and root reliefs would give smoother running as they passed through the mesh (FIG.9).

FIG.9 – TOOTH LOAD DISTRIBUTION FOR ORIGINAL AND MODIFIED GEOMETRIES.
