# IN-SITU STRIP AND REBUILD OF J2 DIESEL GENERATOR

LIEUTENANT COMMANDER P.D. GILBERT BENG, ACGI, MSc, MCGI,  
CENG, MIMeCHE, MIMARE, RN  
(*MEO HMS 'Liverpool'*)  
and  
CPOMEA(ML) K.J. GARWOOD  
(*ADDIESEL, HMS 'Liverpool'*)

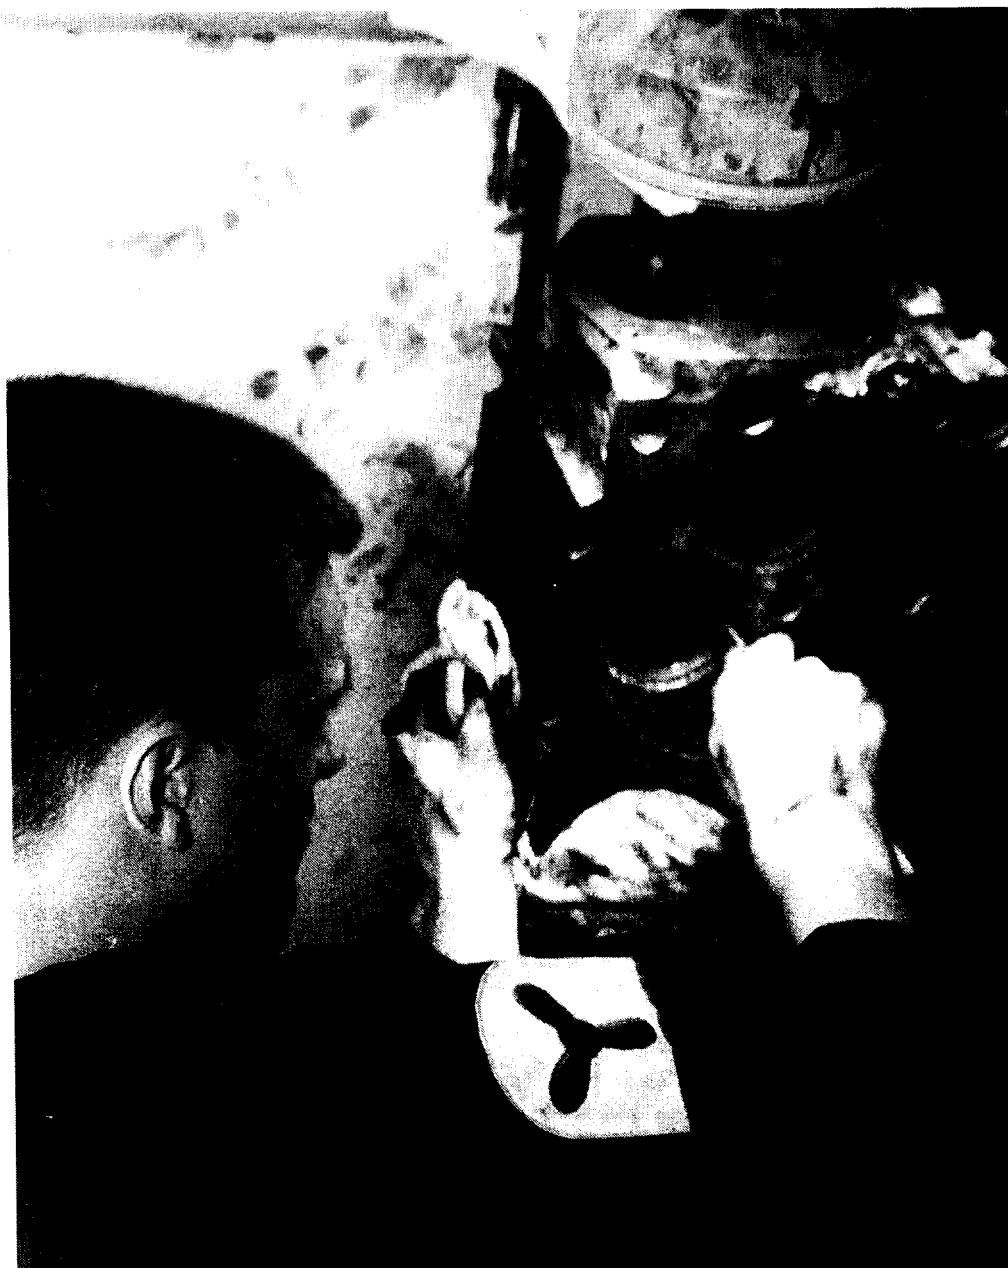
FIG. 1—MEM DOOLEY CLEANING CYLINDER HEAD

With the ship due to visit Kingston, Jamaica on 20 June the strip continued under the direction of the ADDIESEL CPOMEA and the ADICE POMEM(M) (S. HAYTER). By 16 June the demands had been raised for 16 pistons and liners, both blowers, both intercoolers and various articulations and bearings. Examination of the cylinder heads indicated that they were recoverable so ship staff gained the approval of ME213 to re-use them, thereby making a significant financial saving with respect to the air freight of replacements. This did however require a major effort from the whole department, with teams responsible for lifting and slinging the heads whilst the refurbishment of each head became the responsibility of an MEM (FIG. 1). To their credit the mechanics rose to the challenge and it became a source of pride to return the best cylinder head. Only one of the 16 heads was condemned.

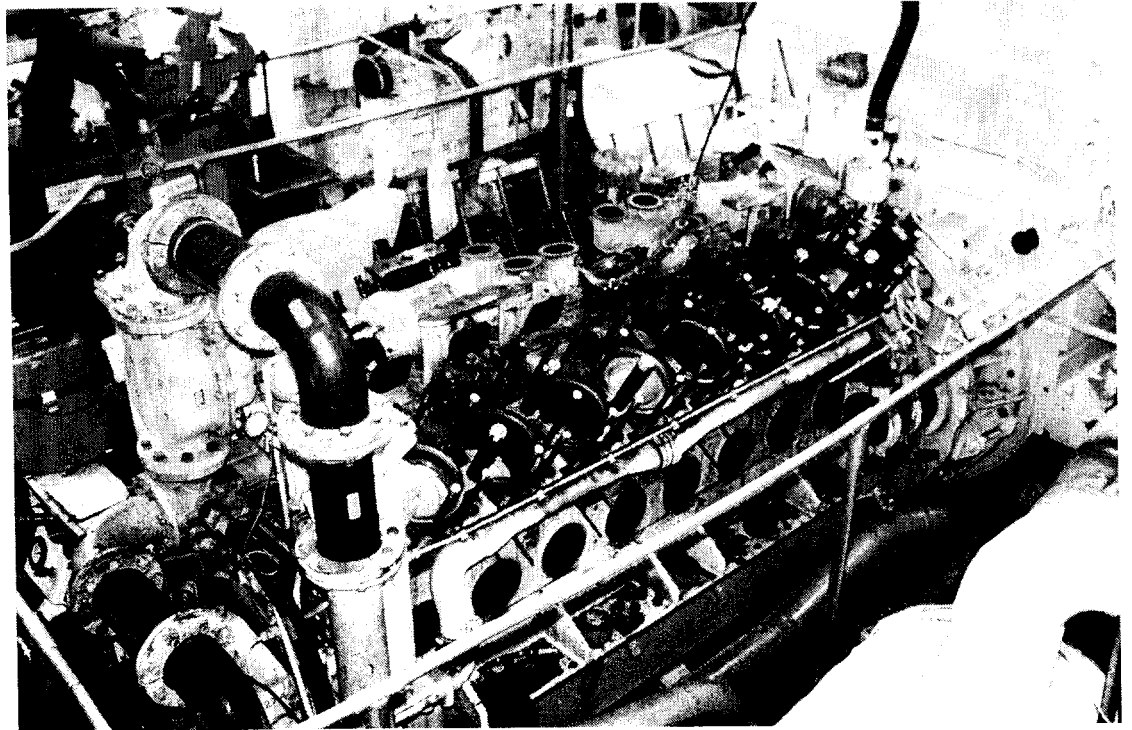
FIG. 2—FAMR—J2 DIESEL REBUILD COMMENCES

With *Liverpool* heading west for Belize the re-build of J2 commenced (Figs. 2&3). Even with J1 diesel shut down for the majority of the time, the temperature in the FAMR remained above 35°C. However, the determination and enthusiasm of GARWOOD and HAYTER proved infectious. As well as motivating their dedicated team, they were always willing to accept help from volunteers; one of the chefs became a regular visitor to the FAMR. On 25 June a major eruption of the volcano on Montserrat caught the islanders by surprise, with pyroclastic flows over-running farms and homes. That night, just hours from Belize, *Liverpool* turned east and sped for three days across the Caribbean. Arriving off Montserrat on 28 June a request was received to land a diesel generator repair party, so for the following week efforts were diverted from J2 whilst several portable generating sets were overhauled and set to work for the islanders.

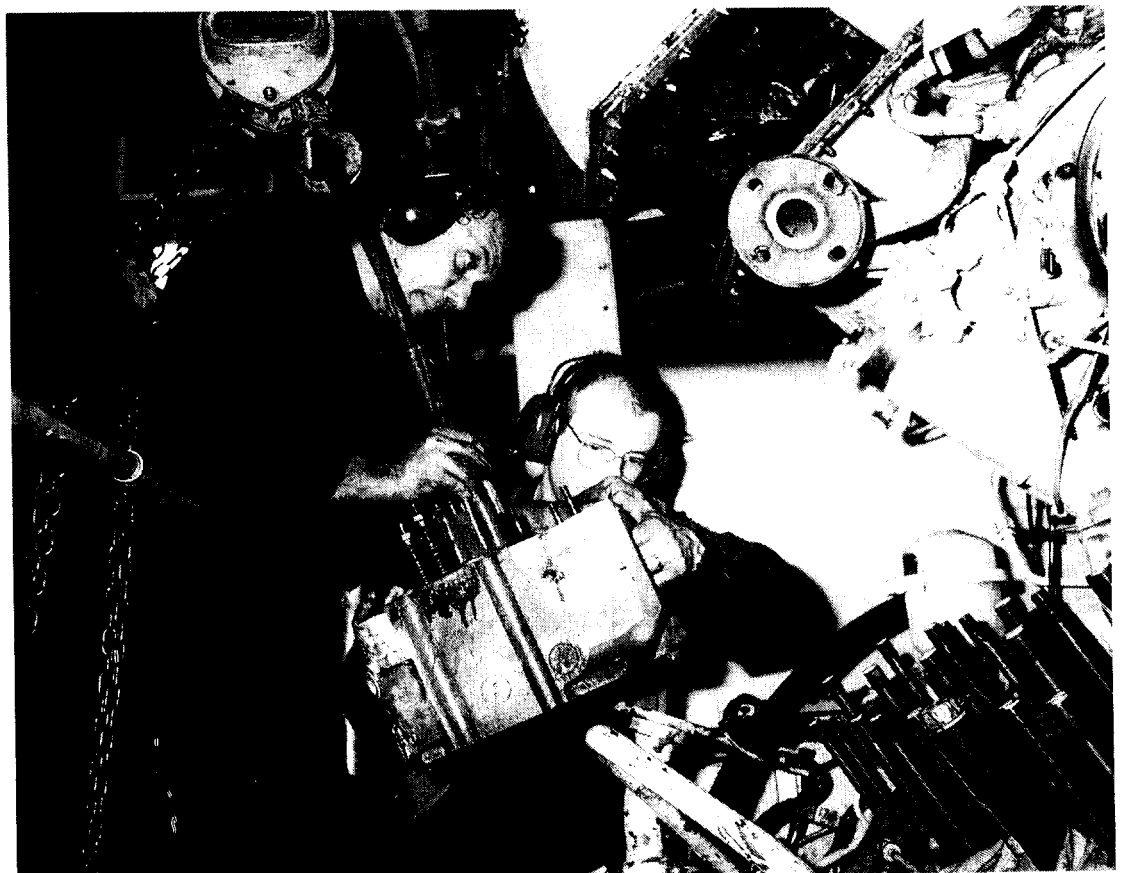
FIG. 3—POMEM HAYTER AND LMEM KING SLINGING CYLINDER HEAD AT SEA
