# CPP BLADE CHANGE USING AN INFLATABLE HABITAT HMS 'BIRMINGHAM' MARCH 1998

LIEUTENANT M.P. McLACHLAN, IENG, AMIMARE, RN  
*(formerly Support Engineer Officer for Superintendent of Diving—(SEO(D)))*

J.Nav.Eng., 38(1), 1998

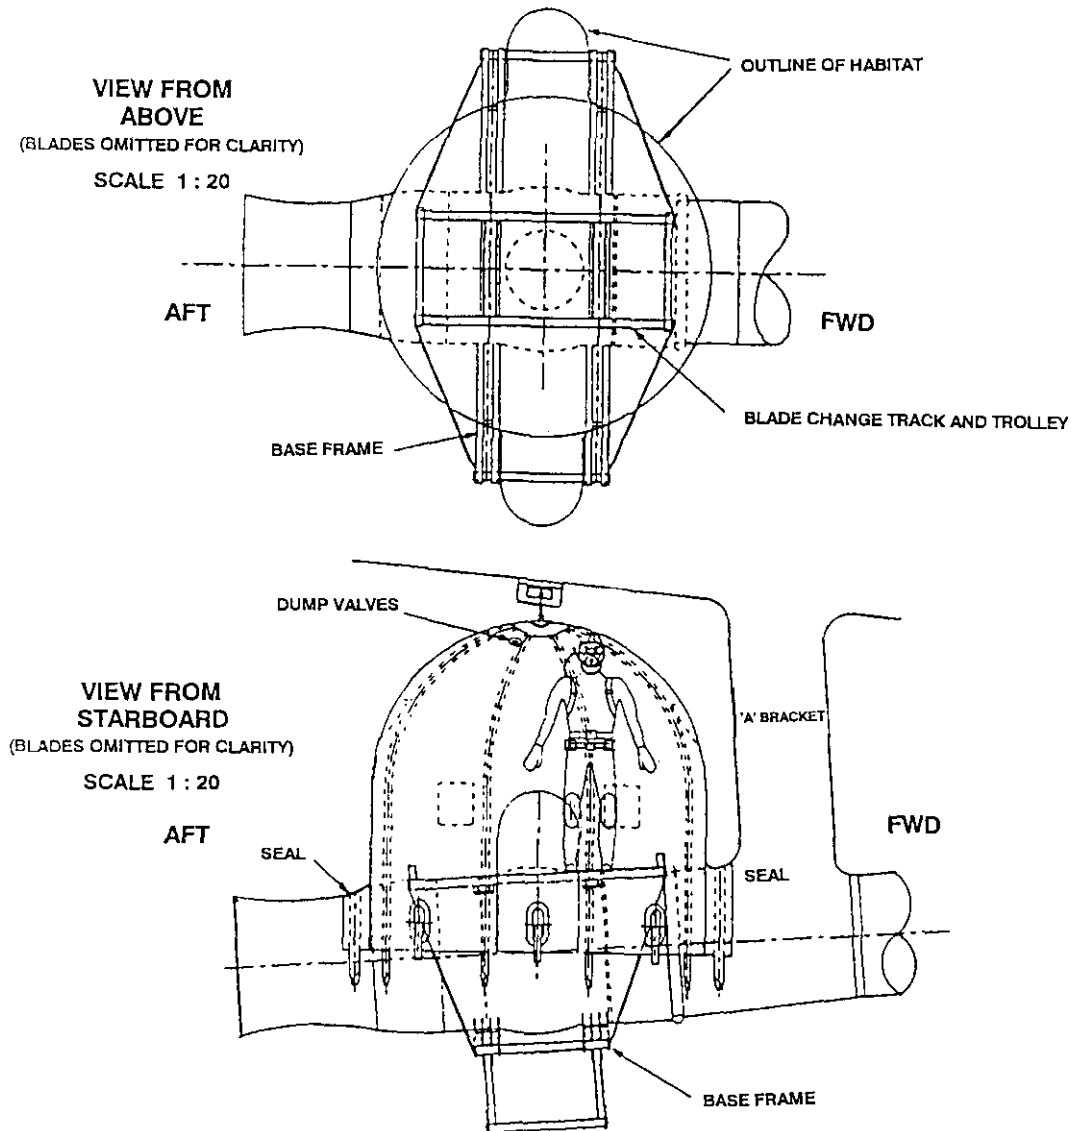
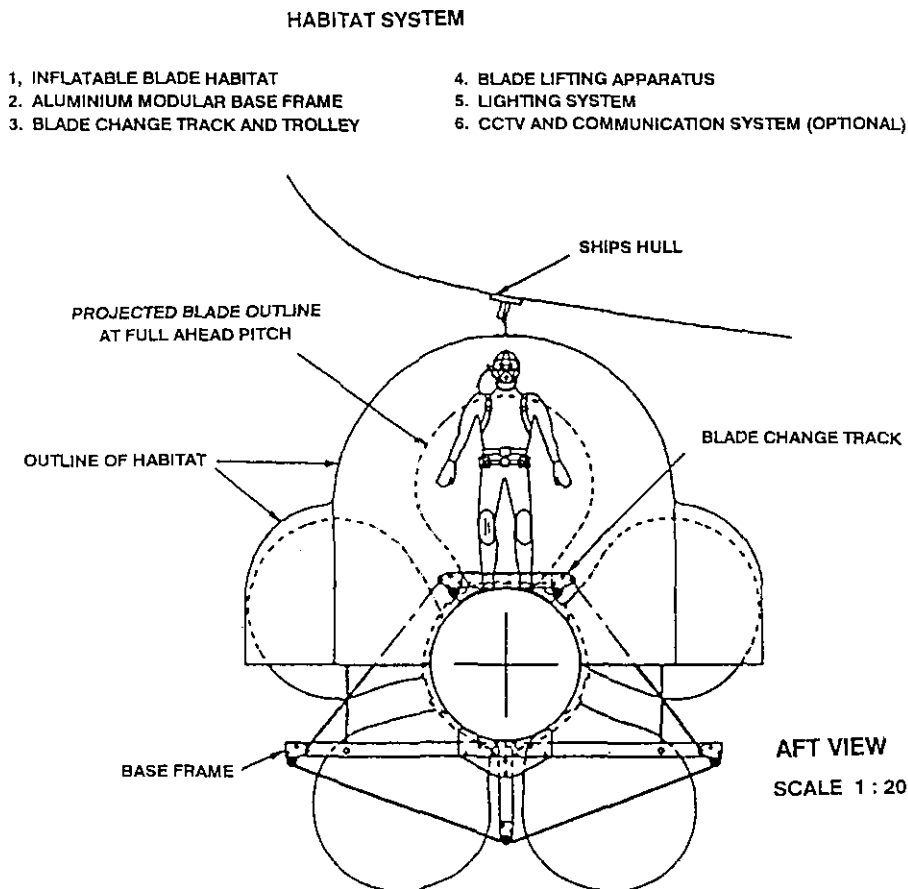
FIG. 1—GENERAL ARRANGEMENT OF INFLATABLE CPP HABITAT

The Habitat is a reinforced coated nylon 'bag' (similar to a parachute style flotation bag) which is inflated over the hub, enclosing the blade at Top Dead Centre (TDC) and the upper portion of the blades each side (FIG. 1). The bag is connected to, and supported by, an inverted A frame slung underneath the hub. A top frame, with rails, is positioned over the hub to carry a wheeled trolley to assist in the blade change operation.

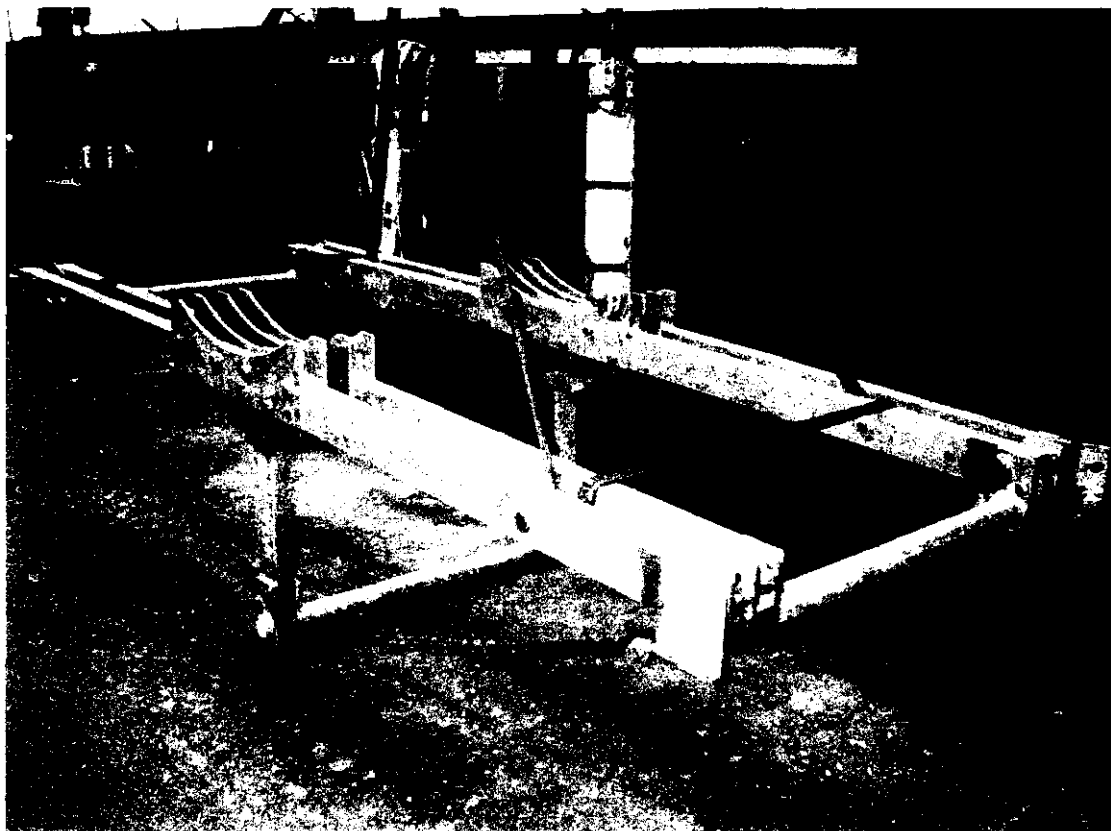
FIG. 2—LOWER FRAME PREPARED FOR SLINGING

The lower frame was assembled ashore and made ready to be slung vertically into a position outboard of the lower 2 blades (FIG. 2). The dockyard crane

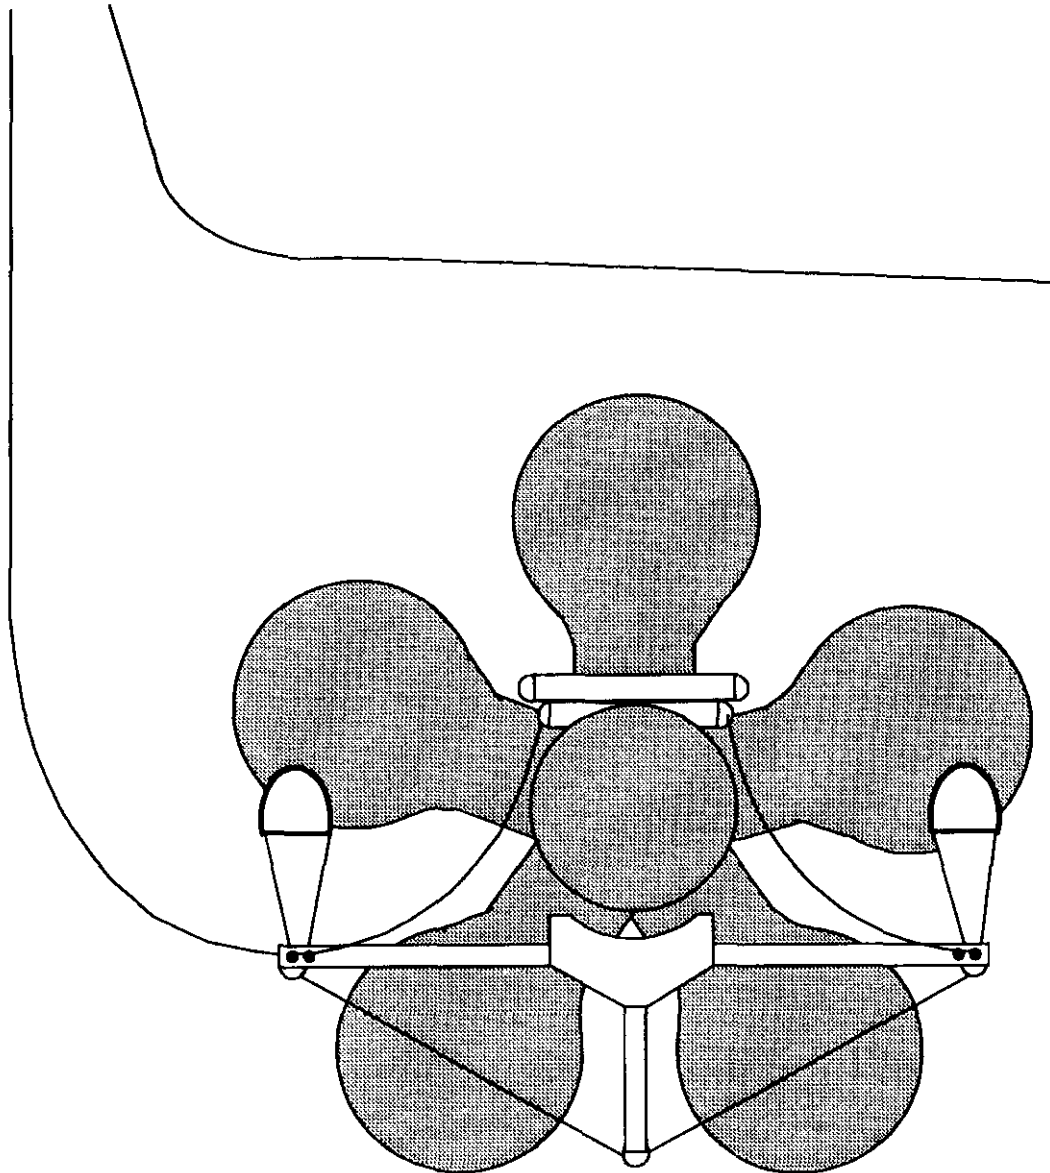
FIG. 4—LOWER FRAME BEING FLOATED INTO POSITION

driver failed to turn up, reporting that no cranes could operate in the dockyard due to high winds. A bottom line was rigged and the lower frame was then manhandled into the water. Once in a vertical position outboard of the blades the securing chains were connected to the top 2 legs of the frame and the outboard side of the top rail (FIG. 3). Flotation devices (air bags) were inflated on the lower legs of the lower frame to allow the frame to be floated into position against the underside of the hub, with the lower blades protruding through (FIG. 4). The inboard chains were then connected between the upper and lower frame and bottle screws tightened to secure the 2 frames to the hub (FIG. 5).
