# HMS 'BRAZEN' SALVAGE AND REPAIR

I. M. PEACOCK, BSc, RCNC  
(*Naval Architect Warships Group 2, NSC, Bath*)

COMMANDER P.J. HORSTED, MENG, MSC, CENG, MIMARE, MINUCE,  
MIMECHE, RN  
(*formerly Marine Systems Manager Warships Group 2, NSC, Bath*)

## ABSTRACT

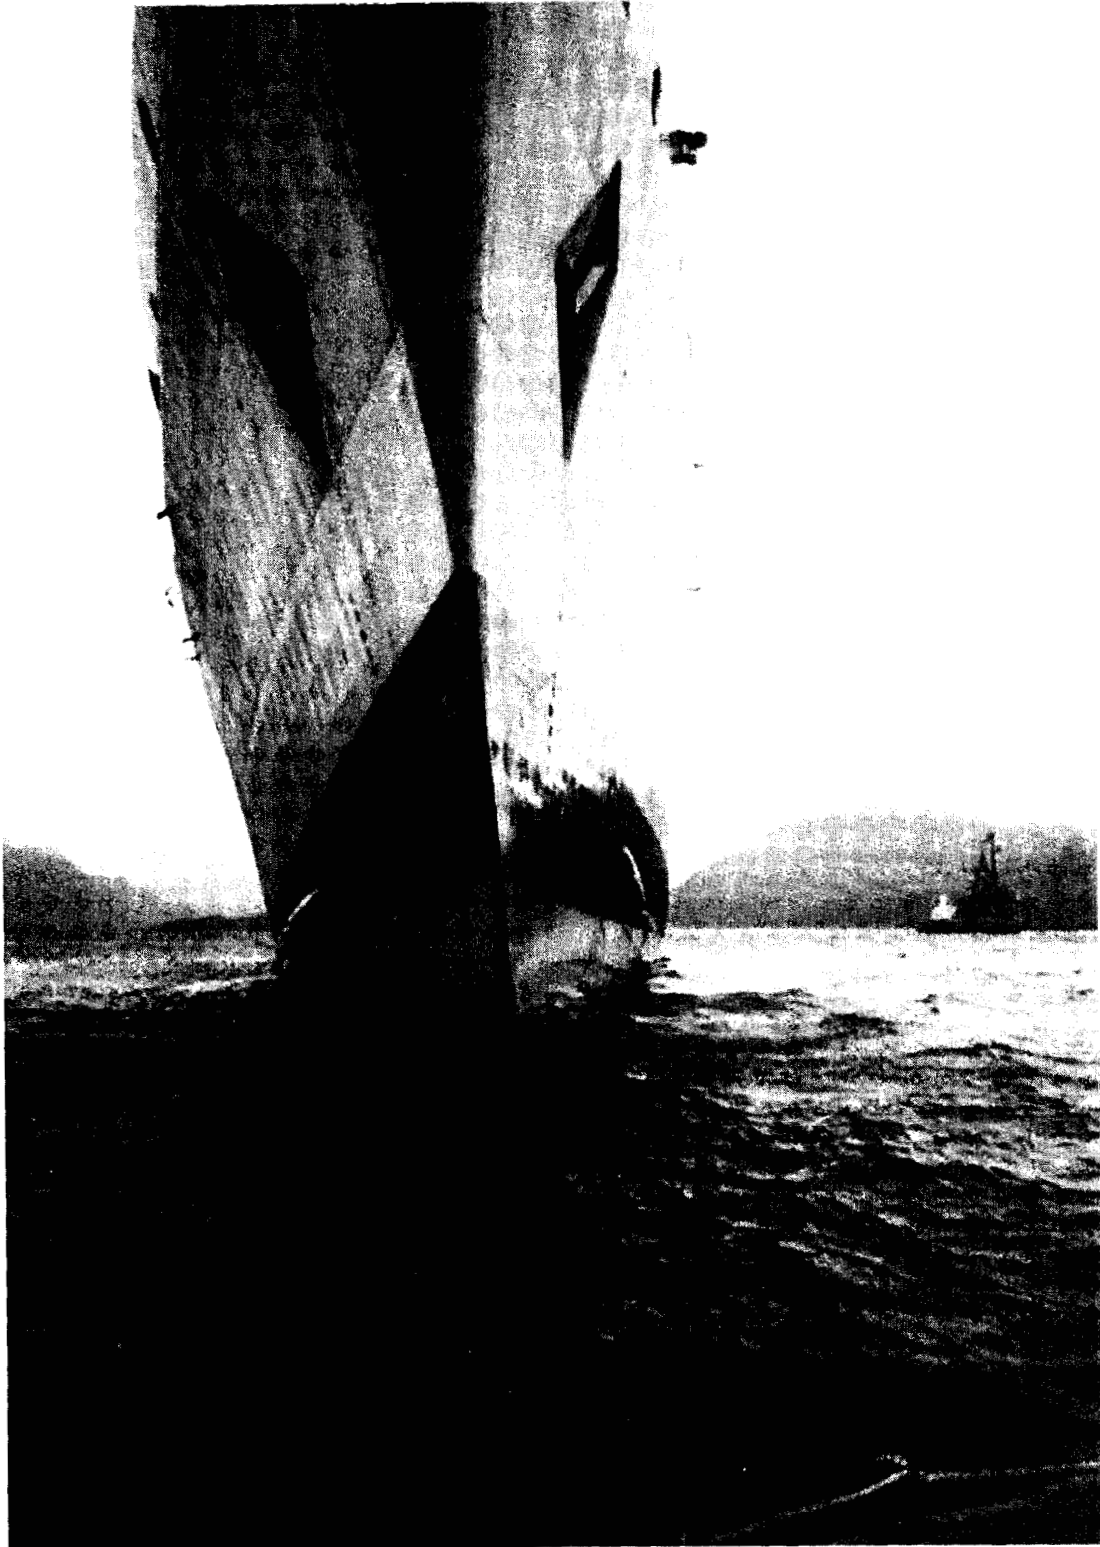
*Brazen* rode onto the submerged rock to a point about 20 metres from her forefoot before coming to rest. In so doing five major watertight compartments had been breached and a sixth, and much larger compartment housing the main sonar had a relatively small leak. The ship's HO29 and HO30 sonar domes (Hull Outfits) had been torn off by rocks before the ship came to rest.

FIG. 1—'BRAZEN' ON THE ROCK

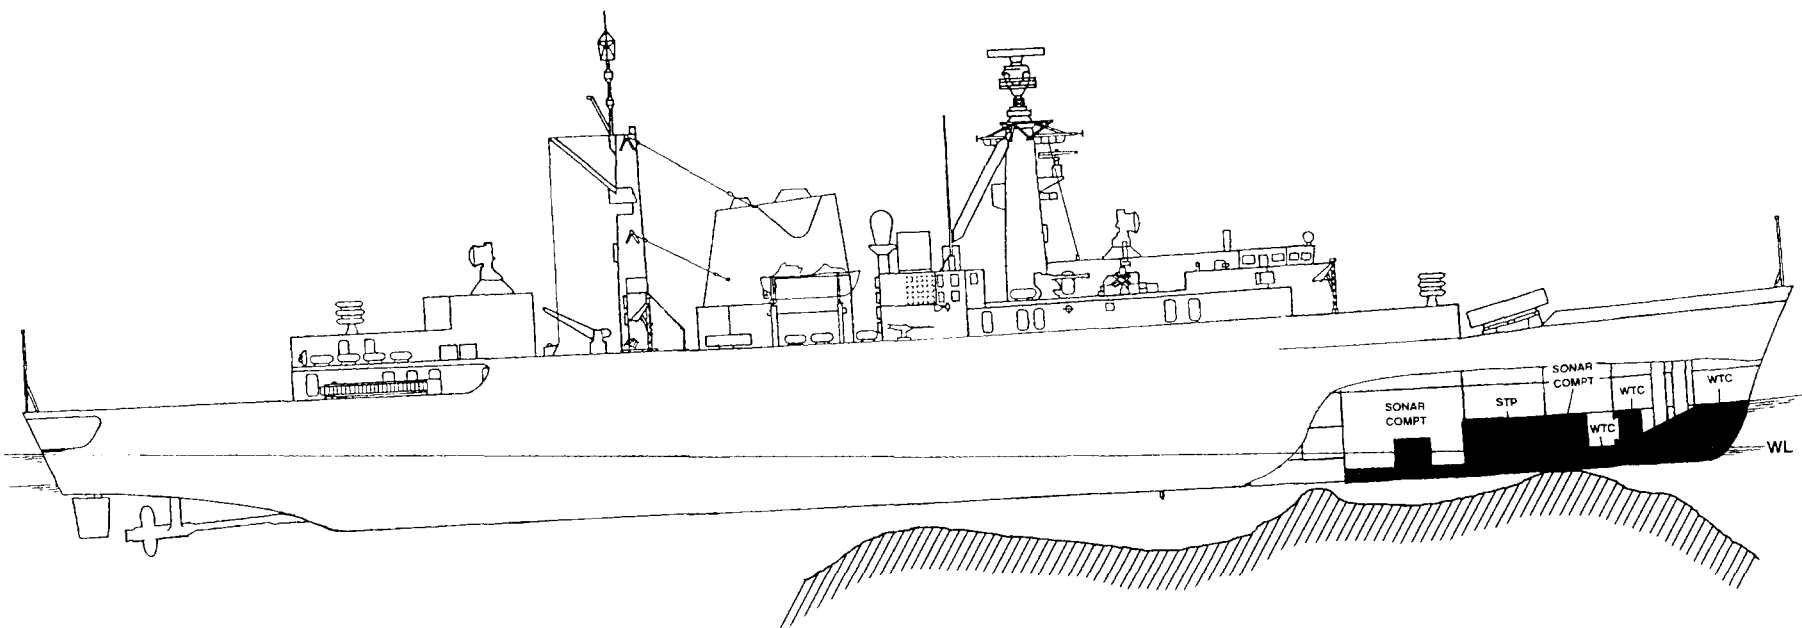
The five severely damaged compartments were flooded and inaccessible but in the sixth (HO29), the leak had been contained using one portable pump and cement boxing, (FIG.3). Inspection within the Hull Outfit 29 com-

FIG. 3—'BRAZEN' GROUNDED—DAMAGE DIAGRAM  
STP—SEWAGE TREATMENT PLANT WTC—WATERTIGHT COMPARTMENT

- The watertight Sonar trunk which appeared slightly tilted
- The Sonar near field monitor, which had been broken off probably by the shock loading at impact.

The sewage treatment compartment forward of Hull Outfit 29 was flooded and the machinery badly damaged. Compressed air had been used to force out much of the flood water and provide an air cushion against some of the potential effects of slamming.

The next compartment housing the Sonar Hull Outfit 30 was breached, completely flooded and badly damaged. This area had been the final pivot point on the pinnacle of rock prior to the ship being freed and at that time Yokohama fenders had been placed in the compartment to provide added buoyancy. The watertight compartment forward of HO30 had been breached and was open to the sea. Finally, at the fore end, the fore peak was breached below No 3 deck but there were no signs of structural degradation above.

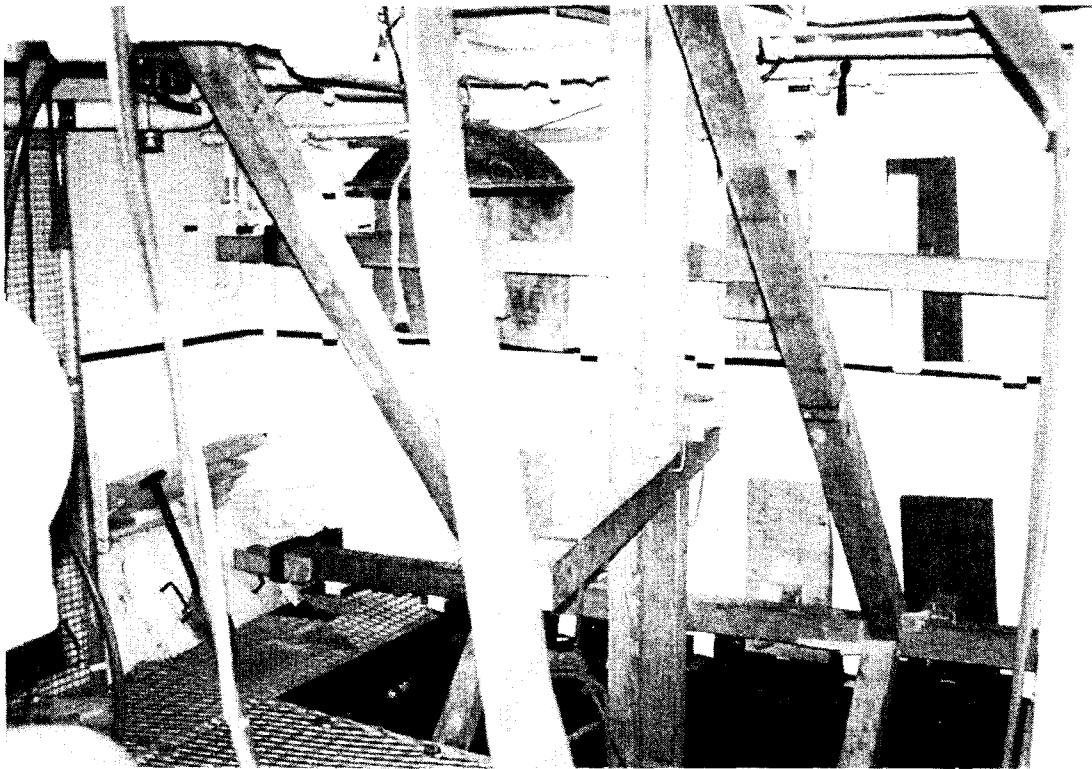
The damage control measures taken by the ship were described as 'text book', (FIG.4). Hatches and decks above breached compartments had been shored using damage control timber or AKROW props and the loads were well spread above.

FIG. 4—DAMAGE CONTROL MEASURES IN THE HO29 COMPARTMENT

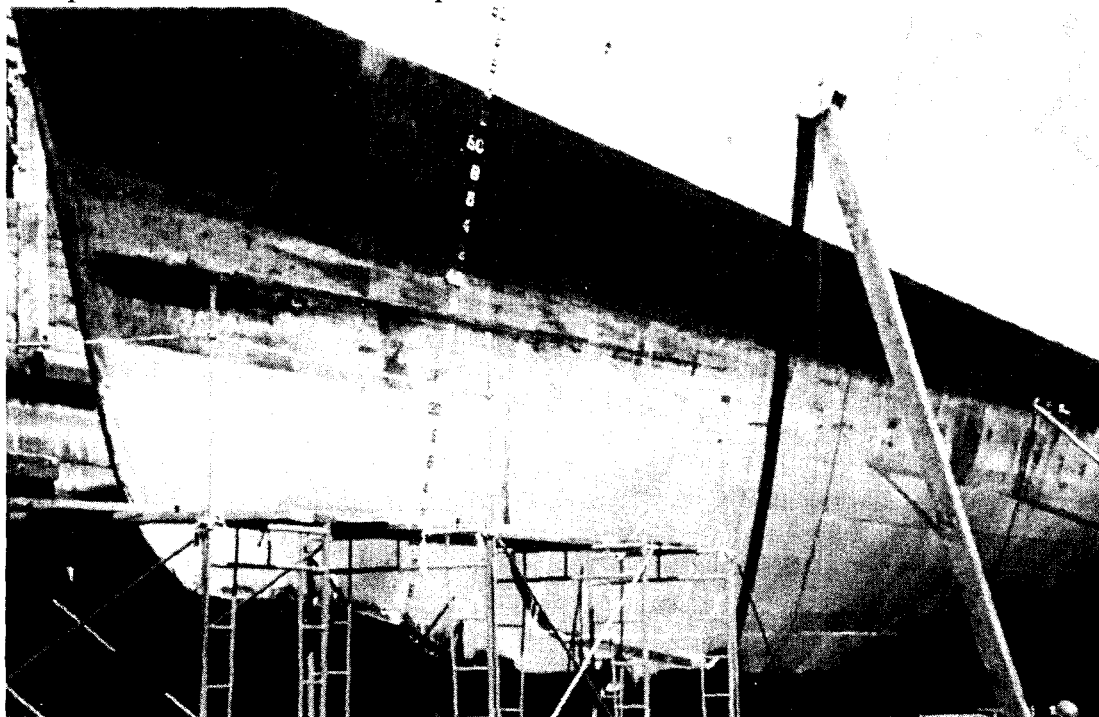
FIG. 5—IN DOCK—THE DAMAGE REVEALED

Hull damage comprised, in simple terms, twisted and petalled plating at the fore foot and crushing by the reaction force on the rock back to frame station 21 at the fore end of the HO29 compartment. The extent of damage up the hull was not as bad as expected and an initial assessment put the maximum height above the line of keel for the removal of structure at about 2.2m at the fore end and as little as 1.2m at No. 21 station. A very rapid analysis of other aspects indicated that:

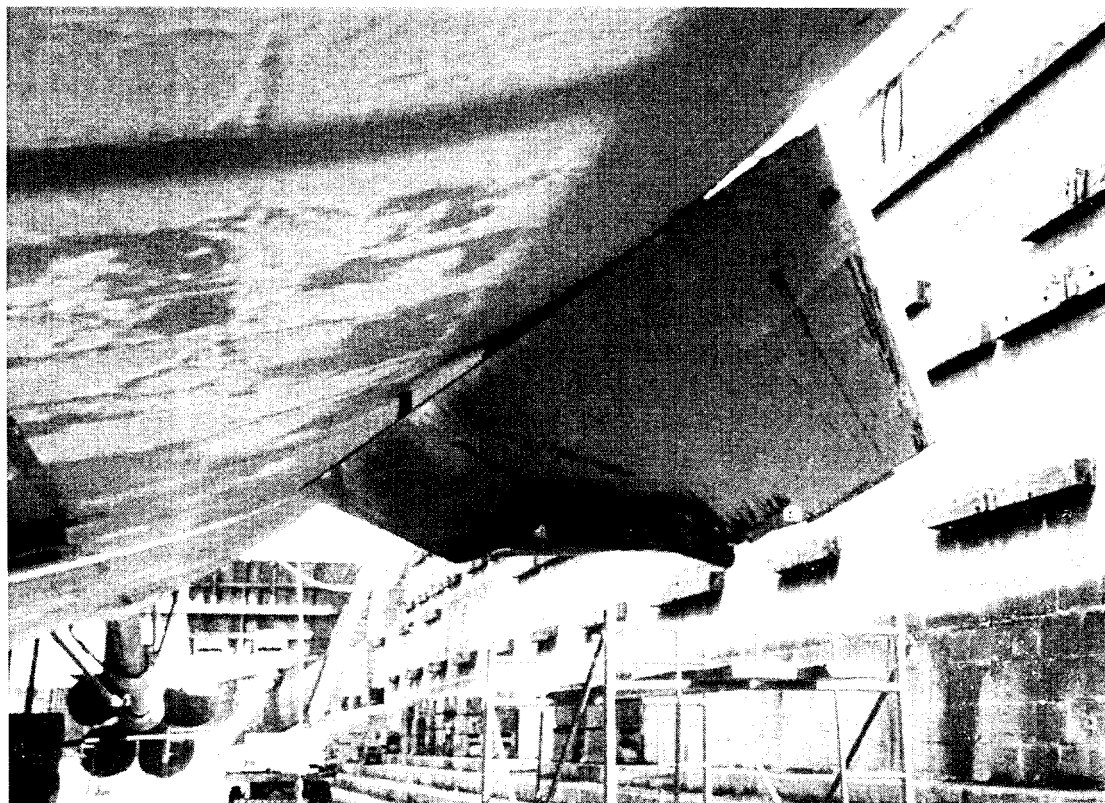
- The HO29 dome seat was unrecognisable at its fore end but only slightly distorted over the remaining 90% of its length.
- The sonar array was missing, but the sonar array seat was intact thus exposing the watertight 'top hat' structure above.
- HO30 dome and array were missing and the seatings were reduced to a mass of compressed metal.
- Most of the equipment in the sewage treatment plant was beyond repair.
- The starboard aft stabilizer was very badly damaged and jammed at an angle, (FIG.6).

FIG. 6—THE DAMAGED PORT AFT STABILIZER

*Brazen* got back to Devonport on 18 November 1994 and was docked on 1 December to have her underwater sensors restored and her port aft stabilizer replaced. This work took another four months and at the beginning of April 1995, with only sonar trials outstanding, she rejoined the Fleet. It is hoped that an account of the last phase of the repairs will be told in a later issue of *Journal*.

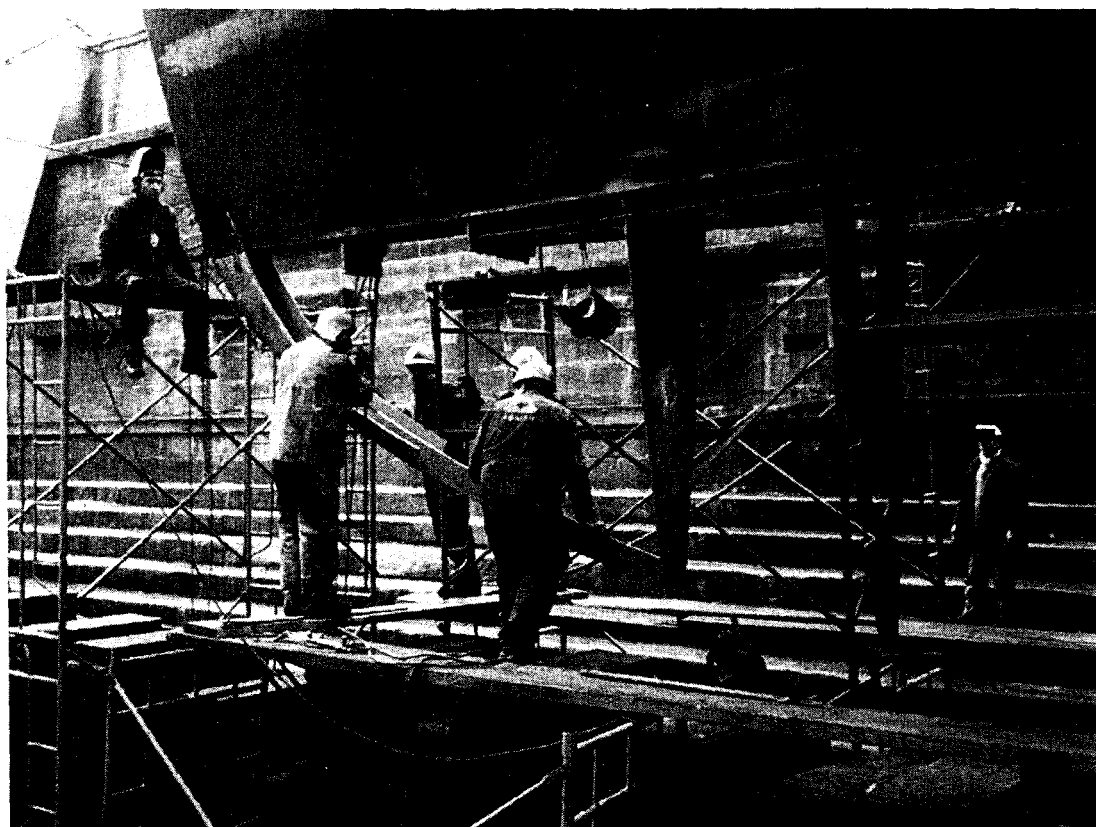
FIG. 8—REPAIRS UNDER WAY

The next ten days saw the long awaited transformation to *Brazen's* fore end. A new accurately moulded forefoot and stem bar was positioned, (FIG.8), frames were erected and plated in and the prefabricated unit to be fitted in place of HO30 appeared. The welders ASMAR deployed were taken from their submarine squad and the quality of their work was not only clearly visible but was validated by the standard of the radiographs—only one small possible fault in nineteen shots. Progressive air testing was carried out on water tight compartments as they were closed up and the standard of presentation was equally high with very few defects emerging. Repairs to the Forward Sewage Treatment Plant went ahead as soon as the compartment became available but in the end, manual operation was the best that could be achieved in the absence of correct control panel parts. Meanwhile, the port, aft stabilizer was removed and secured onboard and the bearing blanked. Reinstatement was to wait until *Brazen* was back in the UK.

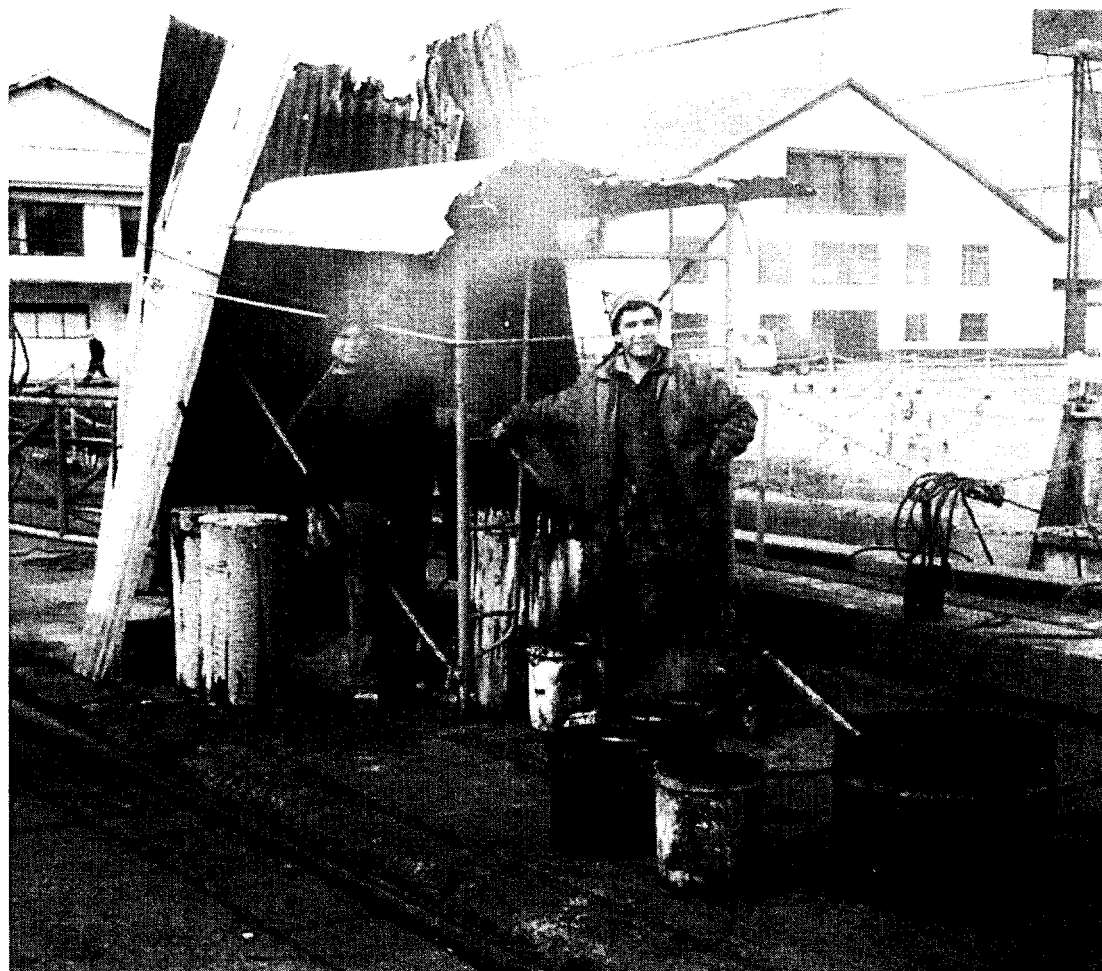
FIG. 9—BITUMEN FOR THE FORE PEAK

The full external paint scheme was achieved by late on Monday. Fortunately the variations in weather conditions had not affected work inboard and compartment preservation went smoothly. One added hazard amidst the mass of activity at the fore end was the requirement to refill the fore peak with several tonnes of hot bitumen, (FIG.9). The raw material was heated on the dockside and carried in buckets by 'runners' up the brow and down through the line of hatches at the fore end. This process took about three days and was achieved without accident or serious spillage.

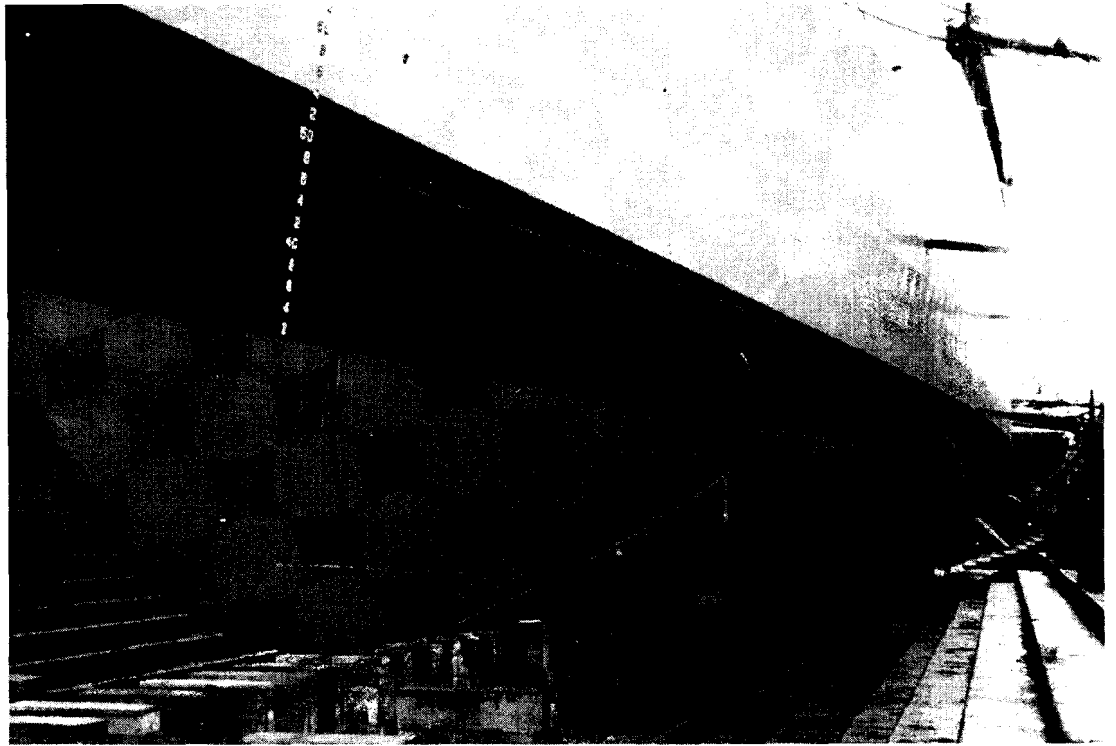
FIG. 10—WORK COMPLETE AND READY TO UNDOCK

And thus the day for undocking had arrived, the hull structure was back to build standard, (FIG.10). Final calculations of the ships condition were made; in this case there were significant changes to weight and buoyancy to take into account! and therefore trim would be significantly affected. All necessary checks were made and by 1245 on Tuesday the 18th, *Brazen* was safely tied up at her original berth, (FIG.11).

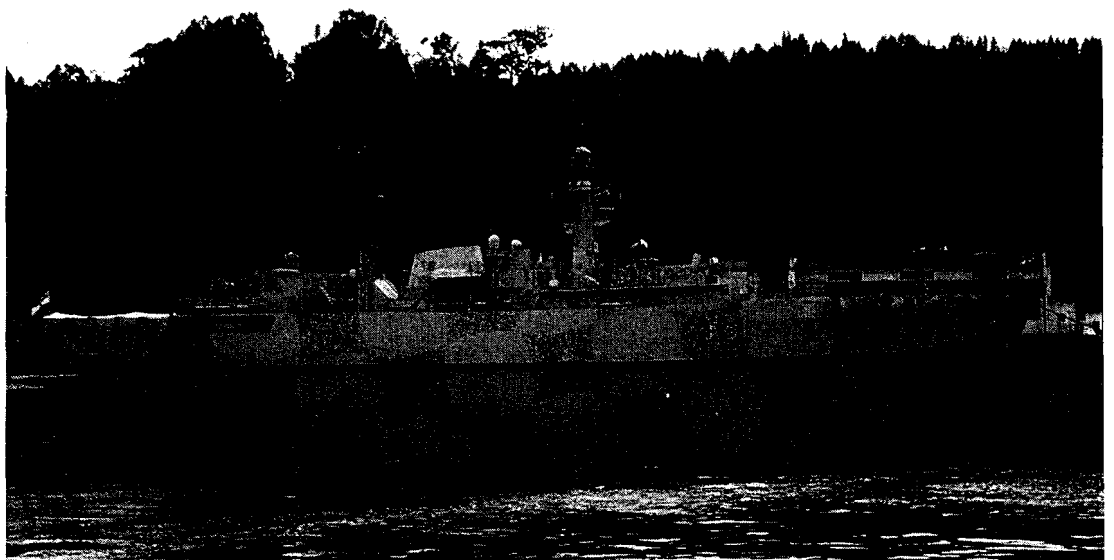
FIG. 11—AFLOAT AND READY TO GO HOME
