OVERHEATING OF MAIN PROPULSION TURBINE ROTOR JOURNAL

A CASE STUDY

Commodore M. K. Banger, VSM, CEng, FIE(Ind), Indian Navy
(formerly of Ship Maintenance Authority, Bombay)

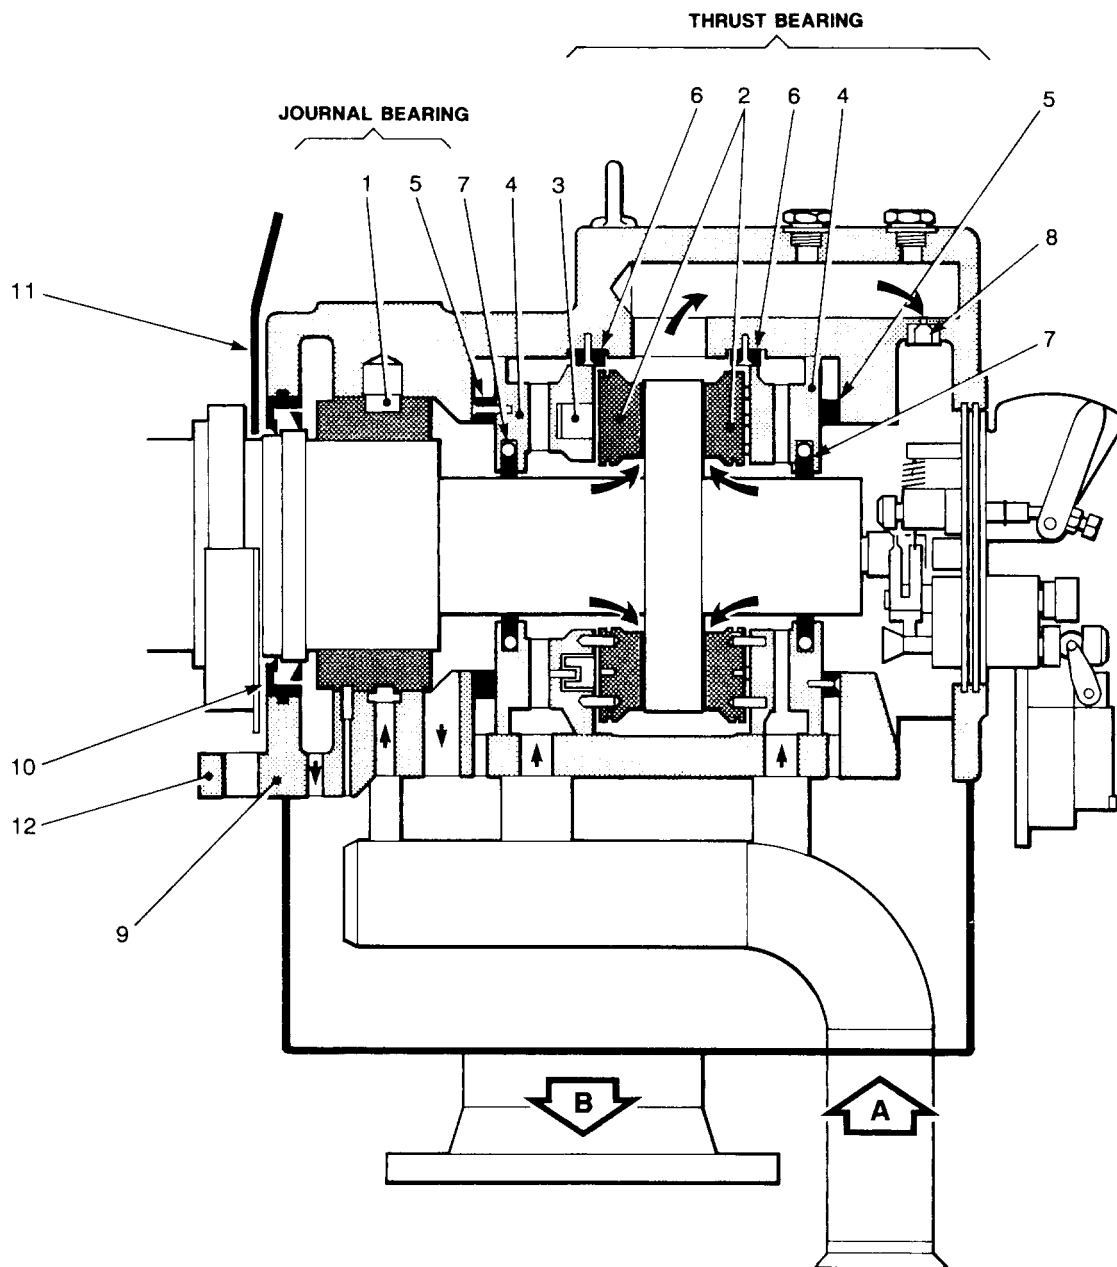
FIG. 1—MAIN HP TURBINE FORWARD BEARING PEDESTAL

Particulars of the Stal-Laval main HP turbine of the vessel are given in FIG. 1 and TABLE I.

The main HP turbine forward bearing and oil baffle were opened up by the ship's staff as a routine examination during the six months long scheduled refit of the vessel. The rotor shaft in way of the oil baffle was found to be discoloured, showing bluish colour marks. The bottom half of the oil baffle also showed excessive rubbing marks, thereby indicating some metallurgical structural changes of the rotor shaft. Metallurgists were called upon to examine and report but were unable to do so as they opined that unless the complete rotor were made available to them on the shop floor, it was not possible for them to make any start in the investigation, let alone arrive at any definite conclusion. This obviously meant that the HP turbine casing had to be lifted to enable access to the rotor shaft for a thorough examination.

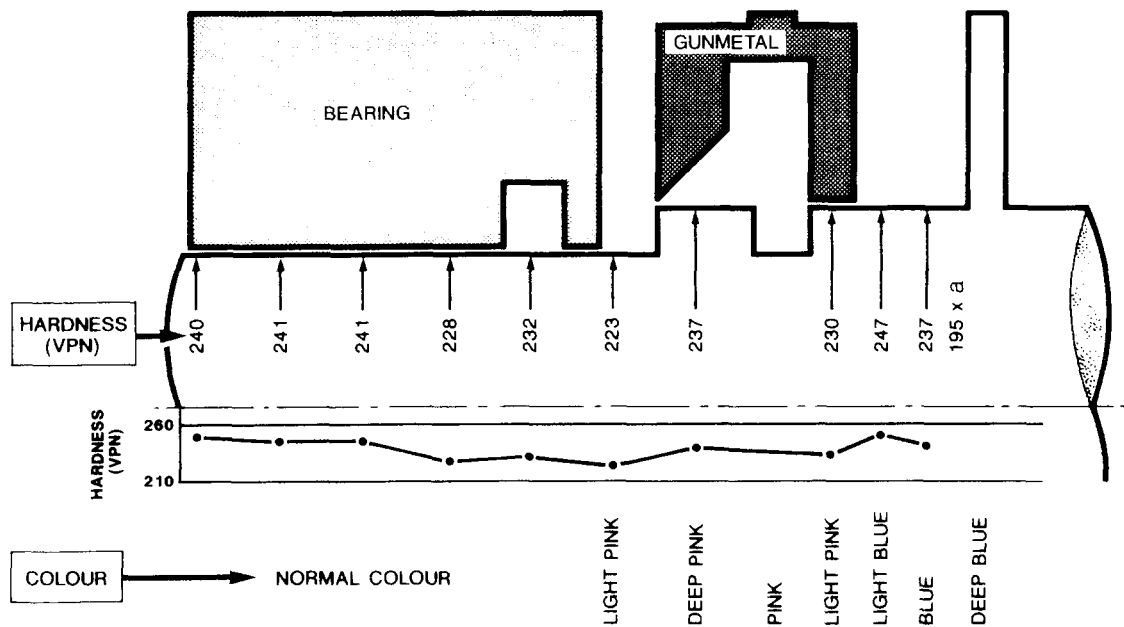
FIG. 2—DISTRIBUTION OF HARDNESS VALUES RECORDED ALONG THE ROTOR JOURNAL
VPN: Vickers Hardness Number

Advantage was taken of the fact that the hardness of a material has a certain relationship with the temperature. Accordingly, the rotor shaft in way of the oil baffle and the forward bearing were subjected to a hardness test by a portable hardness testing meter and the values of the hardness were noted at eleven points along the rotor shaft as shown in FIG. 2. The rotor shaft had a specified hardness ranging from 210 to 260 Vickers Pyramid Number along its length. A perusal of FIG. 2 will show that the observed hardness values, ranging from 223 to 247, were lying well within the specified hardness range of 210 to 260. The deep bluish mark observed in way of the oil baffle could be estimated to have a temperature around 250°C which was well below the maximum working temperature of operation, specified as 550°C for the turbine. Further, the hardness values substantiated this conclusion.

The vessel was cleared for operation without any reservations or limitations. The ship's staff was, however, directed to take the following precautionary measures:

- (a) The following action to be taken on each occasion before turning the main engine for the first time under steam:
 - (i) Main turbine to be rotated by turning gear and the starting and running currents to be recorded.

- (ii) Any unusual noise emanating from the main turbine to be watched for and, if detected, the turbine immediately stopped.
- (b) Vibration meter readings of both HP and LP turbines to be carefully watched and recorded hourly.
- (c) The expansion readings of the HP turbine rotor, both when cool and when under steam, to be recorded *vis-à-vis* the specified normal readings.
