UPHOLDER CLASS SUBMARINE WEAPON DISCHARGE SYSTEM

THE LONG CLIMB BACK

R.A.D. HARRIS CENG FIMARE
(Director General Underwater Weapons)

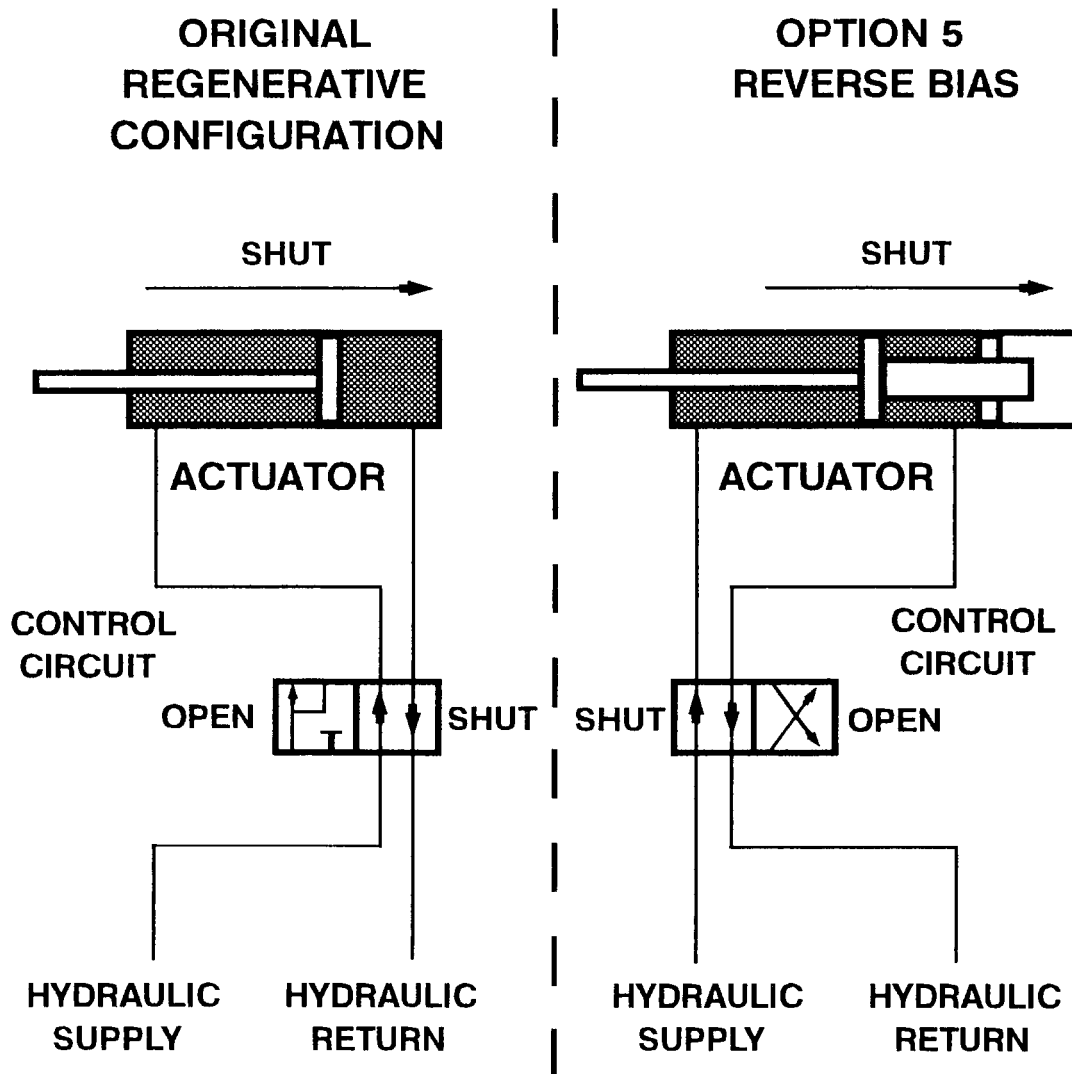
FIG. 4—HYDRAULIC SUPPLY TO ACTUATORS

Its major drawback is that when shut, the actuator's large opening area is directly connected to the submarine hydraulic return system. The return system would not normally experience pressures higher than 5% of the supply pressure. However due to area bias of the actuator, if the return pressure is allowed to rise in the return system to approximately 43–70% (dependent on the actual actuator) of the supply pressure, then the actuator will move towards the opening position. The risk of an inadvertent opening is further increased if hydraulic power should fail since, by design, the shutting pressure quickly dissipates once the accumulators are flattened by leakage flow through the numerous cartridge valves,

leaving the larger opening area to react to any pressure variations that may occur in the return system. The actuators can therefore be described as biased to open. This potential to open is further aggravated by the introduction of the slide valve, which by virtue of its design, receives little assistance from hydrostatic pressure to remain shut. This is further compounded by the siting of the torpedo tubes in the upper part of the hull, where in normal surface trim the two upper tubes are only half submerged.

- (1) To reverse the unsafe bias of all actuators which have a safety implication, both inboard and outboard, to safe bias (see Fig. 4), including the Top Stop for weapon retention in the tube. The extent of the actuators modified to safe bias can be seen in (Fig. 5).

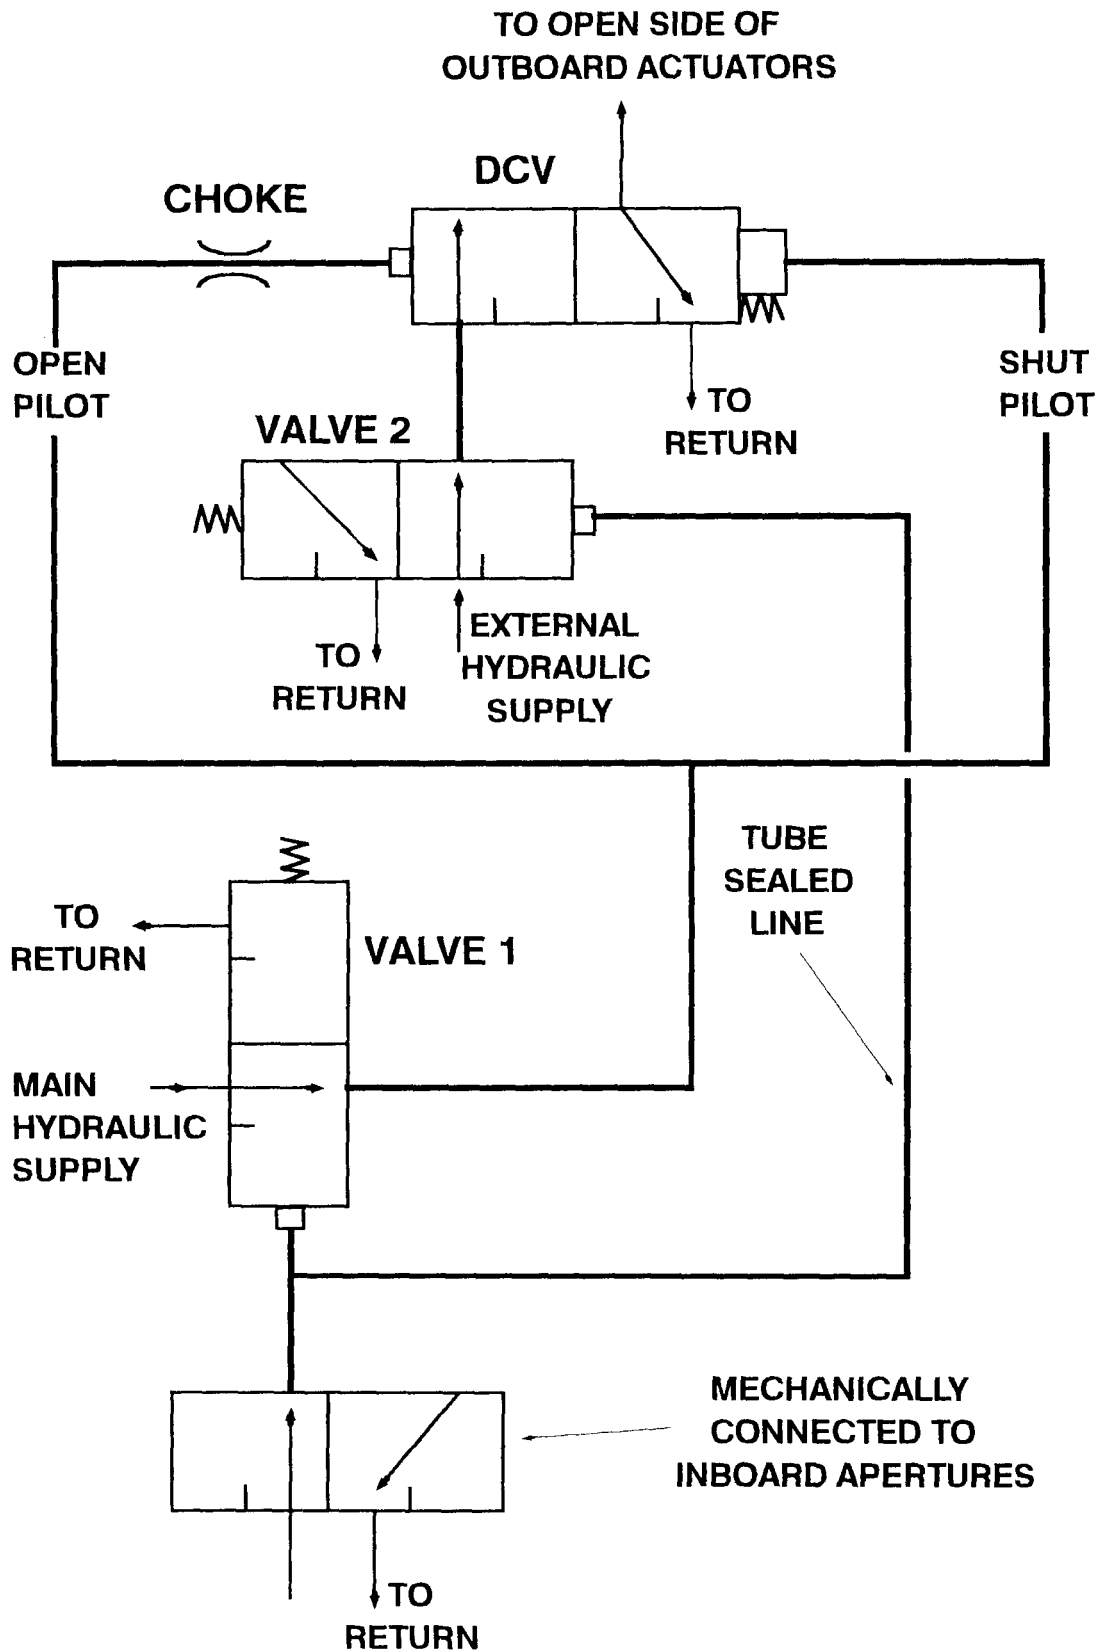
FIG. 7—SIMPLIFIED PART HYDRAULIC CIRCUIT TO ILLUSTRATE PILOT RACE—BEFORE MODIFICATION

One of the hydraulic safety interlocks known as the Tube Sealed Line was designed to prevent any of the outboards being opened whilst any of the inboards remained open. This was achieved as shown in (FIG. 7), where as soon as the interlock chain is broken, valves 1 and 2 switch. In switching:

- (a) Valve 1 dumps main hydraulic supply pressure from both the open and shut pilots of the Directional Control Valves (DCVs) which switch opening power to the outboard apertures.
- (b) When valve 2 switches, it dumps the external hydraulic pressure supply to the DCVs.

The 'open' pilot to the DCV is fitted with a timing choke which is designed to provide a time delay to ensure that on re-pressurization (i.e. shutting the inboard apertures), the 'shut' pilot is always established ahead of the 'open' pilot thus maintaining the outboards shut. During system testing at *Dolphin* in February 1991, inadvertent movement of the DCVs was seen; had valve 2 suffered a failure at the same time then the potential existed for an uncontrolled flooding route into the submarine via the bow cap/slide valve and vent valve/drain valve. The inadvertent movement of the DCVs was intermittent and at first appeared to be of a random nature, however after extensive testing and analysis, the culprit was finally tracked down to air in the pilot lines. By experimentation with varying amounts of air in the pilot lines, it was possible to upset the sequence of the decay and rise times for the 'open' and 'close' pilots which resulted in inadvertent movement. Since the presence of air altered the bulk modulus of the oil by orders of magnitude, the timing choke fitted to overcome the timing problem was completely defeated. Air can find its way into hydraulic systems in many ways:

It was now obvious that the presence of air must be treated as a likely event and that the design must be robust against it, in any event the safety criteria requires three levels of safety for an uncontrolled flooding, the design as it stood was only one fault safe and that one fault could remain latent and therefore undetected, a sobering and frightening thought! It was only now that the dynamic effects of the system began to be understood.

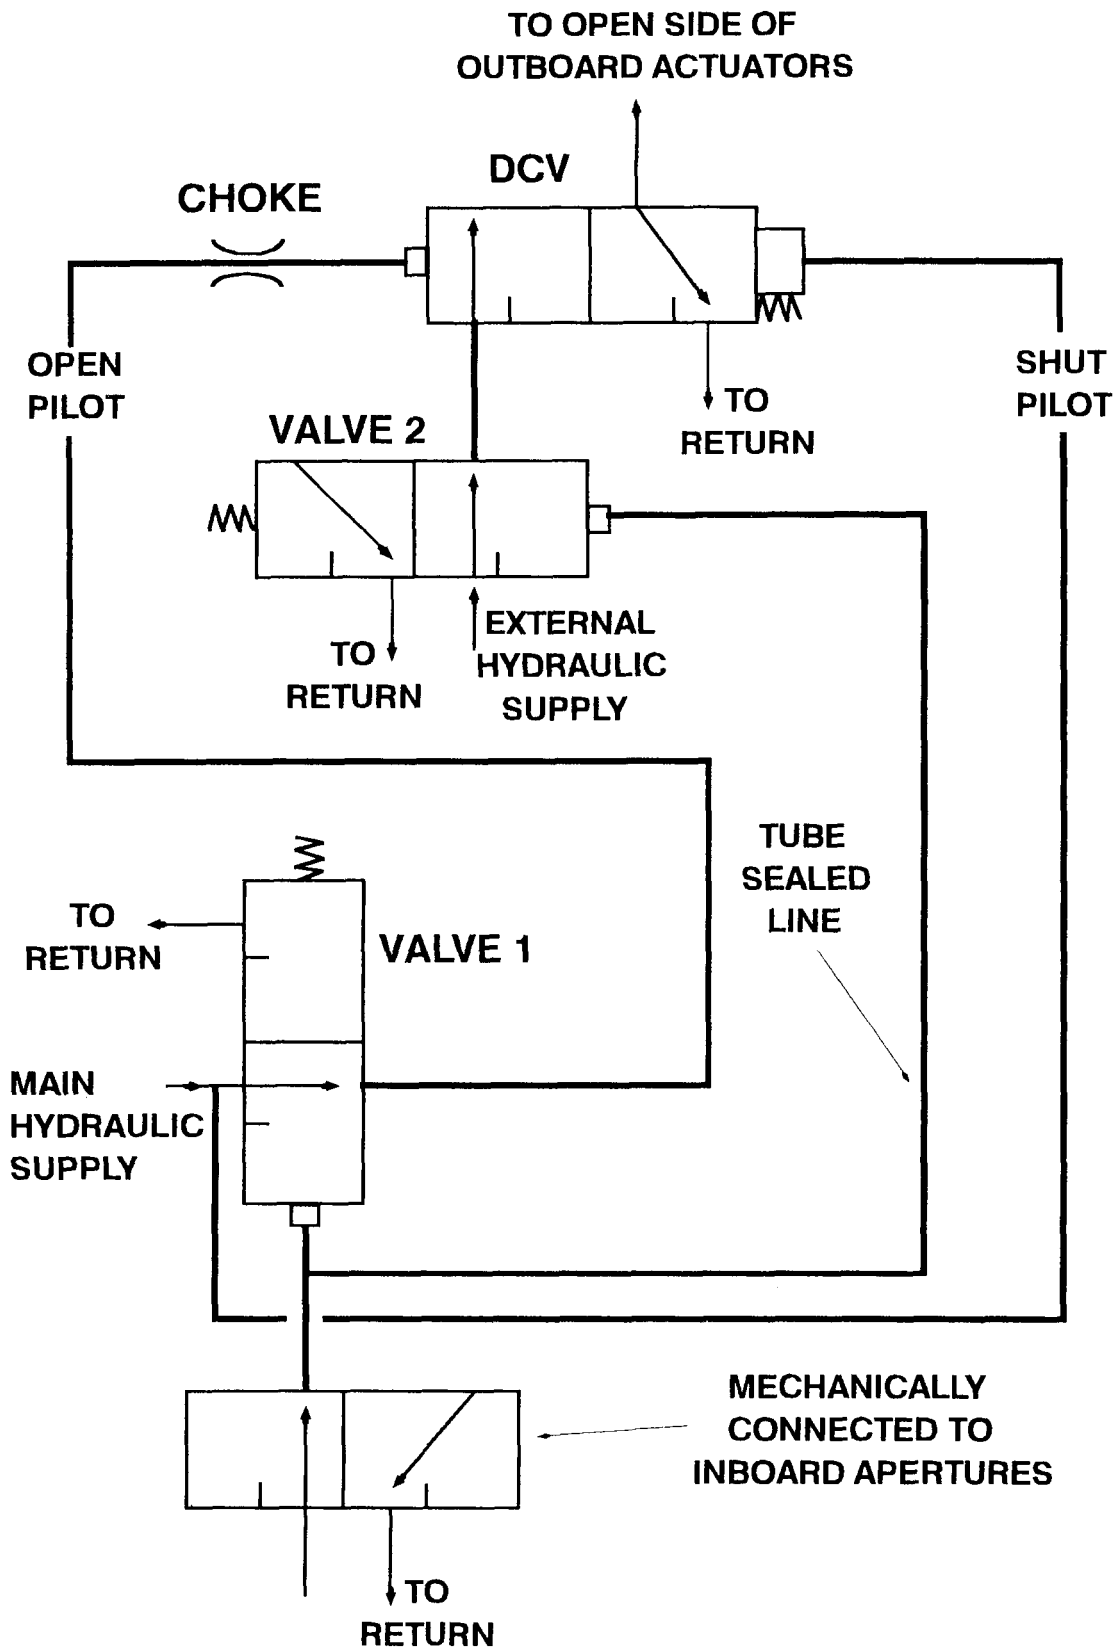
FIG. 8—SIMPLIFIED PART HYDRAULIC CIRCUIT TO ILLUSTRATE RACE—AFTER MODIFICATION

Although this modification has been completely successful in eliminating the pilot race when making and breaking the tube sealed line, it does not cater for a complete loss of main hydraulic supply pressure or its restoration. To date these have been covered by additional crew drill procedures, however a study is currently in hand to address a hardware solution that does not rely on drills.

After assessing numerous schemes it was finally decided to modify the control circuit (FIG. 8), so that there was a continuous supply to the shut pilots, even when the tube sealed line was broken i.e. inboard apertures open. The scheme looks fairly simple on paper, however implementing it into the hardware was a different matter. The modification was incorporated into assemblies known as the

Hydraulic Control Packages which are located adjacent to the tubes, one port and one starboard, with each package serving three tubes. Luckily a complete set of boat spares was held which enabled a rolling modification programme to be initiated. The modification involved drilling and blanking within the manifold to create the revised circuitry. Some idea of the complexity of the modification can be assessed from the photograph shown in (FIG. 9) of a full scale perspex model of a similar modification to another manifold. The new drillings are identified by the green lines.

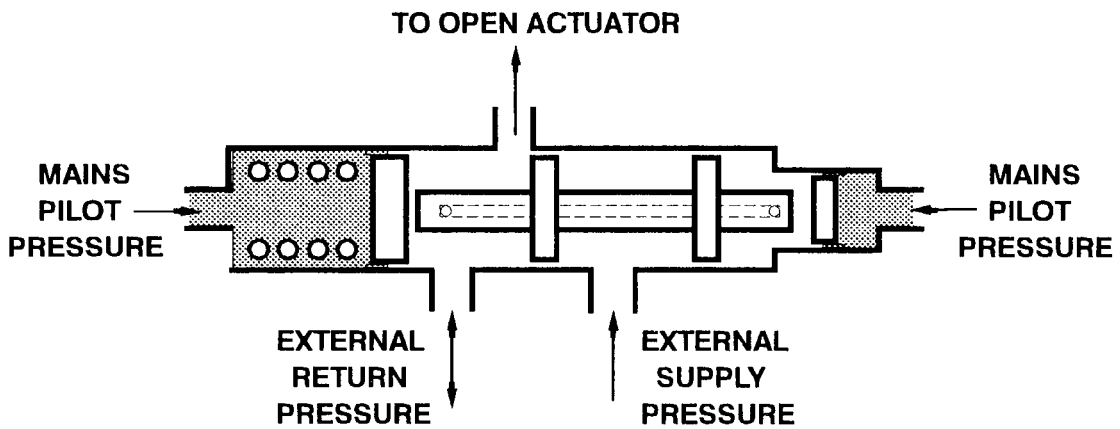
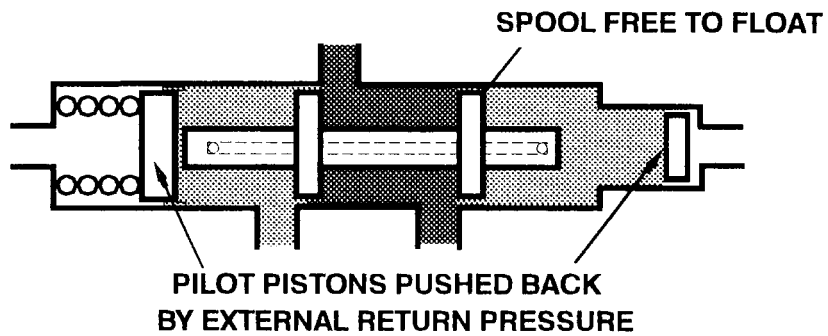
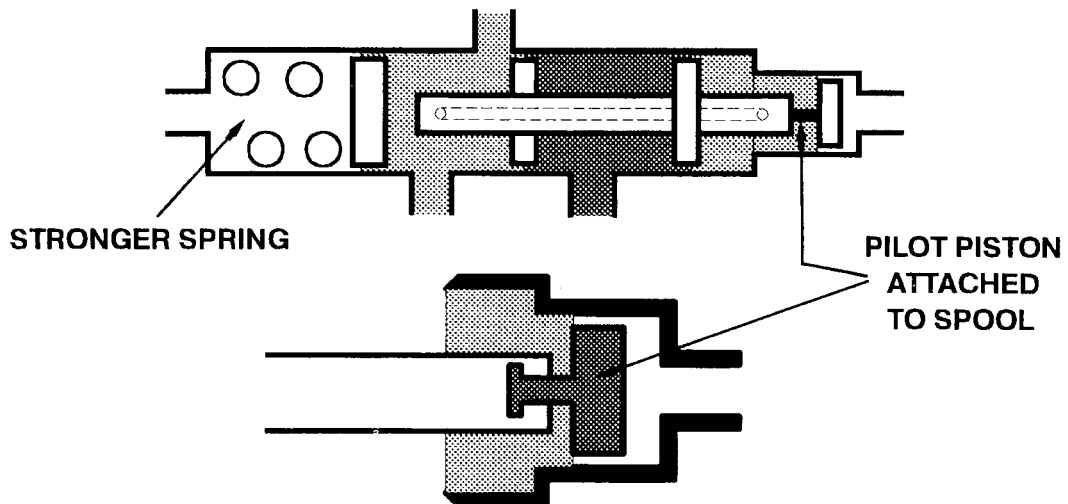
FIG. 10—TYPICAL DIRECTIONAL CONTROL VALVE

In the early days of testing and setting to work with the original design, it was considered by all parties that the safest configuration for the system was to leave external hydraulic power on, thus maintaining the outboards shut, whilst removing main hydraulic supply to prevent the possibility of an invalid pilot signal reaching any of the DCVs. How wrong this proved. Fortunately, the worst that could happen, although still highly undesirable, was that sealed tubes could inadvertently flood. It is now considered likely that this could explain some of the unresolved tube incidents during construction of the submarines at Cammell Lairds.

As already described, the DCVs (FIG. 10), switch opening hydraulic power to the outboard tube apertures. In normal operation with both pilots being supplied from the mains supply, the larger of the two pilots always ensures that the valve is in the position where the opening side of the actuator is connected to the return system. This ensures that with shutting pressure still applied, the outboards will remain shut. If as stated above, mains hydraulic pressure is deliberately removed then both pilots will drop to zero. Unfortunately, by virtue of the central drilling in the spool valve (to ensure it is always balanced), any pressure in the external return system also acts on the reverse side of both pilot pistons, where now, the larger area of the 'safe' pilot piston ensures that it becomes 'unsafe'. In some cases this results in both pilot pistons being pushed away from the control valve leaving the spool free to float. On the worst case valve, this occurred at a pressure of approximately 3 bar. This pressure is normal within the return system without any faults. With the spool now free to float, gravity, any submarine movement or vibration could cause the valve to move to allow opening pressure onto the actuator. Once again a failure mode had been identified that demonstrated that the original design could result in uncontrollable flooding with less than three faults, on the premise that loss of hydraulics and its accumulator back up is not a fault. The solution shown in FIG. 10, is the one which had already been successfully applied in aircraft landing gear, was to physically attach the spool to the small pilot piston and fit a stronger spring to the larger pilot piston. This ensured that the spool was always retained in the safe position on loss of the pilots. The implementation of the modification into the system was achieved by a simple cartridge change.
