# SPEY SM1C GAS TURBINE

## THE FIRST YEAR (1000 HOURS) IN HMS 'BRAVE'

### ABSTRACT

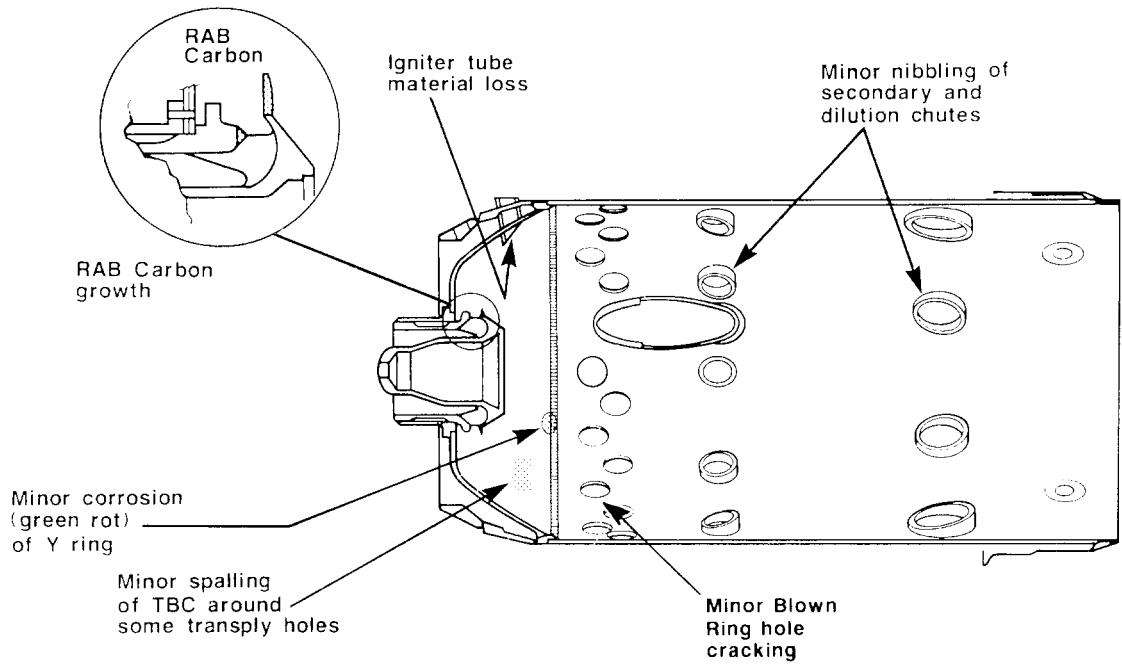
FIG. 4—COMBUSTION LINERS CONDITION AFTER 730 HOURS

- (a) Combustion chambers: two small spots of corrosion (green rot) were evident on the 'Y' ring caused by the high sulphur fuel; there was also minor blown ring hole cracking together with secondary and dilution hole nibbling. There was evidence of a frill of carbon around the Reflex Airspray Burners (RAB) and one igniter tube had lost a small amount of material at the innermost end. (FIGS. 4 and 5).
- (b) Igniters: one igniter on the port engine had suffered overheating at the tip and was replaced as a precaution (FIG. 6).
- (c) LPA System: drain pipes on both engines and one LPA pigtail pipe was blocked by carbon (FIGS. 7 and 8).

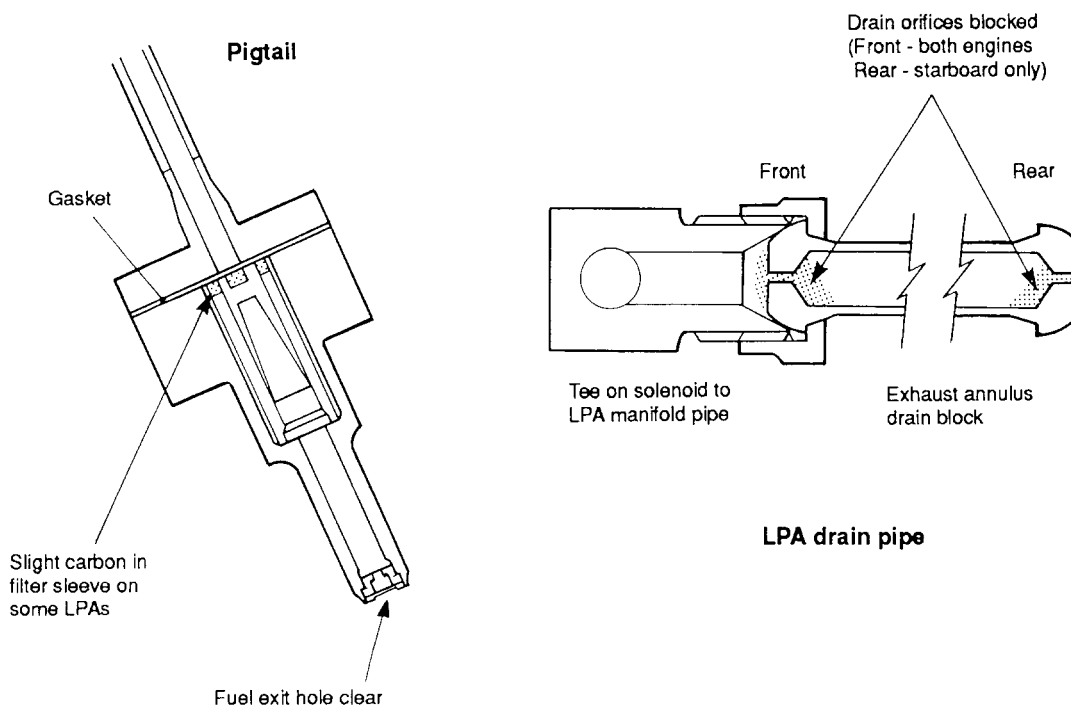
FIG. 8—LPA SYSTEM CARBON DEPOSITS AFTER 730 HOURS

- (a) *LPA drain blockage.* The repeated carbon blockage of the LPA drain pipe is caused by overheating of fuel lying in the drain pipe system. Repositioning the drain connexion and rescheduling a solenoid valve will prevent the build-up of fuel in this area and hence the source of the carbon. To date this problem has yet to affect starting performance but could if allowed to persist. (FIG. 13).

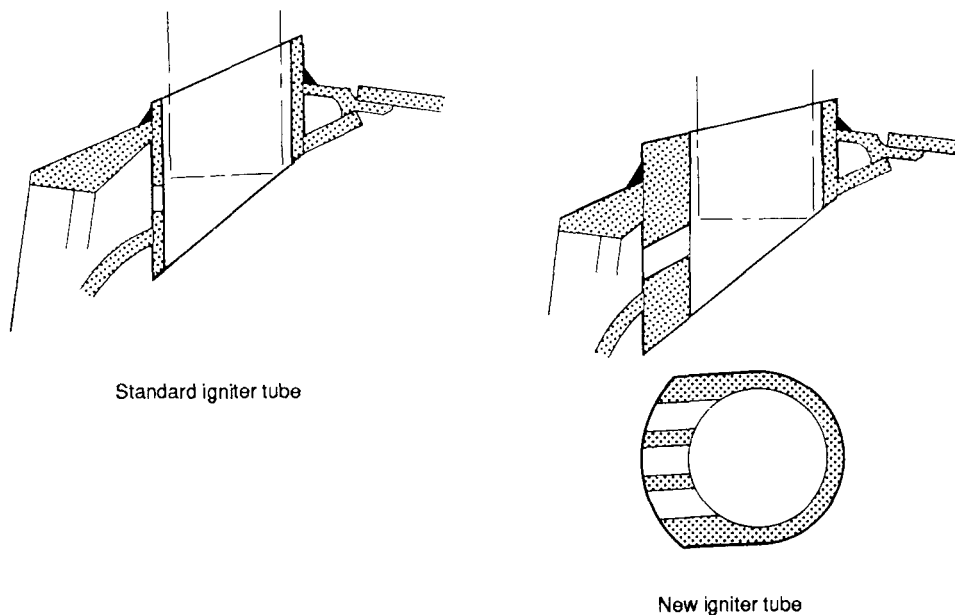
- (b) *Igniter Overheating.* Under certain operating conditions the tip of the igniters in the SM1C are exposed to temperatures above that considered acceptable for long life. Development tests have shown that redesign of the igniter tube dramatically reduces the tip temperature and, at the same time, gives relative insensitivity to igniter immersion depth (FIG. 14). So far two igniters have been replaced in HMS *Brave*, one of the two on each engine, neither failure affected starting performance, thereby unintentionally proving the single igniter starting capability of the SM1C.

FIG. 14—SM1C COMBUSTION—IGNITER TIP DETERIORATION AND IGNITER TUBE MODIFICATION

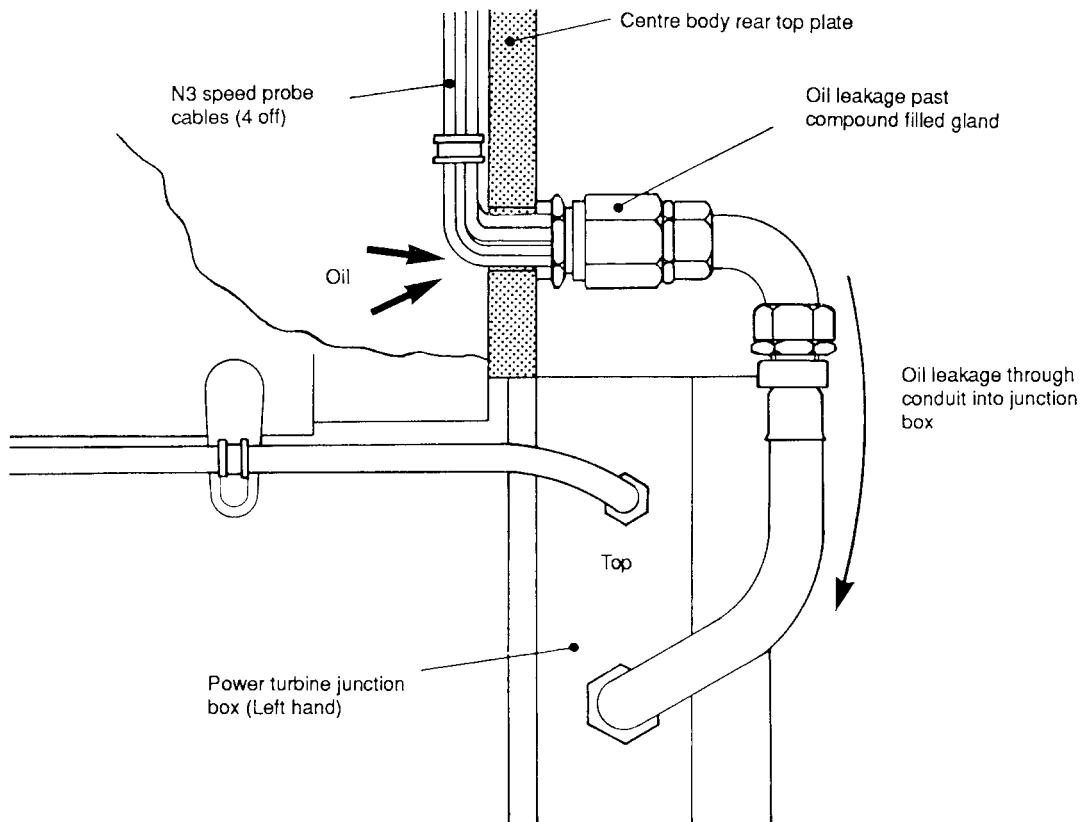
- (d) *Power Turbine Speed Probe.* One unscheduled shut down of the starboard engine was caused when oil leaked into the power turbine speed probe junction box. The defect was traced to a leaky gland on the power turbine centre body allowing oil to track down the conduit and fill the adjacent junction box causing a power turbine overspeed alarm. This was considered to be an assembly shortfall related to the compound-filled gland rather than a design deficiency. (FIG. 15).

FIG. 15—OIL LEAKAGE INTO POWER TURBINE JUNCTION BOX, HMS 'BRAVE'
