SPEY SM1A MODULAR REPAIR EXPERIENCE

LIEUTENANT-COMMANDER M. R. J. MALTBY, BSC, RN
(*Sea Systems Controllerate, Bath*)

ABSTRACT

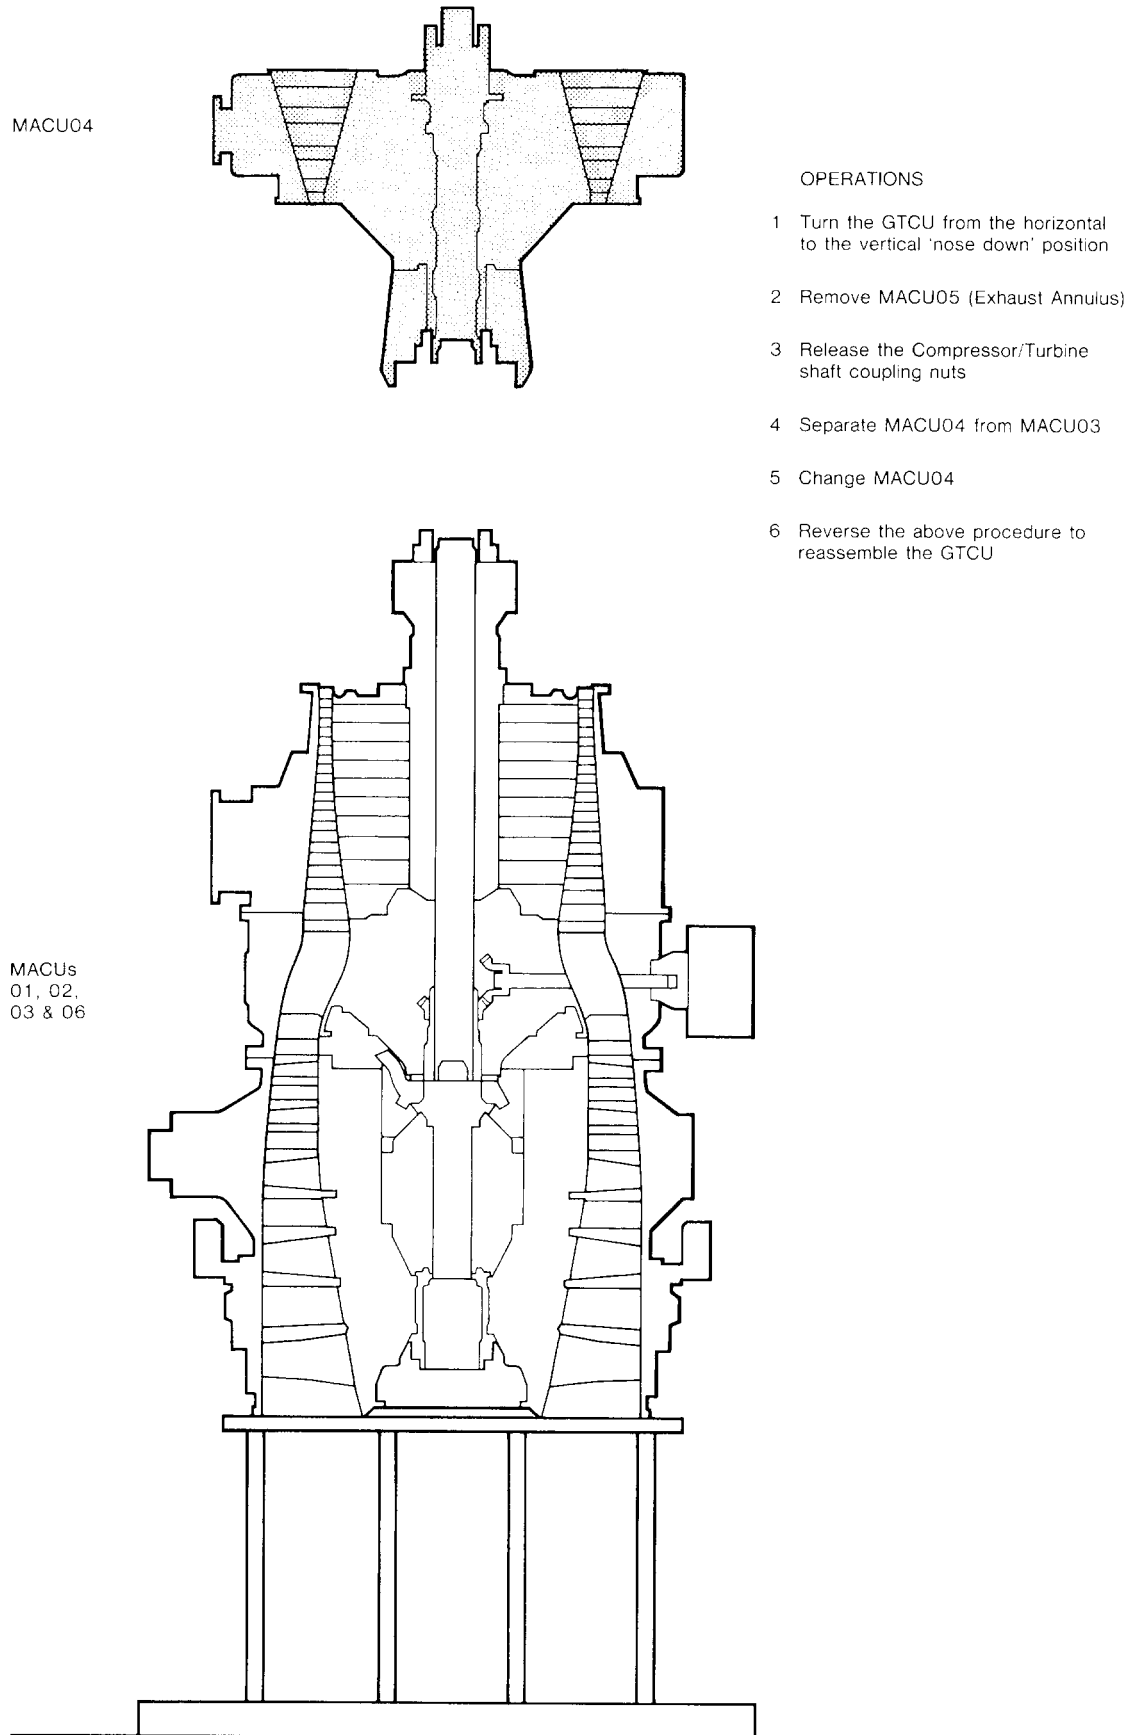
FIG. 4—MAINTENANCE ASSEMBLY EXCHANGE—MACU04

The exchange of MACUs is carried out with the GTCU mounted vertically in the 'nose down' position, as seen in FIG. 3, and the MACUs are lifted away from the 'tail' of the engine, either singly or in groups, to give access to the defective MACU(s) which are to be replaced. Two examples of MAX are shown in FIGS. 4 and 5, but of course it is possible to change more than one MACU at a time should a defect require it.

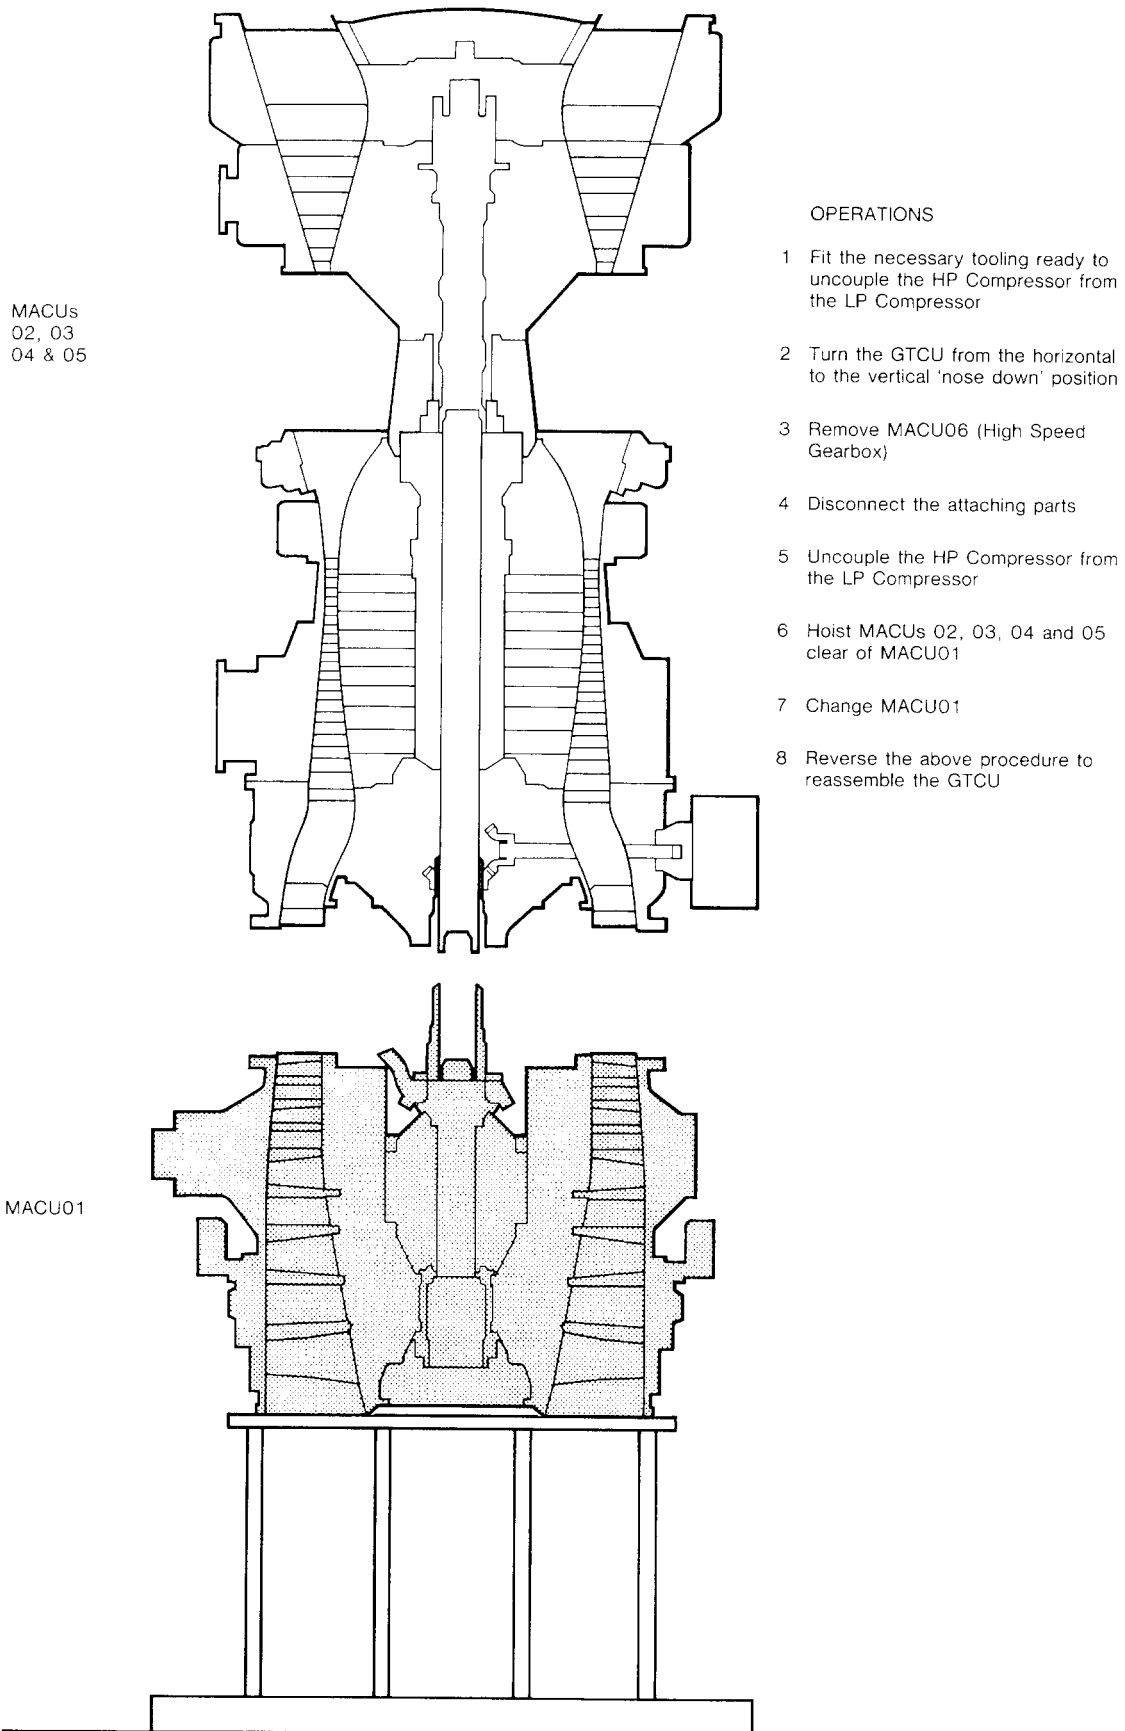
FIG. 5—MAINTENANCE ASSEMBLY EXCHANGE—MACU01

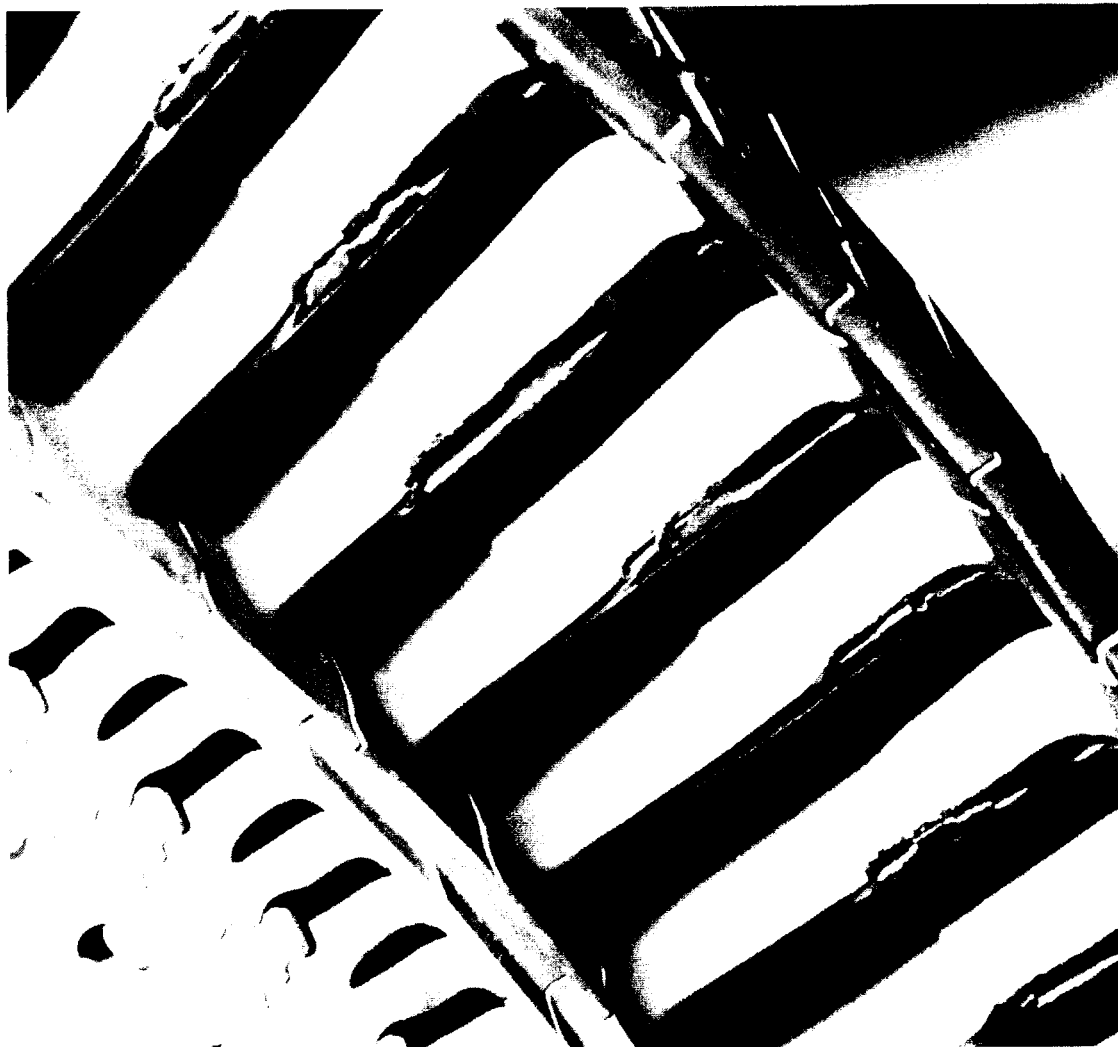
Further study of TABLE I shows that several GTCU removals are annotated as being due to Turbine Erosion. This major problem first came to light during the endurance testing of the SM1A at RAE Pyestock² and it was subsequently also seen in engines removed from the fleet such as the two GTCUs taken from HMS *Brave* in November 1989 (028 & 035) when her SM1As were replaced with SM1Cs for the SM1C Fleet Trial. The turbine damage (FIG. 7) is caused by carbon build up in the combustionware which periodically breaks away and passes through the turbine stages causing erosion as it does so, primarily to the first row of Nozzle Guide Vanes and Turbine Blades. This created a number of GTCU rejections after approximately 1200–1500 hours of running compared with the planned life of an SM1A of 3000 hours running before overhaul.

FIG. 7—TYPICAL SM1A TURBINE BLADE LEADING EDGE EROSION—HP FIRST STAGE

Once again, the MAX process restored the affected GTCUs to serviceable condition whilst the damaged Turbine MACUs remained at Rolls-Royce for repair. Unfortunately though, for the second time in the relatively short career of the SM1A to date, an unexpected influx of one particular form of damage created a material shortage on the Overhaul Line, but again the MAX concept ensured that the parent GTCUs were not withheld from service whilst the damaged MACUs awaited parts, turbine blading having a typical lead time of eighteen months to two years.

The problem of turbine erosion itself has been addressed and solved through improvements to the combustionware, the details of which are outside the scope of this article, except to say that a Modification (SPG 681) is being introduced into the fleet as fast as material becomes available. In the interim, a revised operating profile and a series of regular, detailed hot end inspections has allowed a number of affected engines to be 'run on' and hence the rejection of GTCUs has eased. The most recent SM1A removal due to turbine erosion was after approximately 2400 hours running.
