SM1A MARINE GAS TURBINE EVALUATION AT PYESTOCK

ABSTRACT

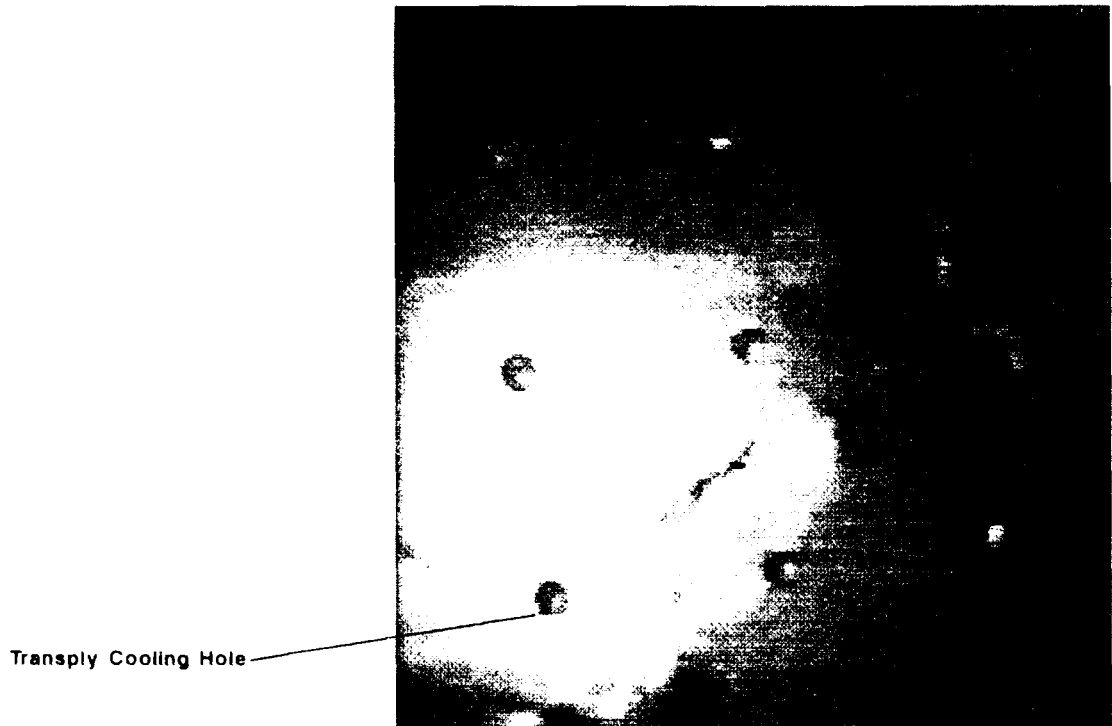
FIG. 4—COMBUSTOR NO.7 RAB END CAP AT 930 HOURS: COLD SIDE (A COMPUTER GRAPHICS PICTURE FROM A VIDEO ENDOSCOPE VIEW). THERE IS SOME SLIGHT MATERIAL DEFORMATION

At the weekly inspection (924 hours), No. 7 combustor RAB end cap began to show signs of distress and metal distortion on both the 'hot' and 'cold' faces. After discussions with DGME and Rolls-Royce, the trial progressed with an agreement for ATH staff to repeat the inspection within another 50 running hours (approximately two days). This repeat inspection was duly done at 963 hours and the RAB end cap was found to be perforated. Figs. 4, 5 and 6 compare appearance before and after perforation. (These pictures are computer graphic stills from the video endoscope inspection; some quality has necessarily been lost in reproduction.) The decision was taken to carry on with the trial until 1000 hours were completed. As an extra precaution the power turbine entry temperatures (T6) were monitored continuously by the watchkeeping personnel, but no significant changes were observed.

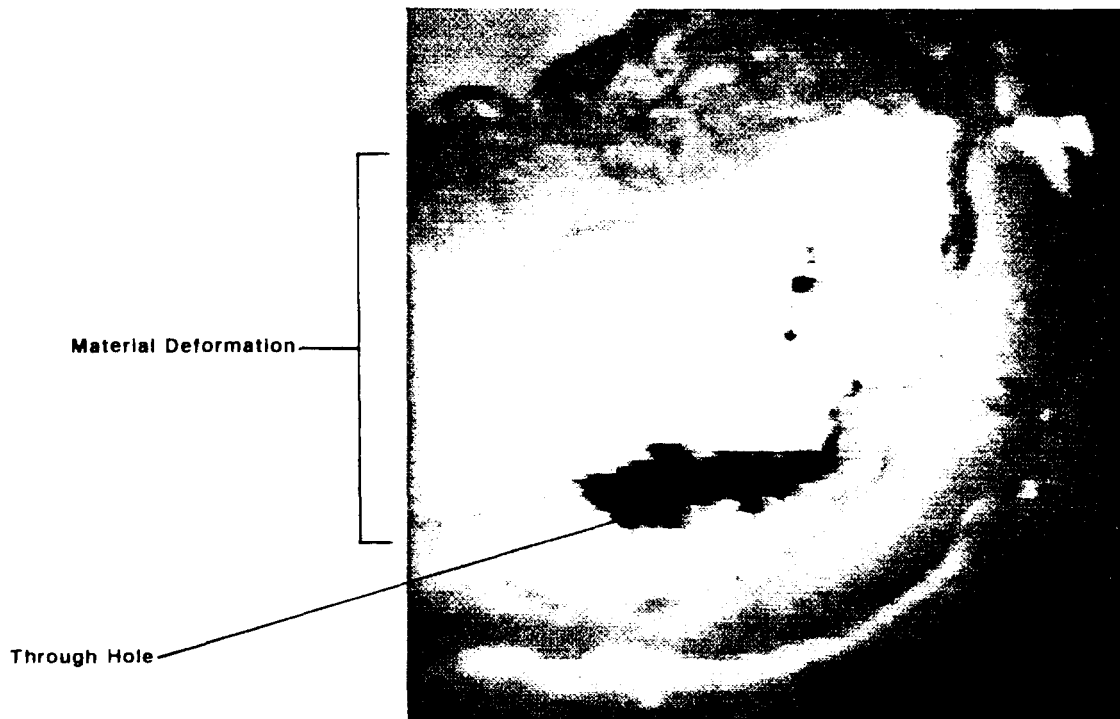
FIG. 5—CORROSION OF NO.7 RAB END CAP AT 960 HOURS: COLD SIDE. NOTE INCREASED MATERIAL DEFORMATION AND THROUGH HOLE

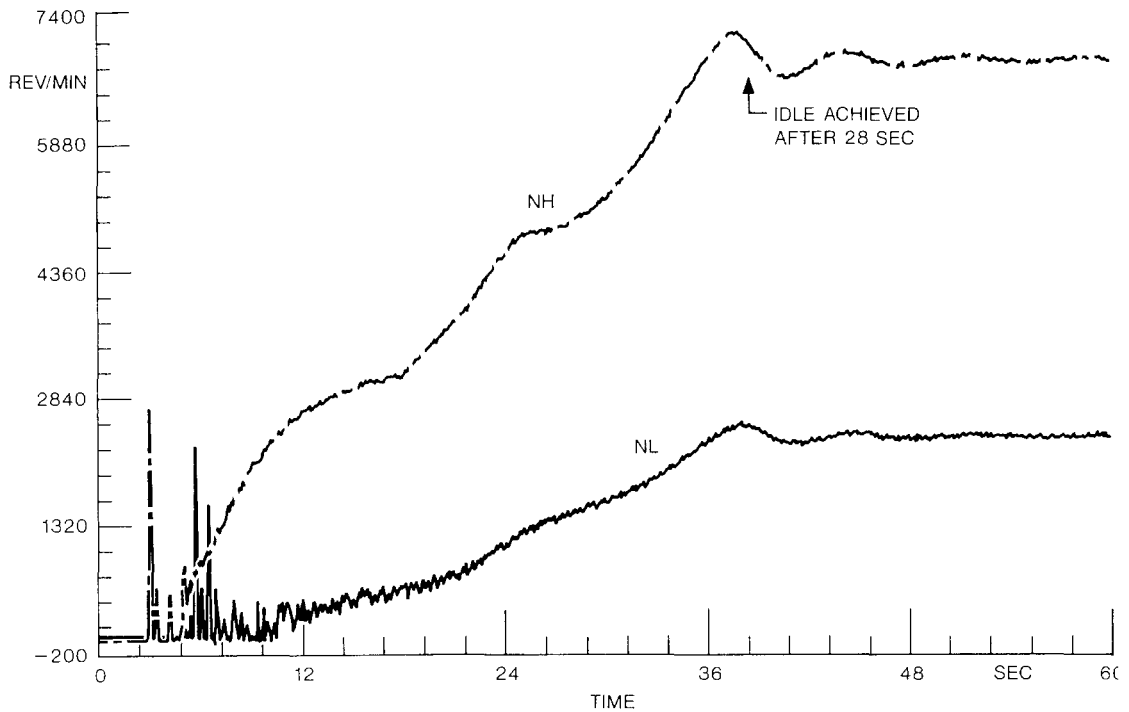
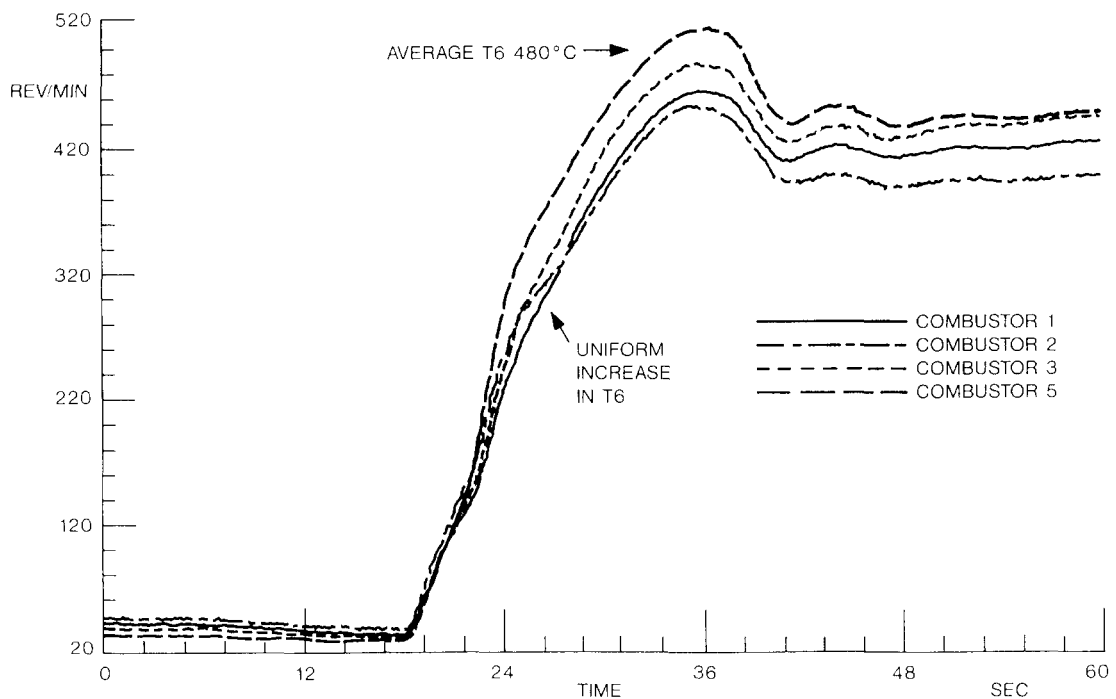
It should be noted that up until this point in the trial, the running performance of the GTCU had not been affected by the degradation and holing of the combustor heads. The transient response of spool speeds and T6s to a normal start cycle is shown in Figs. 8 and 9. However, at approximately 1600 hours the starting characteristics began to be affected by the significant through-holing in the primary zone of No. 3 combustor head. The effect was that the flame in combustor No. 3 was blown out during the start, and did not relight for about 5 seconds. This is shown in Figs. 10 and 11. This not only extended the time to achieve idle but, more significantly, increased the average value of T6 steadily. The GTCU control system has a T6 trip which terminates the start if the average T6 temperature exceeds 500°C. By this point in the trial the average T6 had risen by some 40°C and was within 1° of the trip level. Hence it can be seen that the limiting factor on combustor life may be its effect on GTCU starting temperature rather than structural integrity.

FIG. 8—HP AND LP SPOOL SPEEDS (NH AND NL) DURING START SEQUENCE AFTER 1361 COMBUSTOR HOURS—A GOOD START

FIG. 9—POWER TEMPERATURE ENTRY TEMPERATURE (T6) DURING START SEQUENCE AFTER 1361 COMBUSTOR HOURS—A GOOD START

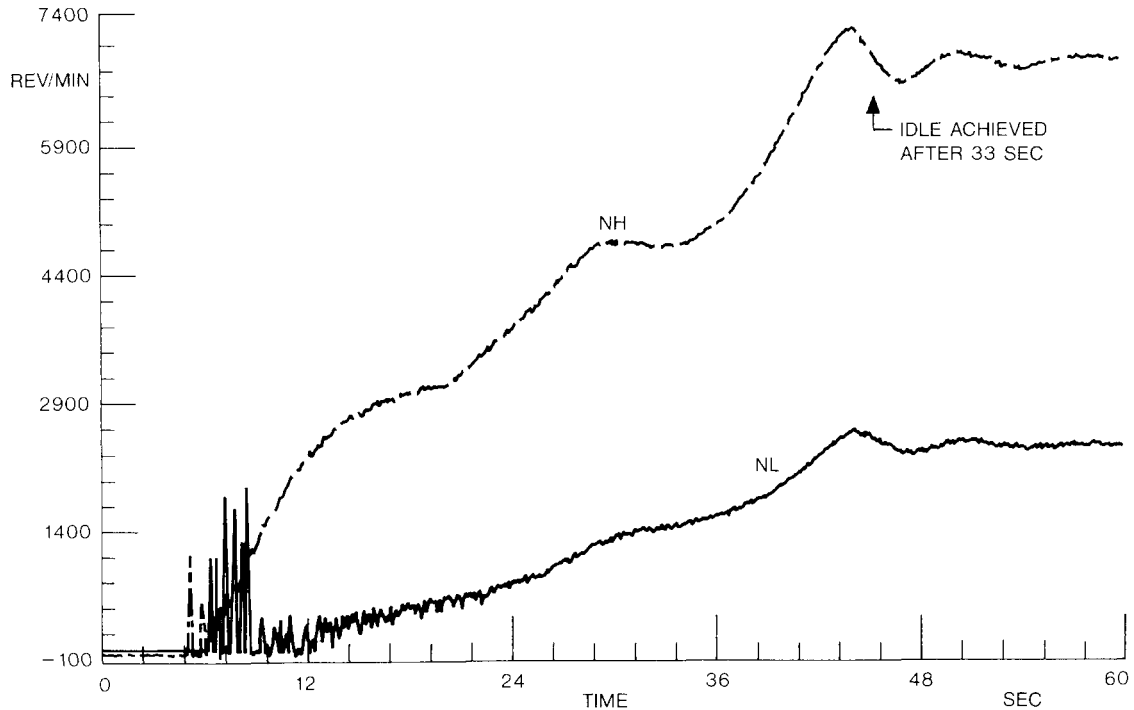
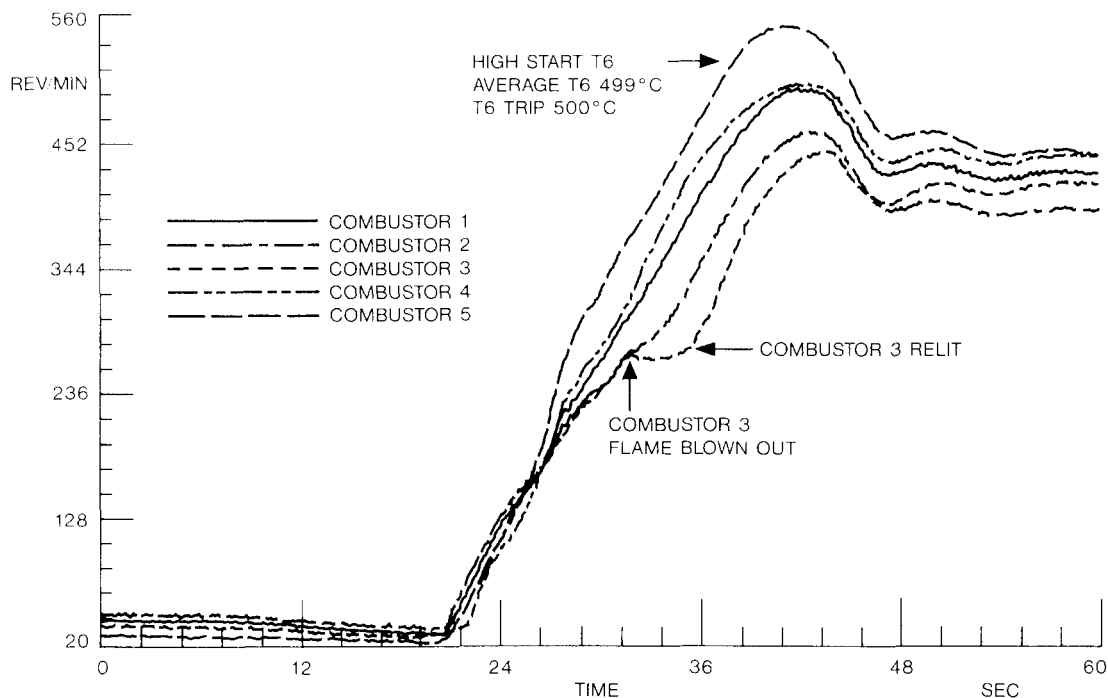
FIG. 10—HP AND LP SPOOL SPEEDS DURING START SEQUENCE AFTER 1625 COMBUSTOR HOURS—A POOR START

FIG. 11—POWER TURBINE ENTRY TEMPERATURE DURING START SEQUENCE AFTER 1625 COMBUSTOR HOURS—A POOR START

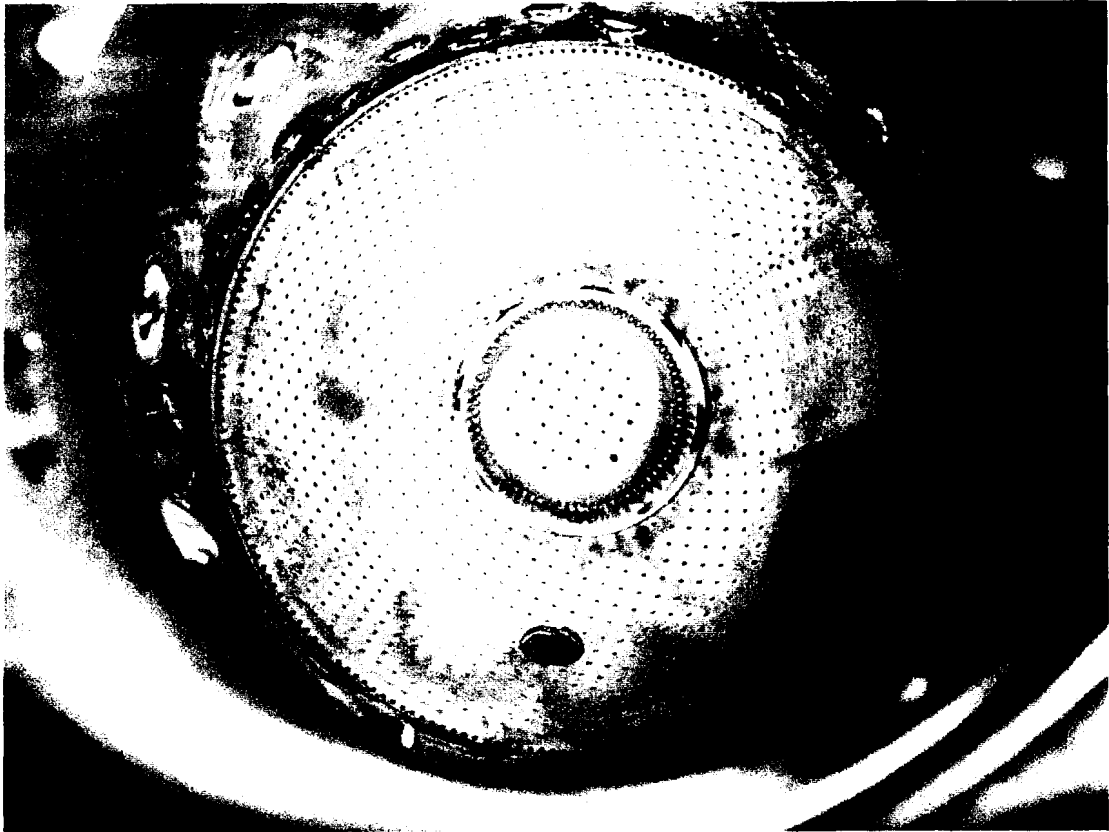
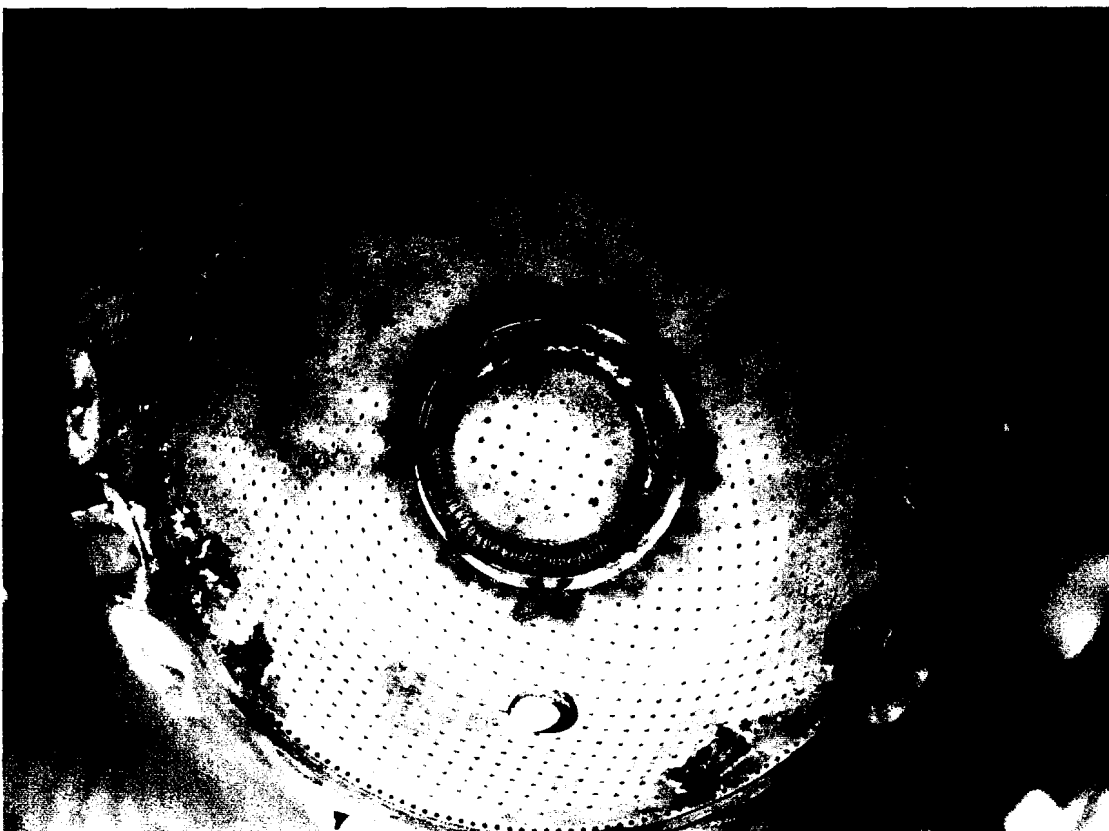
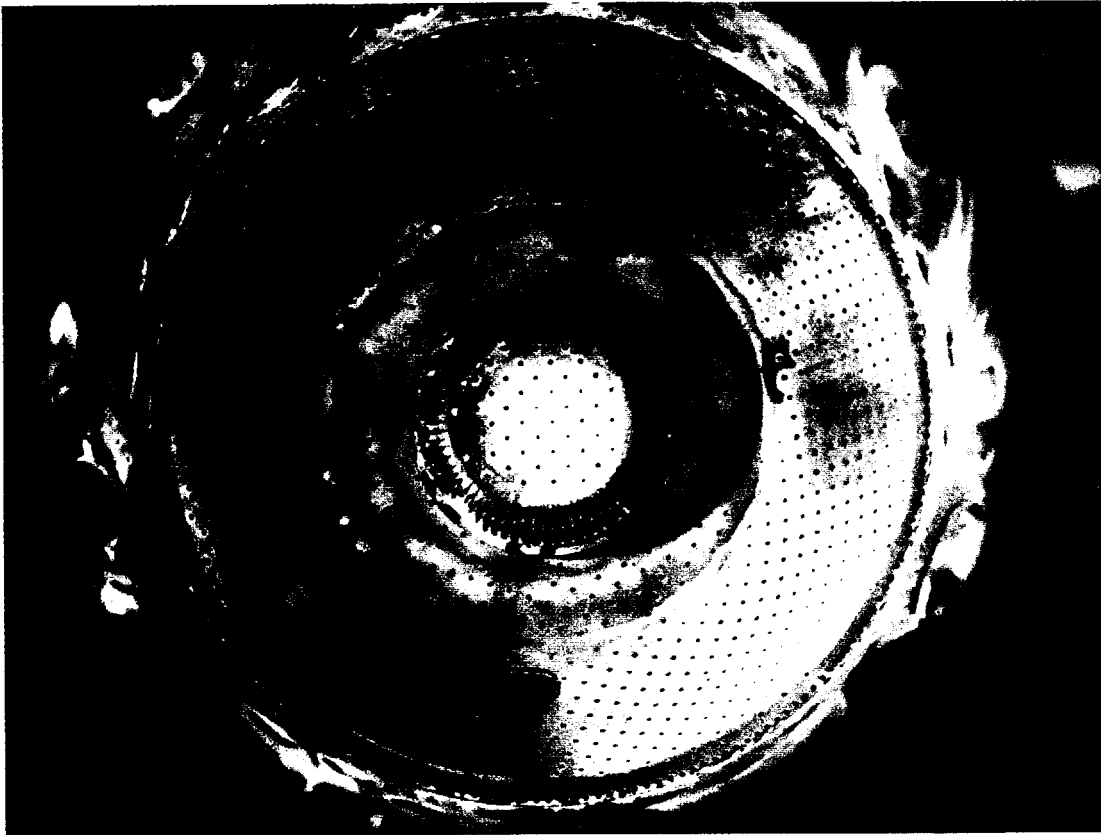
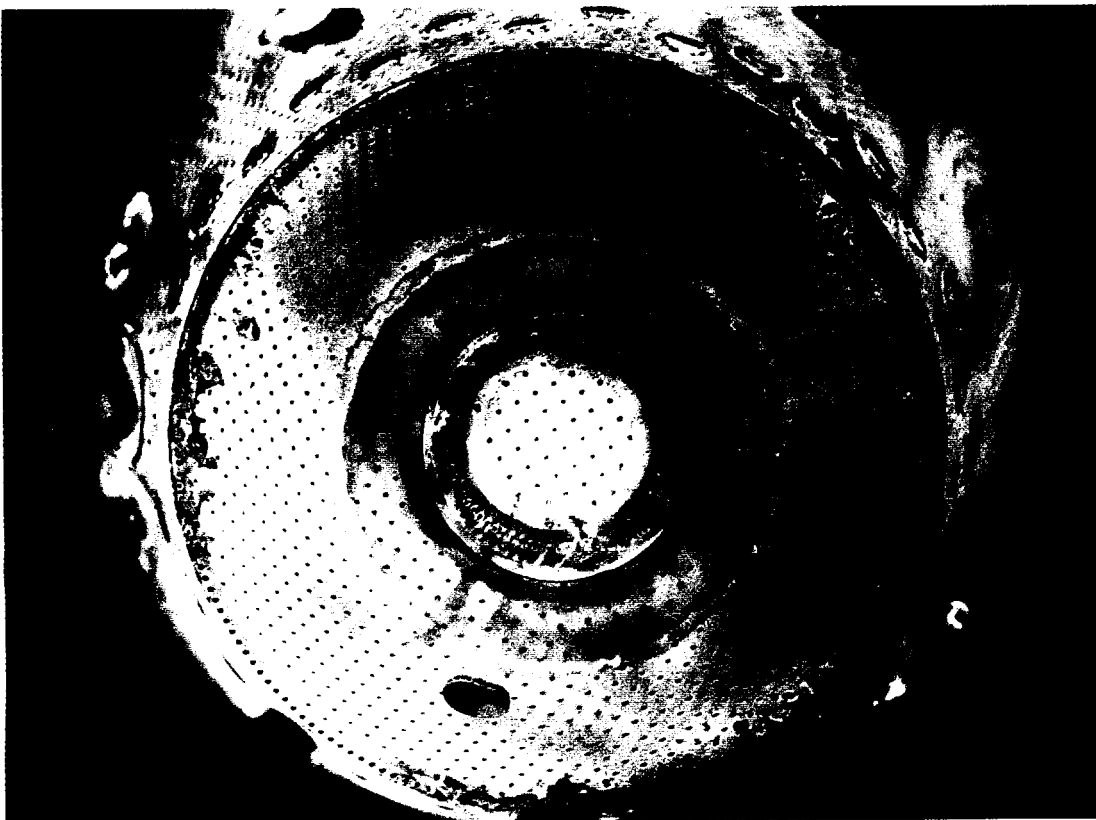
The degradation of the enhanced combustor No. 1 with engine use over 800 hours may be contrasted to that of the original IRAB version of the same combustor by comparing the conditions in Figs. 12 and 13 with those in Figs. 14 and 15. It can be seen that corrosion at the Y ring has become firmly established at the 1000 hours point in each case. The steady progress of this sulphidation corrosion to eventual penetration of both hot and cold

FIG. 12—COMBUSTOR No.1 AT 1200 HOURS (1000 HOURS AS IRAB, 200 HOURS AS ERAB)

FIG. 13—COMBUSTOR No.1 AT 2000 HOURS (1000 HOURS AS IRAB, 1000 HOURS AS ERAB)

FIG. 14—COMBUSTOR No.1 AT 200 HOURS (IRAB)

FIG. 15—COMBUSTOR No.1 AT 1000 HOURS (IRAB)

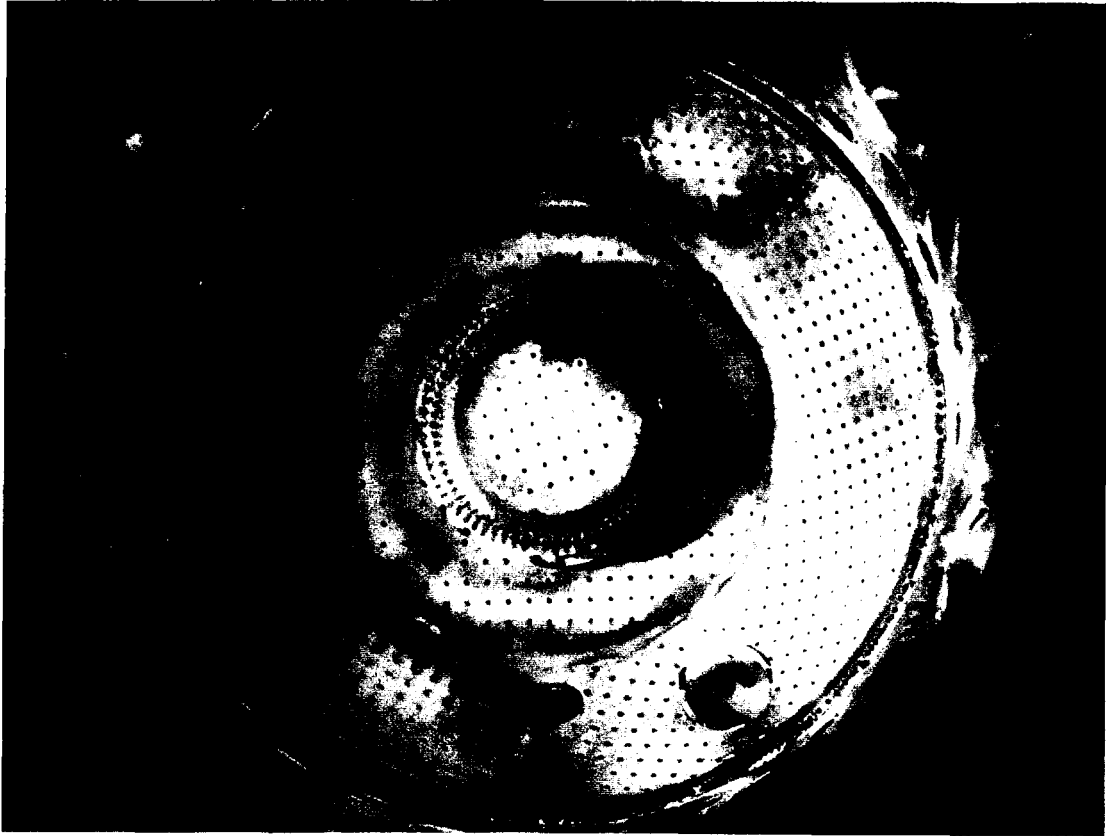
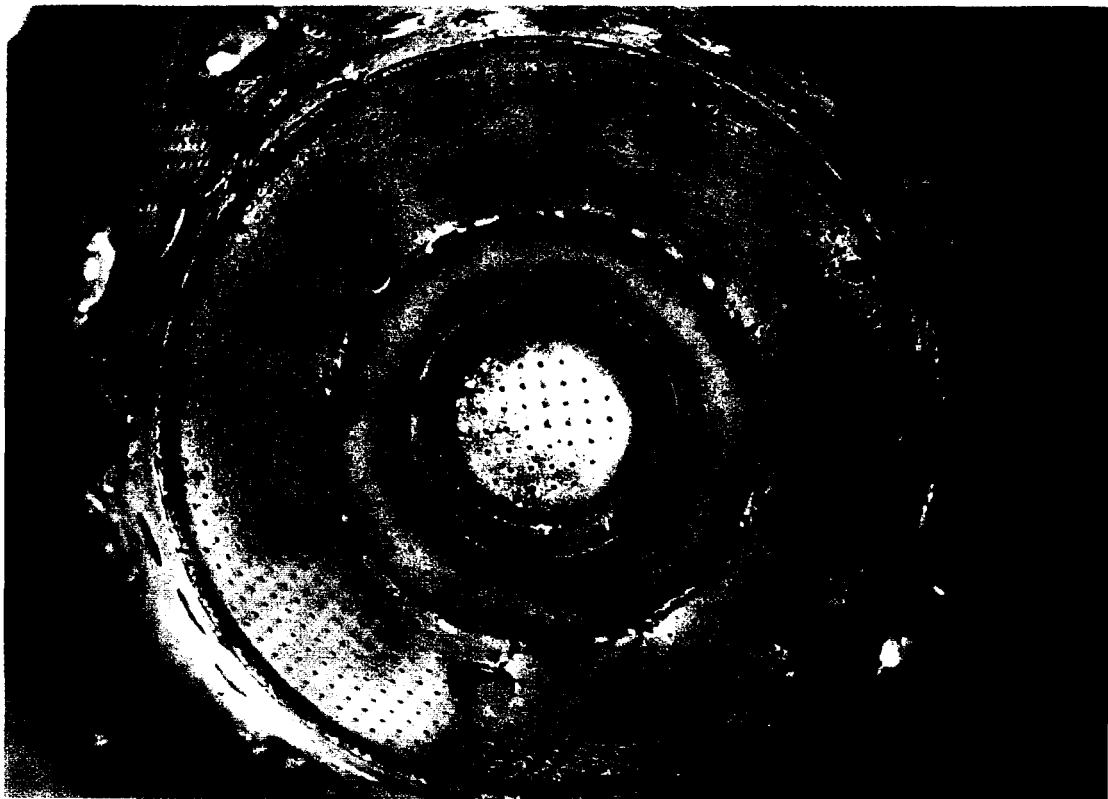
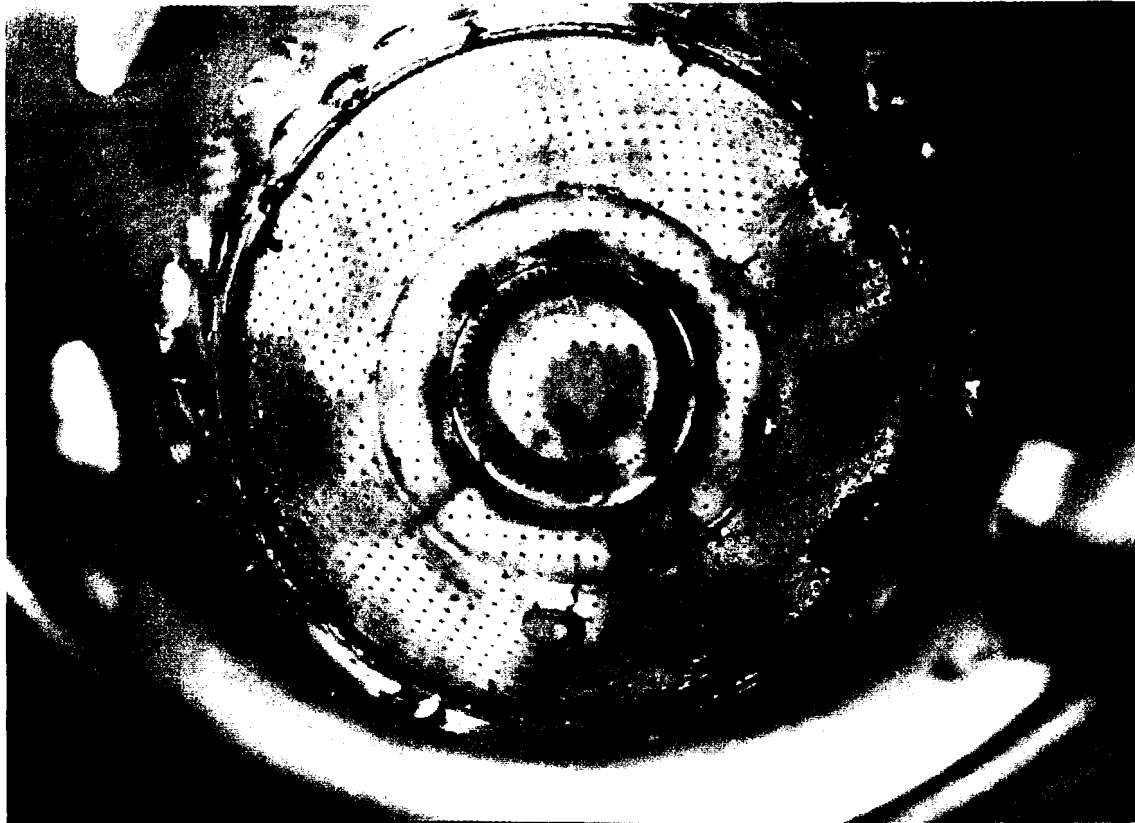
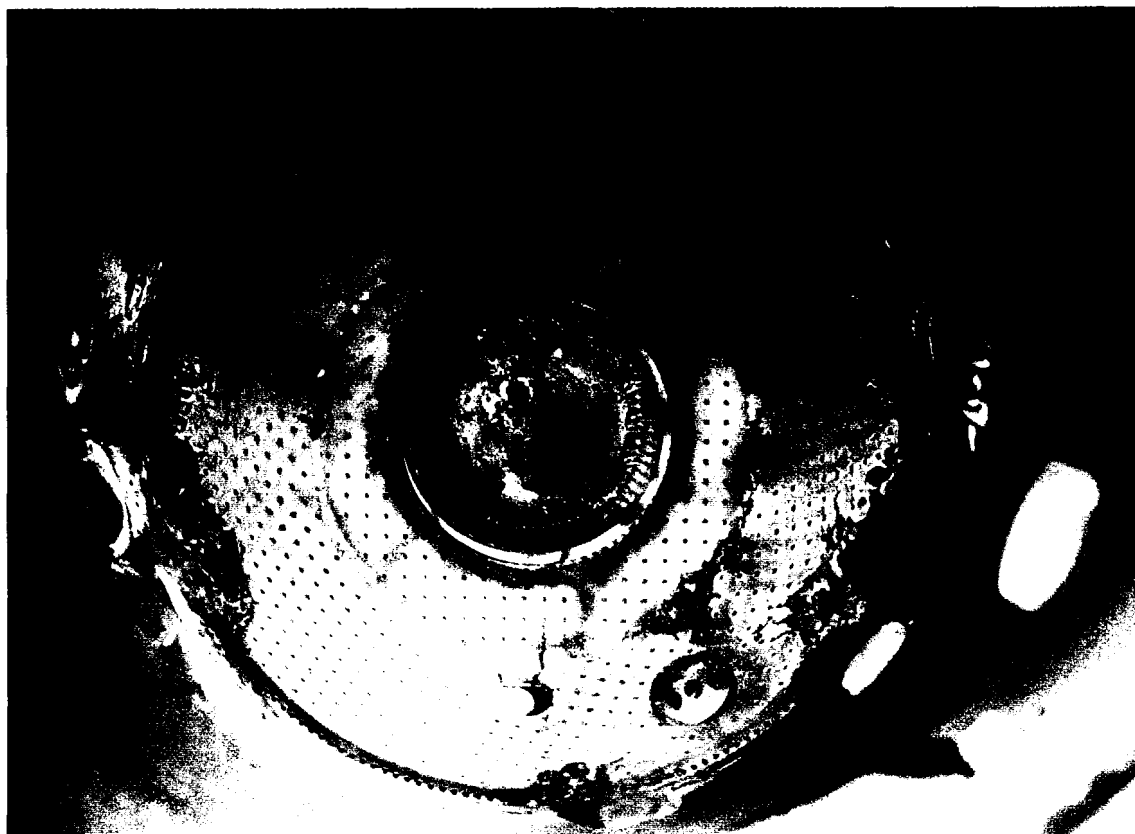
layers of the transply, may be observed in Figs. 16 to 19. This shows the IRAB head of combustor 8 (which was not enhanced to the single piece pressed head construction at 1000 hours) developing to a near critical state by 2000 hours.

FIG. 16—COMBUSTOR No.8 AT 200 HOURS (IRAB)

FIG. 17—COMBUSTOR No.8 AT 1000 HOURS (IRAB)

FIG. 18—COMBUSTOR No.8 AT 1200 HOURS (IRAB)

FIG. 19—COMBUSTOR No.8 AT 2000 HOURS (IRAB)
