# AN AFLOAT REPAIR OF BOW THRUST DOOR LIFTING GEAR

LIEUTENANT R. G. KITE, T.ENG., A.M.I.MAR.E., R.N.  
(formerly M.E.O. H.M.S. *Herald*)

The port bow thrust door of H.M.S. *Herald* jammed and was moved by hand to the open position. After trimming by the stern, divers shored the door open so that the stripped lifting nut and screw could be renewed through a hole cut in the deck above.

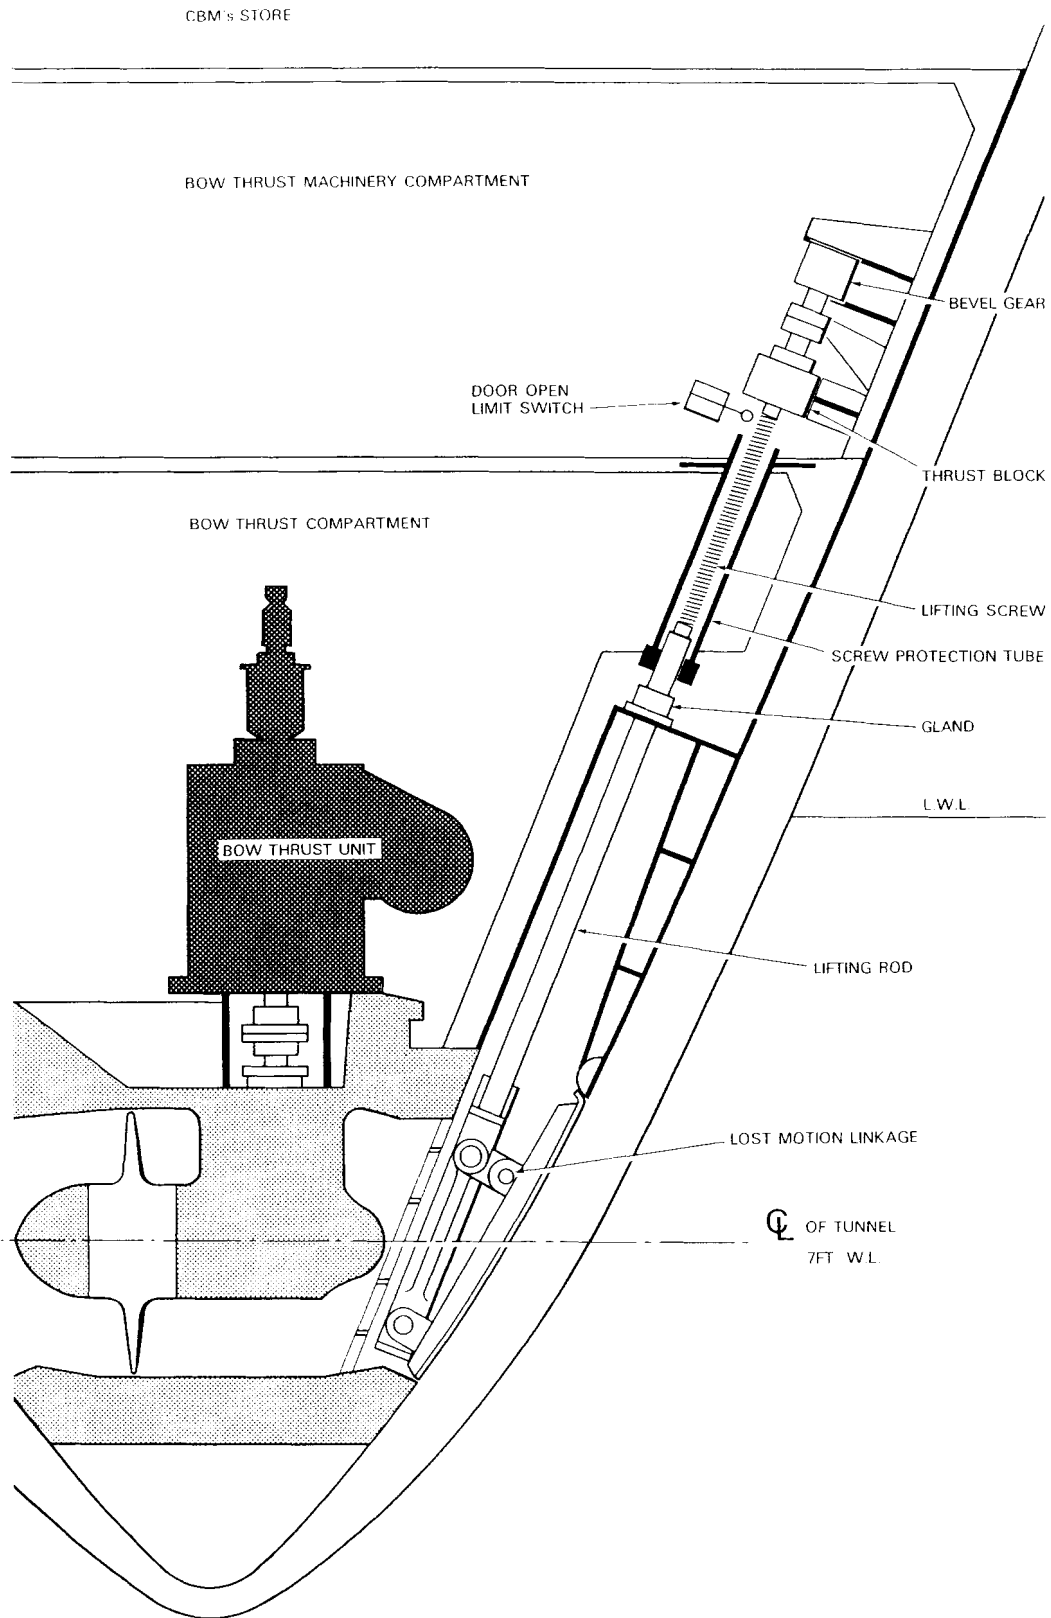
FIG. 1—Bow THRUST DOOR, CLOSED

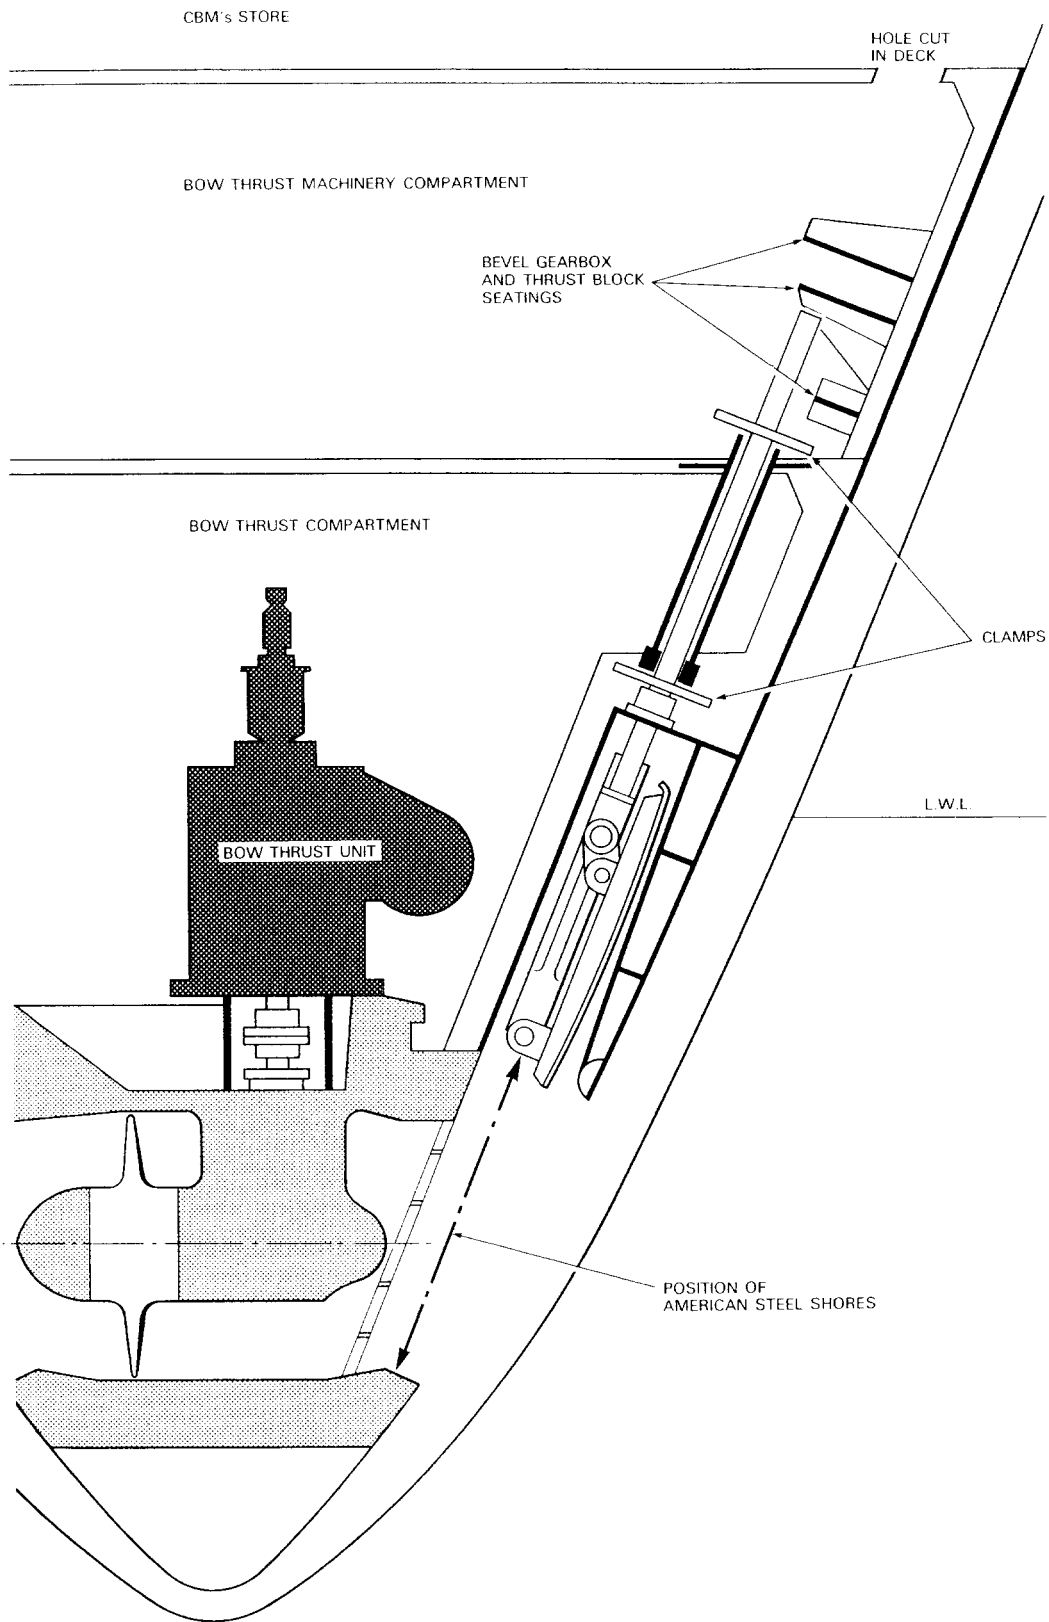
FIG. 2—BOW THRUST DOOR RAISED, SHOWING POSITIONS OF CLAMPS AND SHORES

- (a) Two American steel shores were placed by divers under the lower crossheads of the door (Figs. 5, 6 and 7). The screw adjusters of these shores were tightened until a slight upward deflection was detected by a Dial Test Indicator (DTI) fitted at the top of the lifting rod. By using a DTI, positive support of the door was ensured; also it ensured the door remained square within its guides. (Before any attempt was made to support the door divers had already checked it was square in its guides by using feeler gauges).

- (b) Two locally produced high density cork-lined clamps were fitted round the lifting rod, one just above the gland where the rod passes out of the ship into the door recess (Figs. 8 and 12), the other just above the screw protection tube in the bow thrust machinery compartment. These clamps were supported by wooden blocks and wedges and again the DTI was used to check that no movement occurred which might have caused the door to cant.

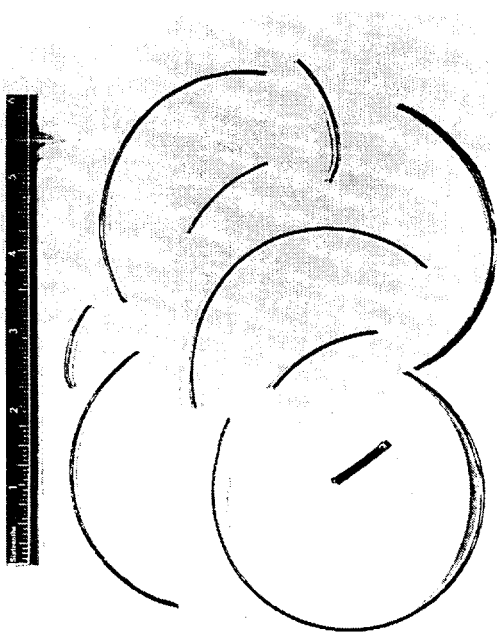
FIG. 3—STRIPPED THREADS REMOVED FROM LIFTING NUT

lifting rods were visible where they emerge into the bow thrust machinery compartment from the tops of their protective tubes and it was obvious that the cause of the failure was stripping of the threads of the lifting nut (Figs. 3 and 4). Portions of the failed thread were protruding from the nut and several sections of stripped thread were resting on the top of the nut and lifting rod.

Using a locally manufactured lugged 'C' spanner, the failed lifting nut was screwed out of the top of the lifting rod. It was clearly evident that the internal 4 (t.p.i. acme) thread had failed as, not only was there very little of the thread remaining, but up to 0.25 inch lateral movement was possible when the nut was replaced on the failed shaft. Also several more sections of failed thread were recovered.

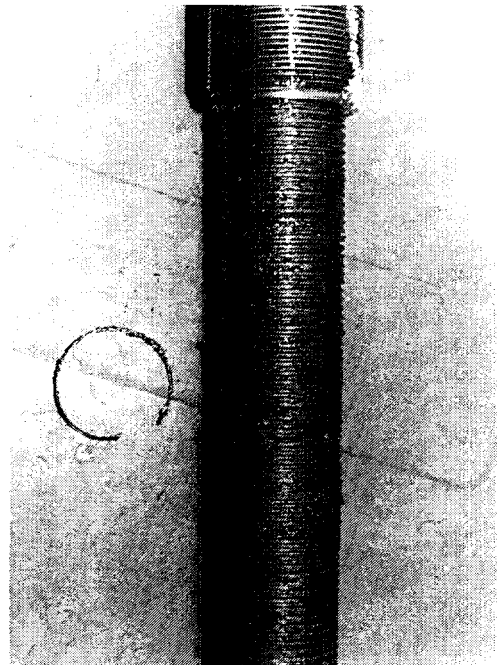
The cause of the failures in 1977 and 1979 was stripping of the nut threads and stretching of the lifting screw threads. The term 'stretching of the lifting screw' is used to indicate that the thread form was tending to change from acme to buttress. The shaft length remained unchanged.

FIG. 4—FAILED LIFTING SCREW SHOWING STRETCHING OF THREAD FORM AND MORE STRIPPED THREADS FROM LIFTING NUT

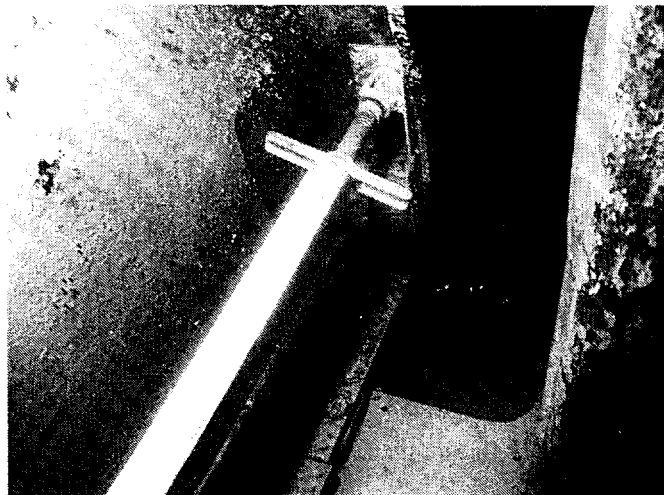
FIG. 5—TOP OF AFTER SHORE BEARING ON LOWER CROSSHEAD

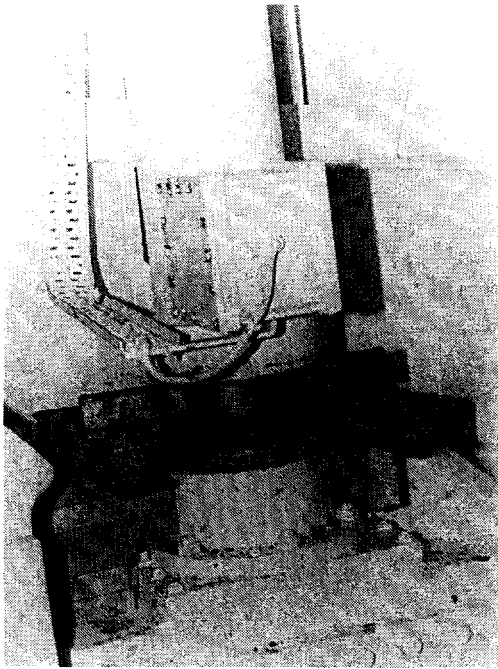
FIG. 8—LOWER CLAMP, FITTED TO LIFTING ROD ABOVE GLAND

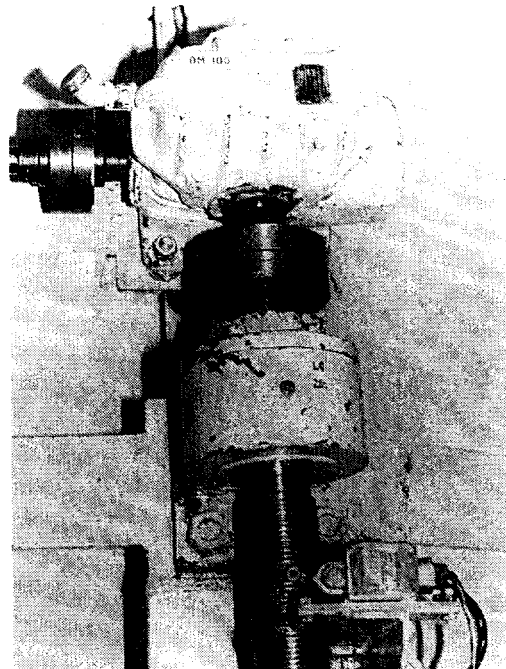
FIG. 9—BEVEL GEARBOX, THRUST BLOCK AND TOP LIMIT SWITCH

To ensure the door was fully supported, the DTI was left in position whilst the thrust block and bevel gearbox (FIG. 9) at the top of the screw shaft was loosened. No downward movement was detected, proving that the clamps and shores had taken the weight of the door.

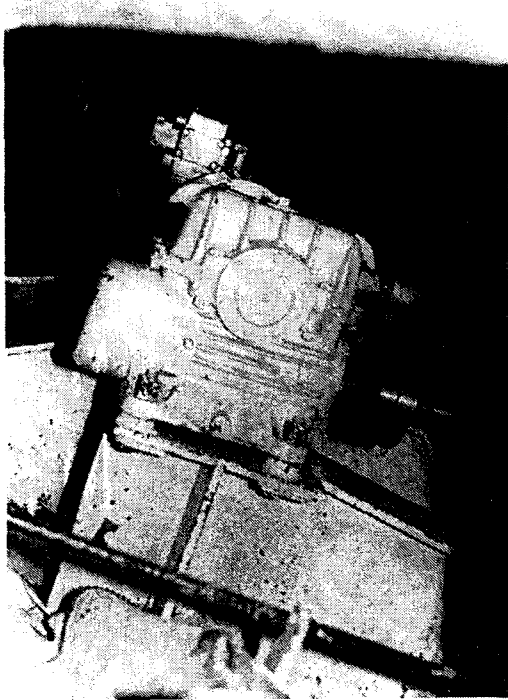
FIG. 10—VIEW THROUGH HOLE IN DECK OF CBM'S STORE, SHOWING BEVEL GEARBOX BEFORE REMOVAL

The compartment above the port forward lifting screw is the Chief Bosun's Mate's Store (CBM's Store). The deck is non-watertight and it was fortunate that no ventilation trunking or cable runs fouled the proposed route. A 350mm by 450mm hole was burnt in the deck above the failed screw (FIG. 10) in line with the direction in which the screw would be withdrawn. A section of workbench and shelving in the CBM's store was also removed to ensure adequate clearance when the screw shaft was raised. Usual safety precautions were observed during the burning operations.

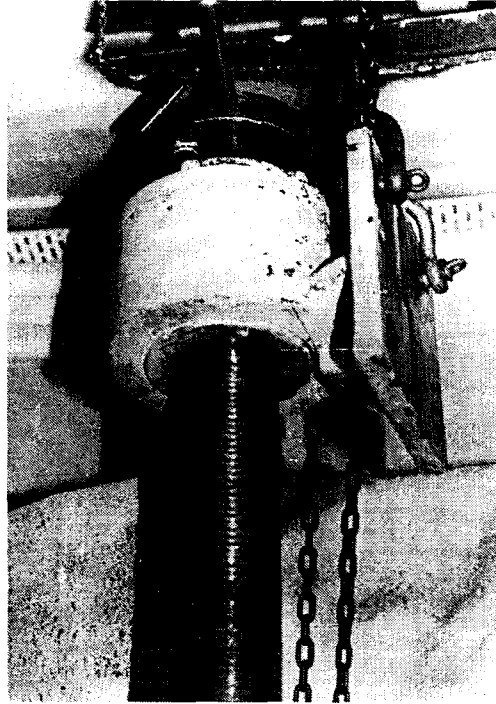
FIG. 11—FAILED SHAFT SUSPENDED BY CHAIN BLOCK

The thrust block mounting bolts were removed and, by using the ratchet handle, the screw shaft and thrust block were raised sufficiently for a chain block to be shackled to the thrust block mounting bolt holes. The chain block was suspended from an eyebolt in the deckhead of the CBM's Store. By using the ratchet handle together with the chain block the shaft was screwed completely out of the lifting nut and pulled clear (FIG.11).

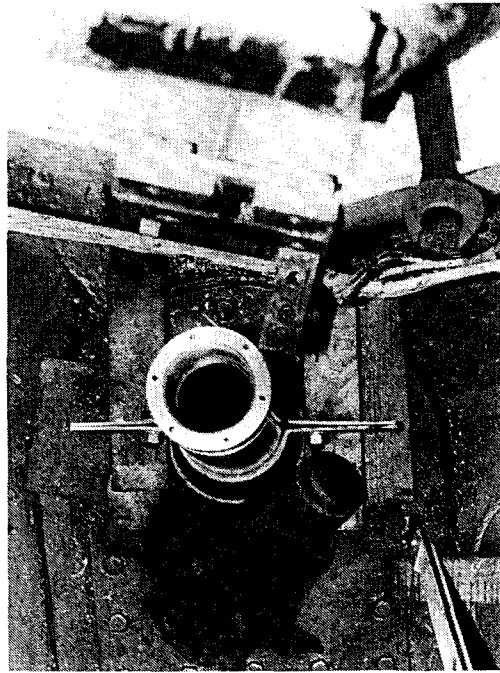
FIG. 12—VIEW THROUGH HOLE IN DECK OF CBM'S STORE WITH FAILED LIFTING SCREW REMOVED

The thrust bearing housing was opened, the nut locking split pin was withdrawn and the nut removed (FIG. 12). The failed lifting screw was removed and both thrust roller bearings were then driven out of the housing. Although there were no signs of excessive wear in the bearings they were renewed.
