SYNTHETIC LUBRICATING OIL IN PROPULSION DIESELS

C. TRUMAN
(*Sea Systems Controllerate*)

ABSTRACT

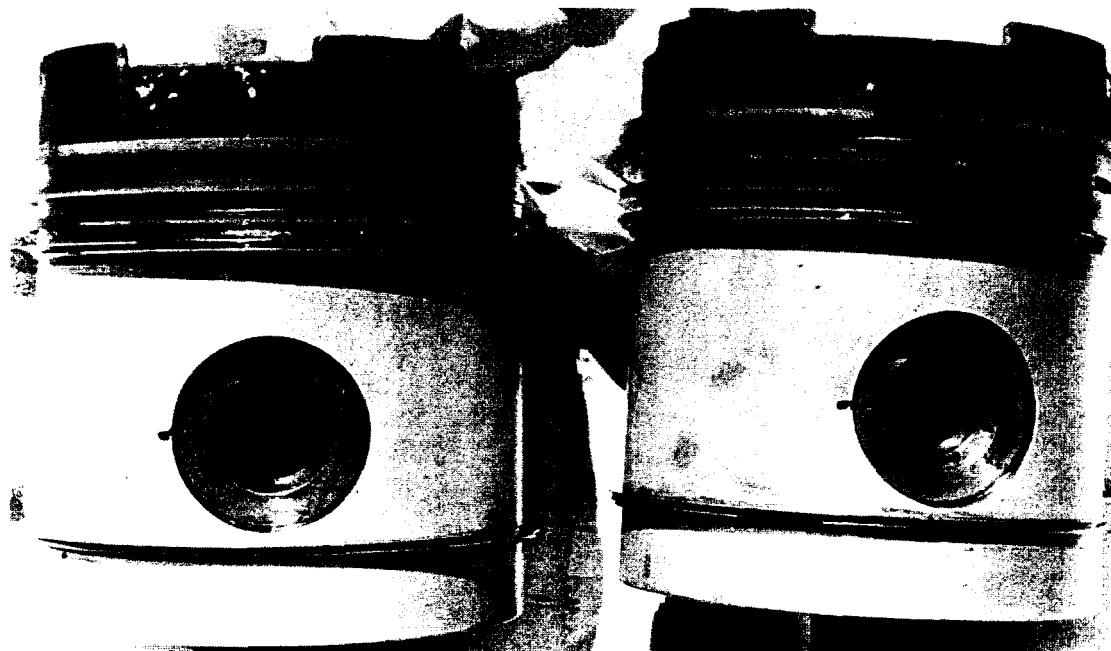
Examination internally revealed the engine to be very clean and with no sign of sludge or condensation build-up in the rocker covers. The piston condition was excellent with no evidence of lacquer on the crown or skirt. Carbon deposit was minimal on the crown and none on the ring belt or skirt. From FIG. 3 it can be seen that the original marks where the lacquer was removed before the trial are still clearly visible, confirming that no build-up of lacquer had occurred since changing to Mobilguard.

FIG. 3—PISTONS REMOVED FROM H.M.A.F.V. 'SPITFIRE' PORT ENGINE AFTER 575 HOURS RUNNING ON MOBILGUARD SHC 120 OIL, SHOWING ABSENCE OF LACQUERING

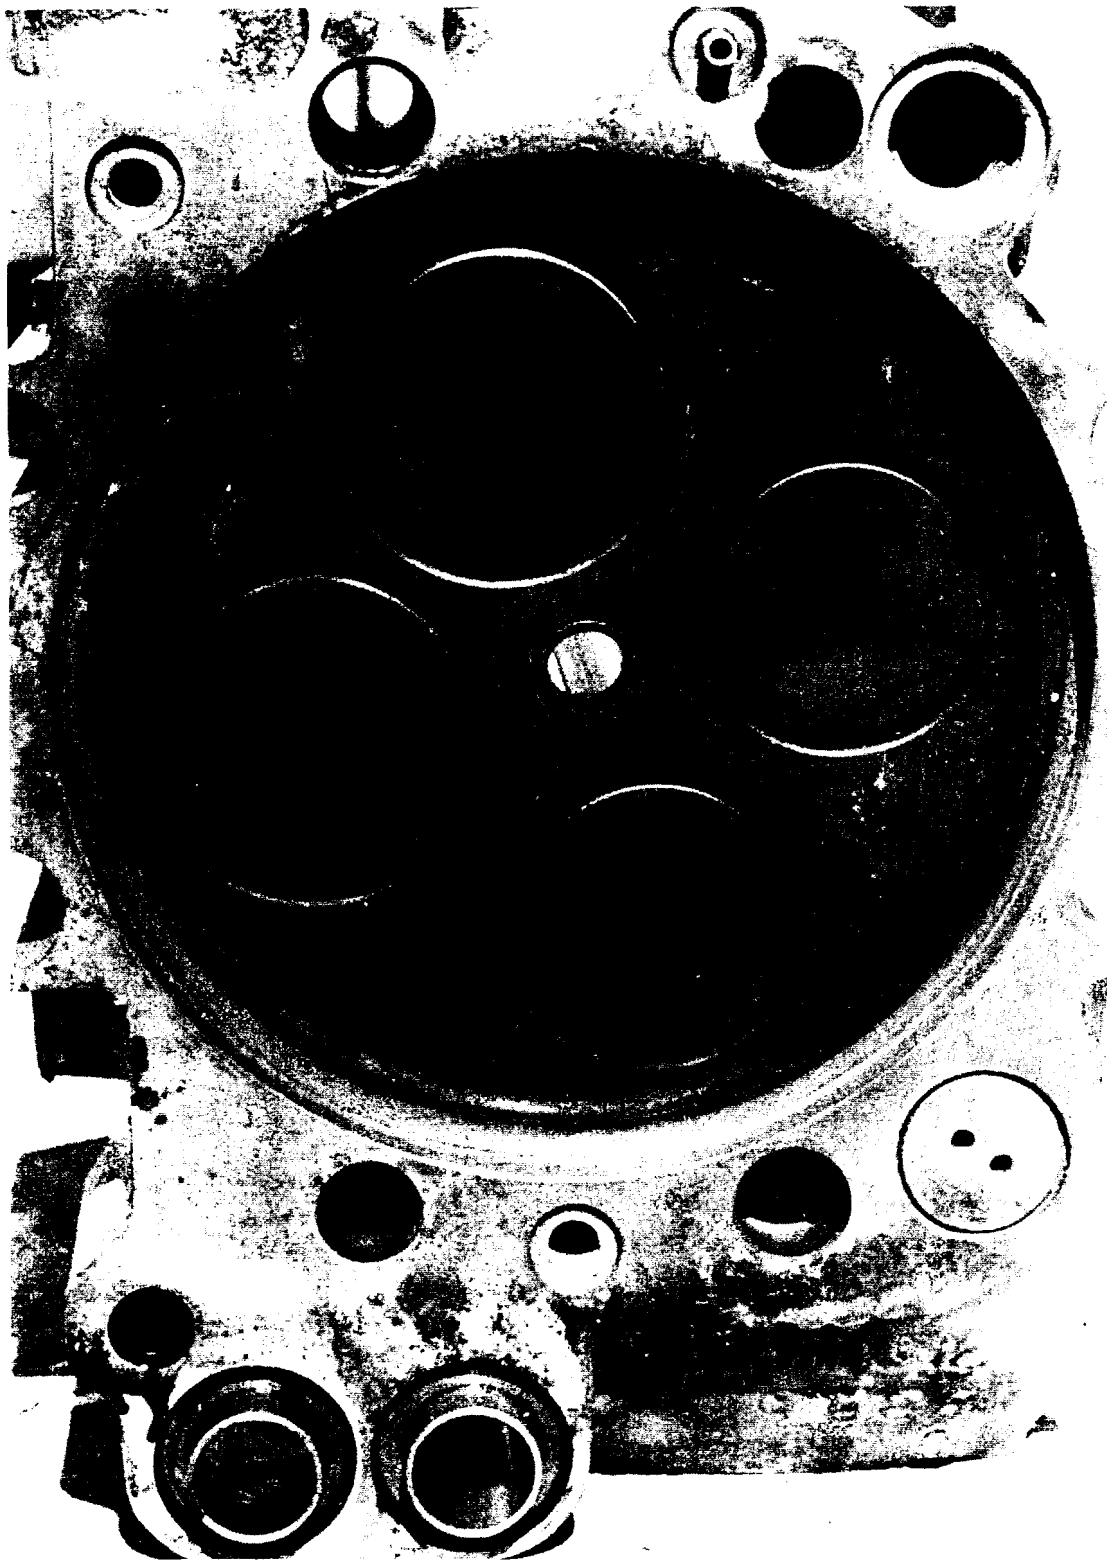
Cylinder head condition was good with only a light carbon deposit on the combustion face (FIG. 4) Valve seats and valves were in excellent condition with no signs of lacquer and only slight carbon deposition on the lower stem of the exhaust valves—rather less than that seen on engines running on OMD-113.

FIG. 4—CYLINDER HEAD REMOVED FROM H.M.A.F.V. 'SPITFIRE' AFTER 575 HOURS RUNNING ON MOBILGUARD SHC 120 OIL

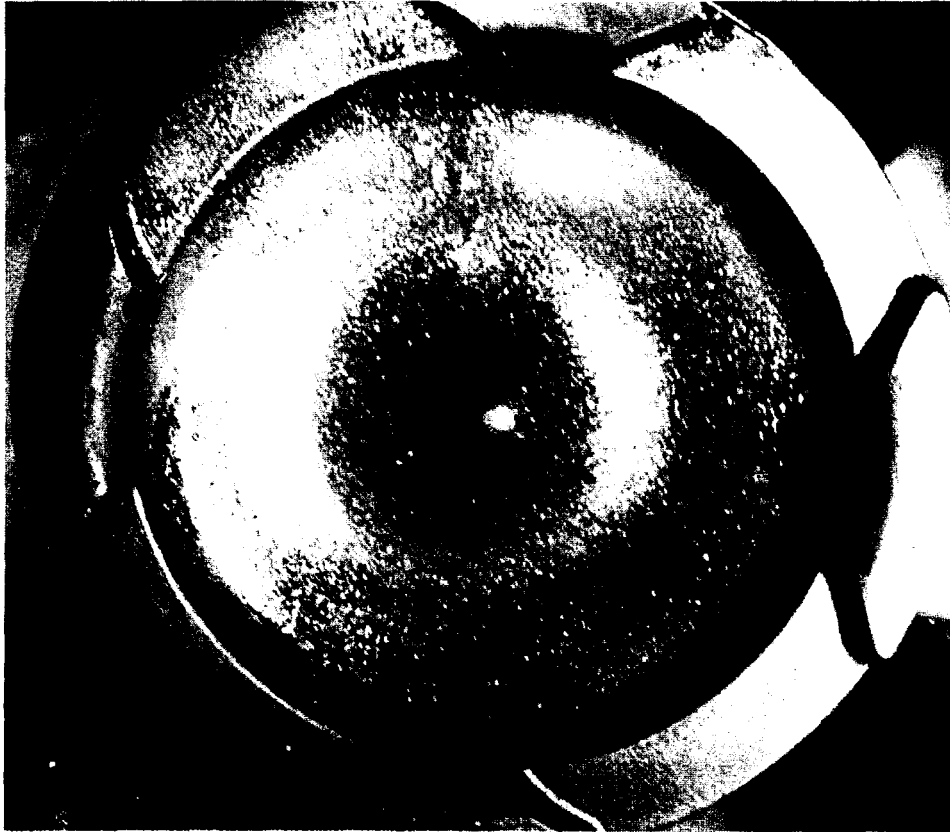
Due to the evidence of lacquering in the turbocharger it was decided to carry out further investigations on *Spitfire's* port main engine. Endoscope examination of cylinders revealed a clean combustion face after a period of sustained running whilst on exercise. The following day when the engine was completely cold it was started and run for a period of three minutes then stopped. Further examination by endoscope showed a small pool of oil and fuel on top of each piston crown, together with a wet surface finish across the whole surface area (FIG. 5).

FIG. 5—PISTON REMOVED FROM H.M.A.F.V. 'SPITFIRE' AFTER 800 HOURS RUNNING ON MOBILGUARD SHC 120 OIL. THE SURFACE IS WET

The engine was then run for a further 35 minutes at 600 r.p.m. and stopped; one cylinder head was then removed. Both the combustion face of the cylinder head and the piston crown were coated in a satin black lacquer. This lacquer also extended into the exhaust manifolds and explains the presence of lacquer in the turbo-chargers examined at Napiers. The piston was removed and it was seen that the lacquer had not reached the ring pack, ring grooves or the skirt of the piston.

It would appear that synthetic lubricating oil is still passing the piston ring pack to mix with unburnt fuel to form a lacquer although not to the extent of OMD-113 in cold low-load running conditions. However the synthetic oil does not encroach into the piston ring grooves, but follows the gas path, i.e. it forms deposits on the exhaust ports and exhaust turbine in the turbocharger.

- (a) The cooling water supply to the intercooler is to be shut off until the manifold temperature reaches 60°C and then be maintained at or near this temperature by minimal opening of this valve. (It was found during one visit that these valves were left open all the time.) This will enable the engine to be brought up to operating temperature more quickly.

- (b) Operating the vessel from port to station and return on one engine. This has the advantage of operating the engine at a higher temperature/load.
- (c) Introducing a larger lubricating oil drain from the turbochargers to enable the oil to flow away from the turbocharger sumps more quickly.

- (d) The pre-heating of the lub oil and water overnight before the craft are used and the use of ambient air heating. At present all these craft have lubricating oil and water heaters fitted and they are used on all the vessels except those at R.A.F., Mount Batten. This is because the craft there have to be moored at a buoy with no electrical power available.
