COMMERCIAL DOCKING

THE SINGAPORE STORY

COMMANDER B. P. TOFT, B.SC.(ENG.), C.ENG., M.I.MECH.E., R.N.
(*Marine Engineer Officer, H.M.S. Invincible*)

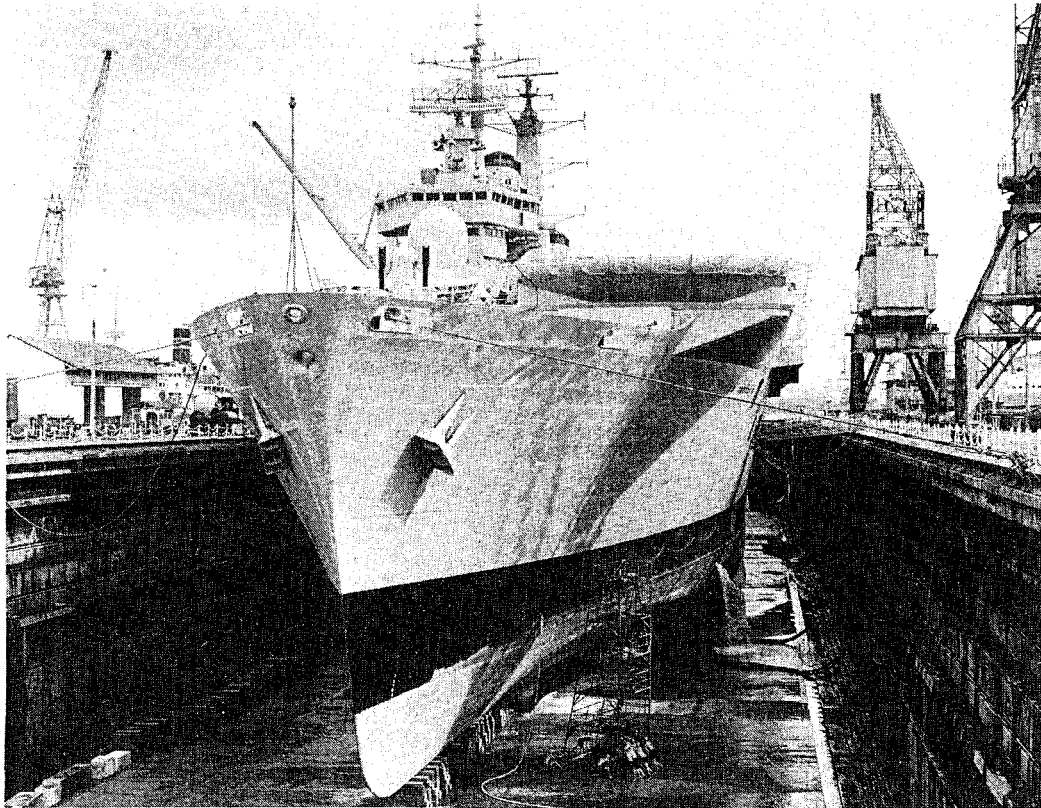
H.M.S. 'INVINCIBLE' IN KING GEORGE VI DOCK, SEMBAWANG SHIPYARD
