H.M.S. 'INVINCIBLE'

THE CASE OF THE KNOCKING SHAFT

LIEUTENANT-COMMANDER D.N. BRITTEN, B.SC.(ENG.), C.ENG.,
M.I. MECH. E., R.N.
(Sea Systems Controllerate)

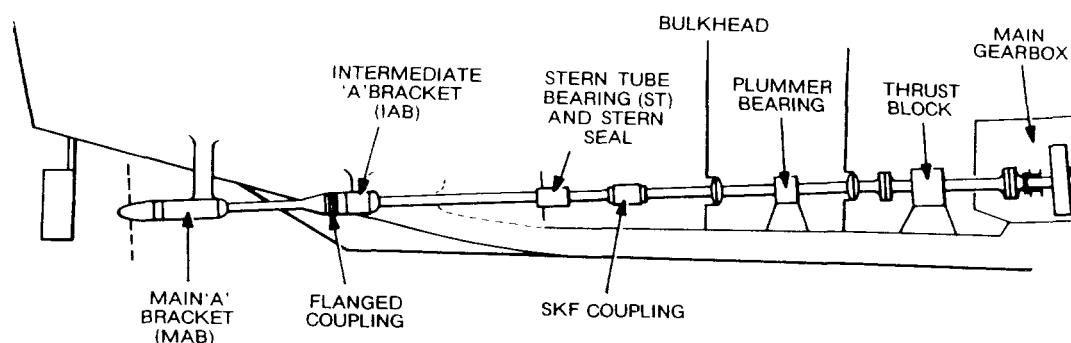
FIG. 1—H.M.S. 'INVINCIBLE' PORT SHAFT

Problems with the port shaft were first reported in October 1983 as a combination of excessive shaft TIR (Total Indicated Reading, i.e. twice the shaft eccentricity) at the first bulkhead inboard (see FIG. 1) and a high rate of wear down at the port intermediate 'A' bracket bearing (IAB). Neither of

FIG. 1 shows the configuration of the port shaft of the INVINCIBLE Class. Conventional wisdom says that 0.001 inches per foot shaft distance from the nearest bearing is the maximum tolerable TIR. *Invincible* rapidly achieved over 0.1 inches at the first bulkhead inboard at 160 r.p.m. Deflections of this magnitude must be accompanied by a similar amplitude somewhere in the outboard (i.e. UW) shafting, the IAB being the most likely position from simple geometrical considerations. This could only be harmful and at this stage it was uncertain whether the observations were the cause or effect of the rapid wear down measured at the IAB.

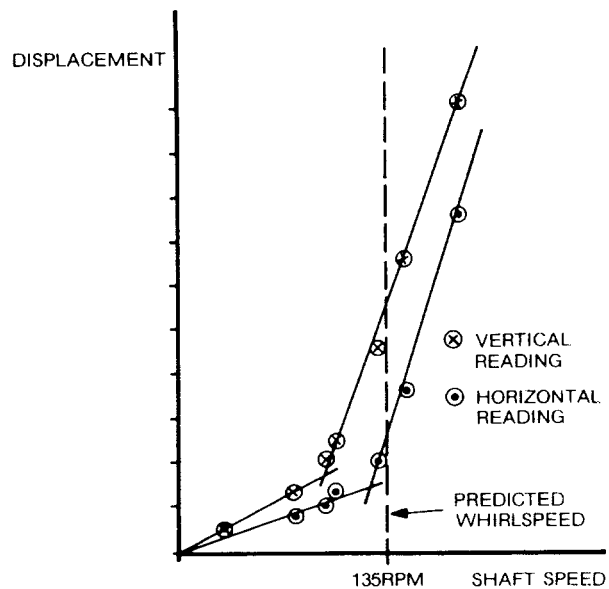
FIG. 2—SHAFT DISPLACEMENT READINGS AT FIRST BULKHEAD INBOARD

The calculations on whirling speeds were confirmed by further readings from the ship (FIG.2). The main concerns at this time were:

- (a) Damage to gearbox main wheel bearings. The measured deflections reflected along the shaft were of the same order as the oil film thicknesses.
- (b) Damage to plummer bearings.
- (c) Accelerated wear in the UW bearings adjacent to the IAB.
- (d) Absorption of clearances and damage to the stern seal. (The stern seal was of a type which would suffer damage from shaft contact with the housing if the ST wore to 60% of its maximum allowance).

- (a) The port shaft speed should be restricted to 100 r.p.m. in order to keep well clear of the whirling frequency.
- (b) The port IAB pads should be renewed as soon as possible.

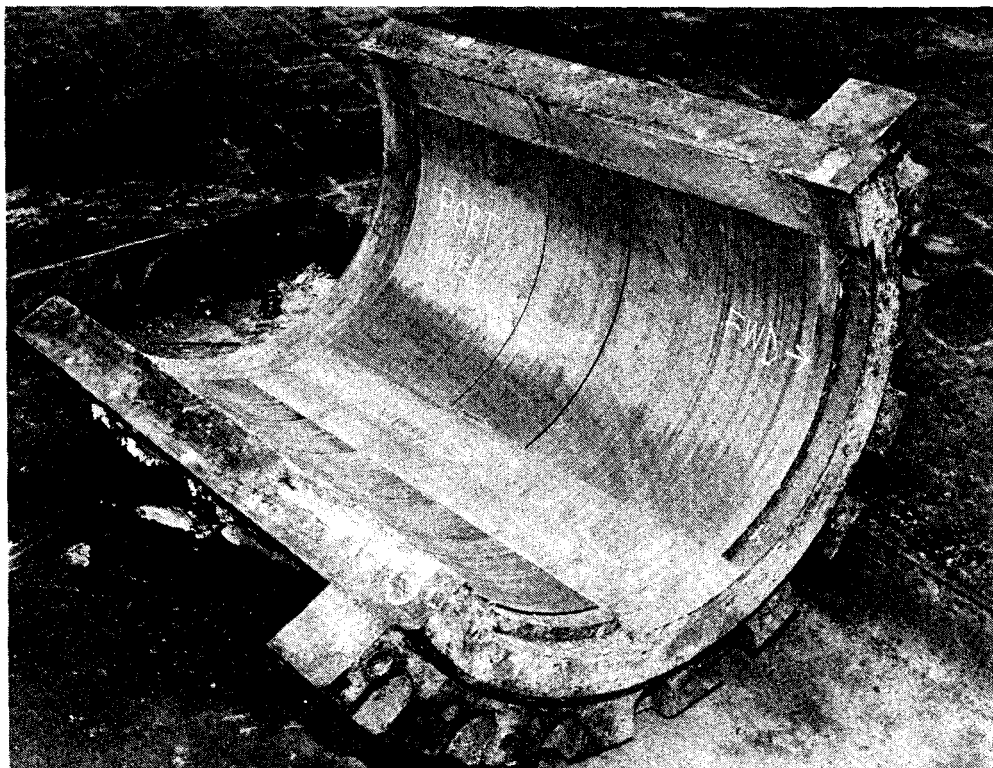
FIG. 3—WORN PORT INTERMEDIATE 'A' BRACKET BEARING (IAB)

- (a) Port IAB bottom pads worn down to the bearing housing (see FIG. 3).
- (b) Port IAB shaft liner scored circumferentially at each end, outside the bearing surface, but in line with the bearing pad keep rings.

- (a) Replace both IAB and ST bearings.
- (b) Replace both stern seals with a modified type which could accommodate the full wear-down allowance of the ST bearings.

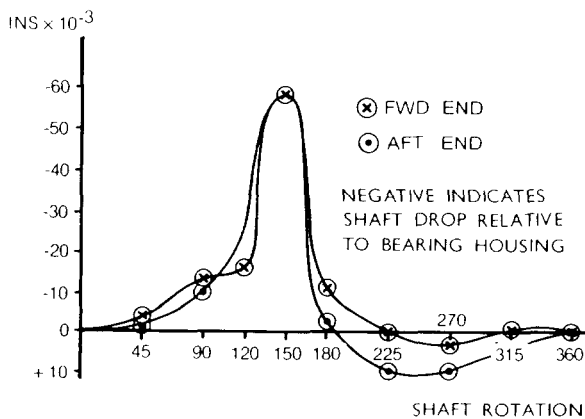
FIG. 4—TIR AT PORT IAB: SHAFT ROTATED WITH NEW BEARING IN PLACE

Of the above the TIR readings were the most significant pieces of evidence and are plotted in full in FIG. 4. They showed quite clearly that the shaft locus at the IAB, faithfully mirrored at the bulkhead, had a distinct discontinuity, best described as a 'step' over which the shaft appeared to 'fall' once per revolution. This was a positive indication that one of the causes/effects had not been eradicated, and, more importantly, one which could not be explained by any of the visual evidence.

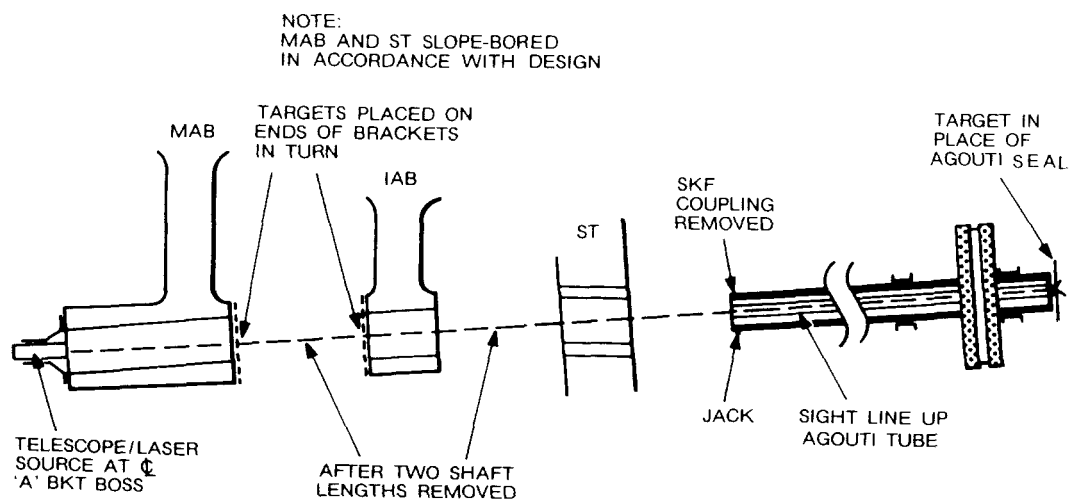
FIG. 5—METHOD USED FOR SHAFT ALIGNMENT CHECKING

Invincible's original shaft alignment had been performed by VSEL on the building slip. It is a straightforward line of sight alignment between the MAB and a datum mark on the engine room forward bulkhead. Gearboxes are set in relation to this line to achieve a specified gap and offset between the two halves of the gearbox output coupling, and MAB and ST are slope bored to the shaft elastic line (FIG. 5). It is assumed that the bearing reactions

- (i) The MAB and ST were slope bored in the correct sense. (The design calls for the MAB to be bored at an angle of 0.5 milliradians to the line of sight, aft end low; and the ST at an angle of 0.3 milliradians, aft end high (see FIG. 5).)

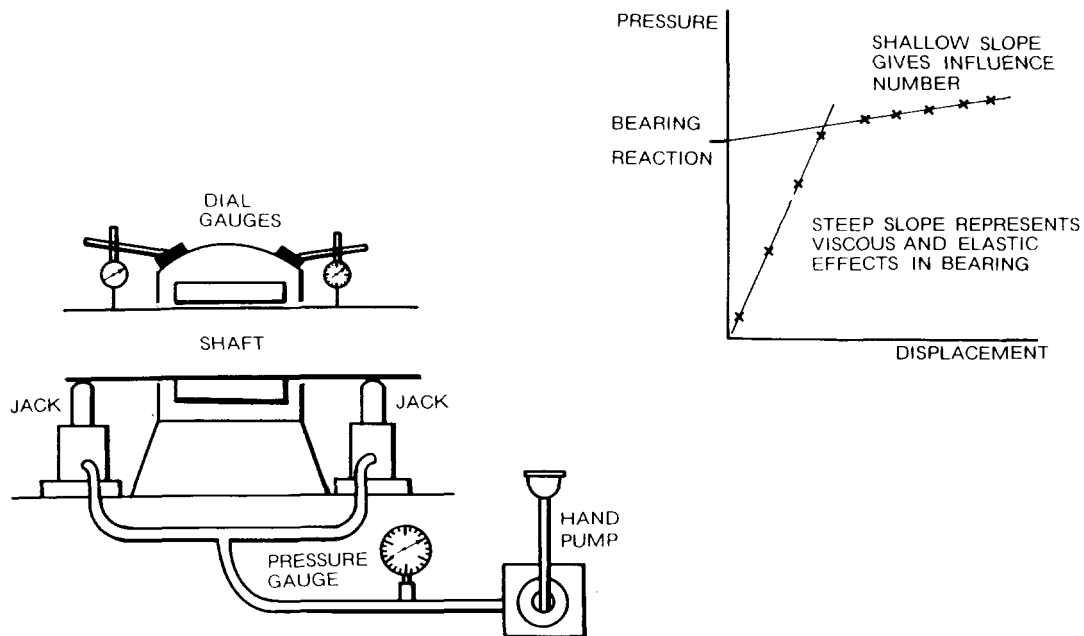
FIG. 6—MEASUREMENT OF BEARING REACTION

Values of bearing reactions were probably the most crucial clues to any significant changes to shaft alignment since build. Obviously the UW bearing reactions could not be measured afloat but any gross changes in the UW alignment would show up in the plummer bearing reactions. Comparison could then be made with the complete set of reaction measurements to be taken in dry dock to attempt to predict the real loads on the MAB and IAB afloat. Afloat measurements of the plummer bearings were taken in Portsmouth by the Dockyard with VSEL supplying the method, the gear, and on-site advice. The method used is shown in FIG. 6 and the readings

taken in TABLE II. They showed no significant departures from the design. The fitting of strain gauges, as in (b) above, was an alternative method of achieving a similar result.

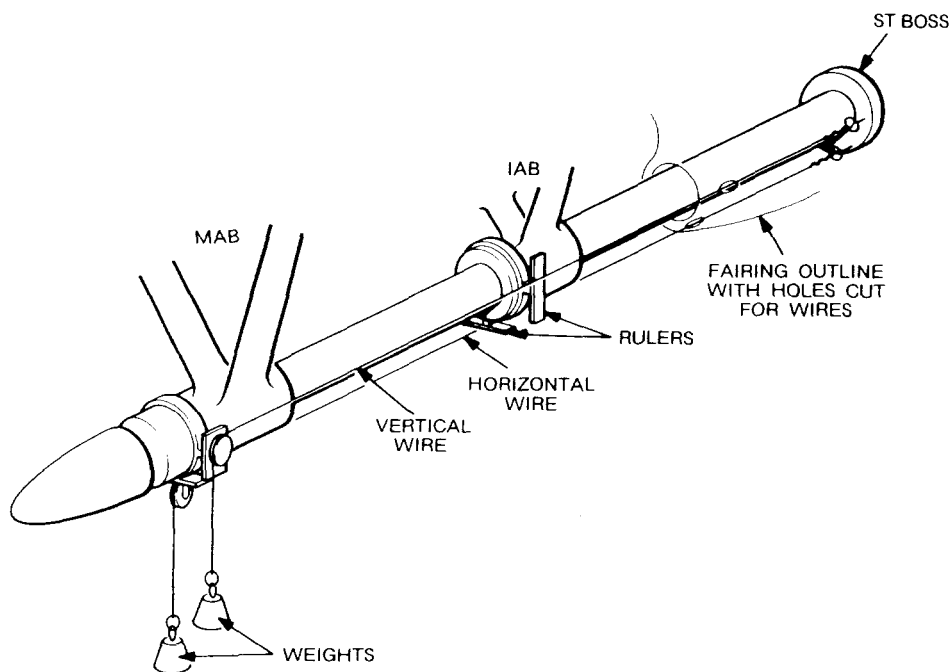
FIG. 7—UNDERWATER ALIGNMENT WIRE

up therefore on the flight deck on three lines, centreline, port, and starboard, for telescope alignments to be taken, together with a subsidiary line in the hangar. By this means it was hoped to be able to relate the hull movement on docking to the shaft line movement. It was recognized that this would be difficult and at best very empirical and so the 'engineer's' solution was added to the package. This comprised simply of a wire stretched between the ST after boss and the MAB, tensioned with weights hanging on the end. A suitable rule was fixed to the IAB, across which the wire ran, thus enabling the change in position of the IAB relative to the ST and MAB to be determined. In the event two wires were fixed to each underwater shaft line, one to measure the horizontal displacement, the other the vertical. This gear was designed at Bath, turned into a practical proposition by Devonport FMG, and fitted by Plymouth CD Team in a mammoth feat of diving lasting almost 36 hours immediately prior to the ship docking down. FIG. 7 illustrates the apparatus.

- (d) *UW Wire*. Remarkable consistency was achieved in the use of this apparatus by at least four different divers. It showed a maximum possible interpretation of a 1 mm rise at the port IAB, and 0.75 mm on the starboard.

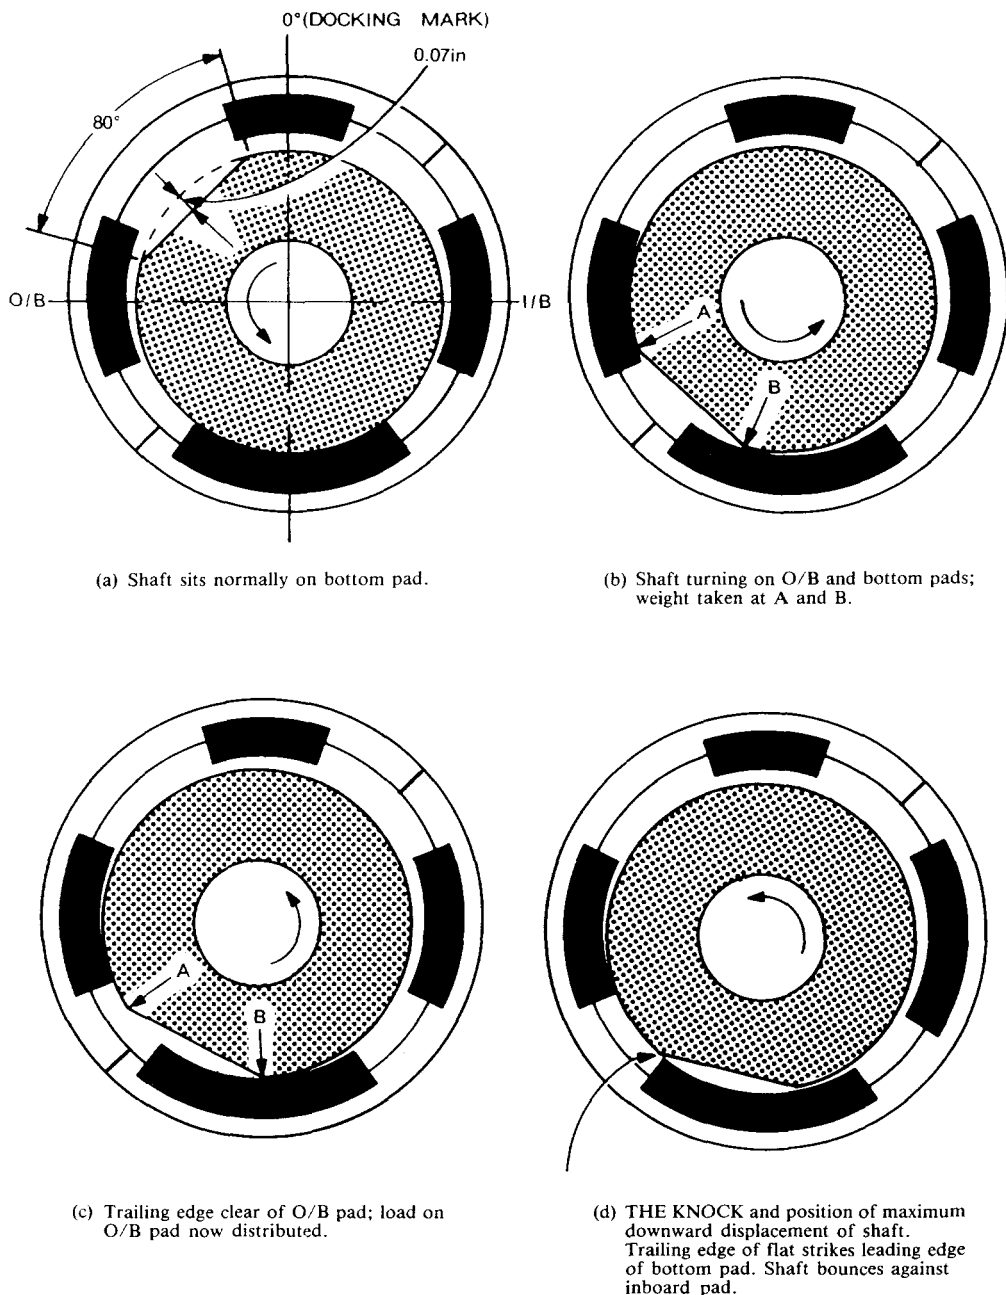
FIG. 8—THE 'KNOCK'

- (a) *Port IAB Liner*. A 'flat' of maximum depth 0.070 inches, 70°/80° arc length existed on the liner at a position which coincided with the discoloured area previously reported, and in such a position that it would be at the bottom of the IAB when the knock occurred. It ran the full length of the bearing surface of the liner and had a bright strip at each extremity of the arc.

Once the bearing material was completely worn away the shaft would make contact with the bearing housing under high thrust and cause damage to the liner and housing. Precisely why the liner should be worn over an arc of only 80° is not fully understood though it is thought to be caused by the natural throw of the shaft. At one stage it was believed to be associated with propeller blades being out of pitch but this theory was not borne out by measurements. A large scale model of the 'flat' liner was manufactured by the author and served to demonstrate how a flat of the kind measured could cause a knock (see FIG. 8).
