A CRACKING TALE OF CPP BLADES AND HOW THEIR HEALTH IS BEING RESTORED

LIEUTENANT-COMMANDER N. D. LATHAM, M.Sc., R.N.
(formerly of Sea Systems Controllerate)

LIEUTENANT-COMMANDER D. N. BRITTEN, B.Sc.(ENG.), C.ENG.,
M.I.MECH.E., R.N.
(Sea Systems Controllerate)

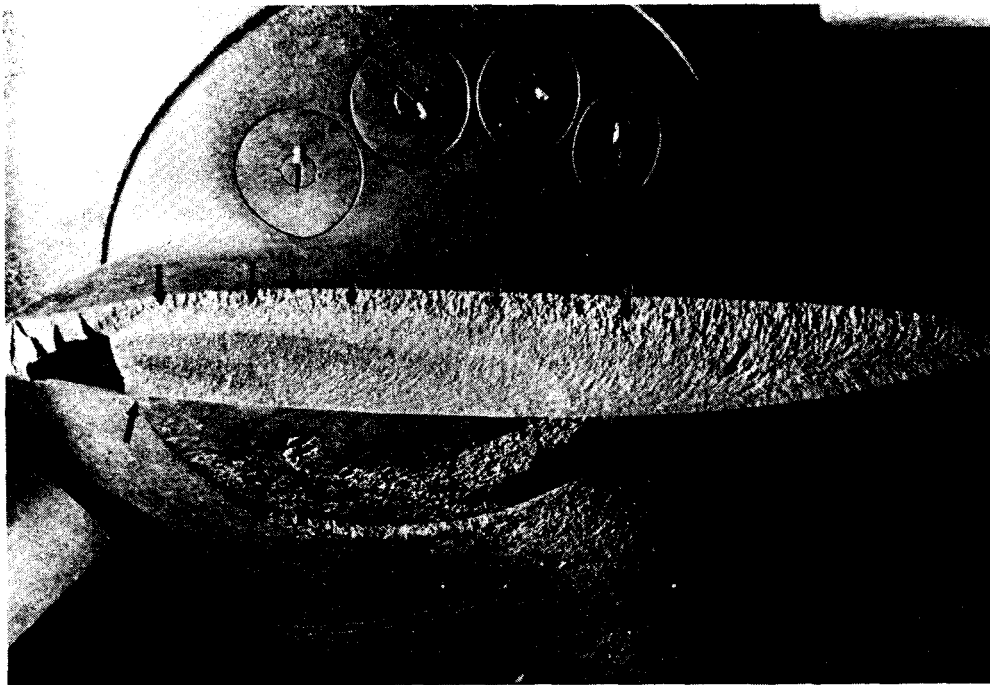
FIG. 3—FRACTURE CHARACTERISTICS OF FIRST FAILURE

A photograph of the stub of the first failed blade is shown in FIG. 3, and indicates the area over which a fatigue crack had propagated before final loss occurred by fast fracture. The axial markings present also indicated that crack initiation had occurred at the Agouti channel cover plate weld which was furthest from the leading edge. Detailed metallurgical examinations^{3,4} concluded that the blade had failed by the initiation and propagation of a corrosion fatigue crack from a defective weld repair, the extent of which is shown in FIG. 4. The repair itself had been necessary because the Agouti channel had been cast with a greater than designed cross-sectional area and was further from the leading edge than intended.

More rigorous cleaning procedures and dye penetrant crack detection routines in the Agouti channel area were introduced for in-service blades as a result of the investigations, and in particular those blades which had been subjected to repair concessions during manufacture were identified. Two blades in a Type 42 destroyer were soon rejected because of crack-like features, and subsequent examination showed them to be corrosion fatigue cracks associated with defects within the Agouti channel welding. FIG. 5 shows the type of defect which could result in failure by the resulting cracks running into the blade material.

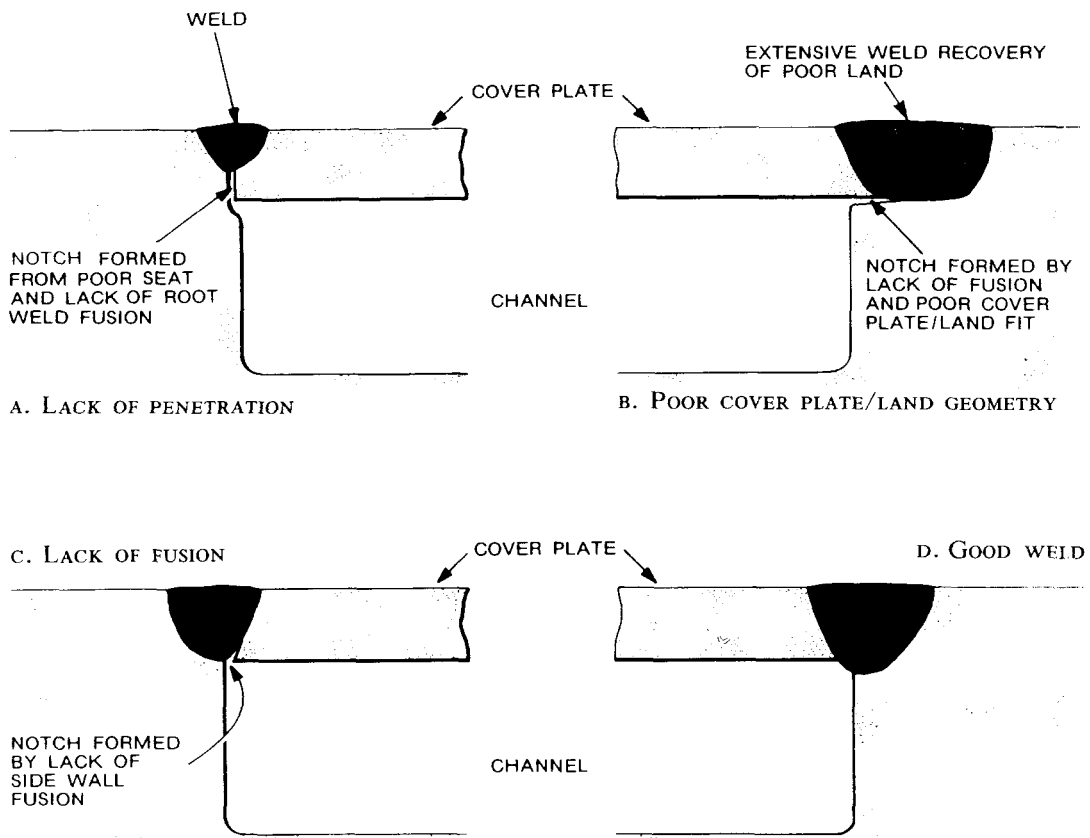
FIG. 5—EXAMPLES OF AGOUTI CHANNEL COVER PLATE WELD, ILLUSTRATING TYPICAL DEFECTS

- (a) *Agouti Channel* The origins of four out of the six failures were in deficiencies in the construction of the Agouti channel, either in the casting of the cover plate 'land' (see FIG. 5), or in poor welding.
- (b) *Casting* The remaining two failures had been shown to be a result of subsurface casting defects of the 'filamentary oxide' type.

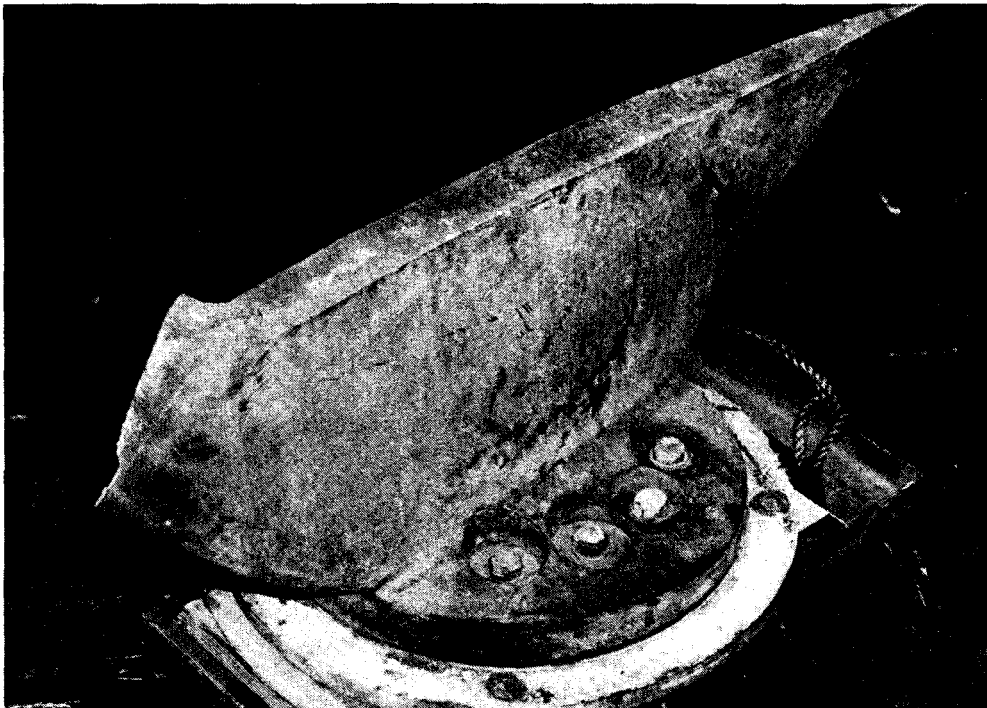
FIG. 6—FRACTURE CHARACTERISTICS OF SECOND FAILURE

After several years without a catastrophic failure, the second such instance (in July 1982) was both unexpected and alarming. From an inspection of the fracture surface, shown in FIG. 6, it was evident that the nature of the defect was entirely different from that previously experienced, although as before it had been caused by a fatigue mechanism.

Metallurgical examination⁶ revealed that the defect was a filamentary oxide entrapment near to or actually breaking the free surface of the pressure face,

introduced when the blade was cast. An extension of dye penetrant testing to the entire lower half of the blade surface was recommended, but a similar failure of another blade in the same ship highlighted the measure of the task confronting those responsible for determining NDE methods for obtaining the required assessment of blade integrity both at the production stage and after the blades had entered service. The specific problem was that the latent defects could be within the blade and might only be manifest at the surface during the fracture process. Furthermore, it was felt that the fatigue characteristics of Superston 70 were still not fully appreciated and further fracture mechanics studies were set up⁷ to provide more detailed acceptance and rejection criteria for the blades in terms of the defects that could be tolerated.
