A VIBRATION ANALYSIS OF A TURBO-GENERATOR DEFECT

CMEA(P) L. E. HART, R.N.
(Fleet Vibration Analysis Unit)

The machine in question was a turbo-alternator in a LEANDER Class frigate, which at the time was working up at Portland.

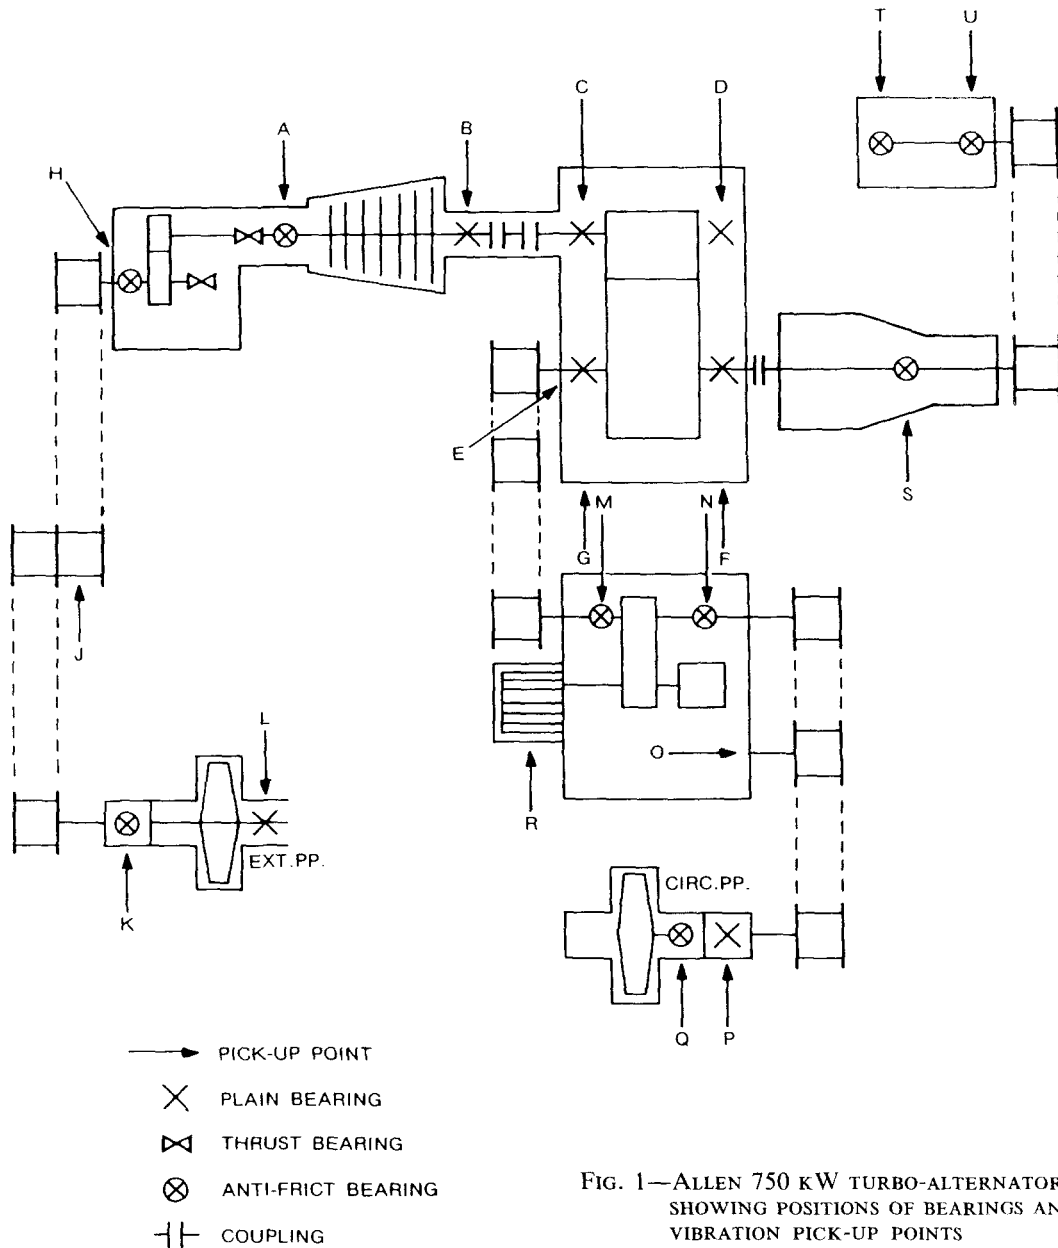
FIG. 1—ALLEN 750 kW TURBO-ALTERNATOR, SHOWING POSITIONS OF BEARINGS AND VIBRATION PICK-UP POINTS

The survey was conducted using IRD 820 and 880 vibration analysers, with a model 970 accelerometer transducer. Readings were taken at the positions indicated on the outline machine sketch in FIG. 1.

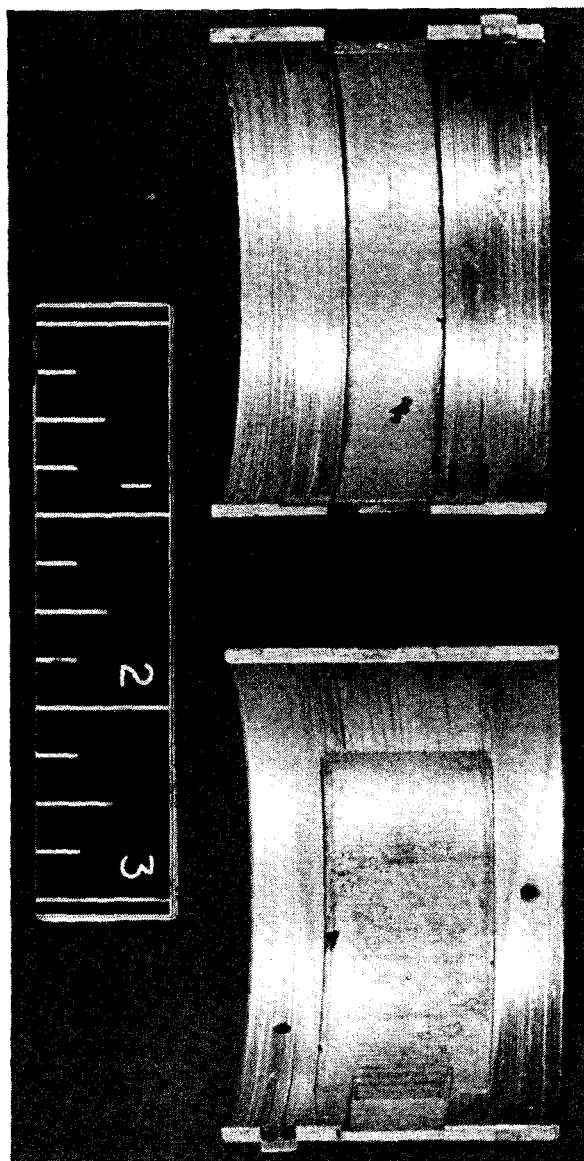
FIG. 4—WORN TURBINE FREE END BEARING (POINT A) FROM ALLEN 750 kW TURBO-ALTERNATOR

The half speed frequency was the more significant. Whereas a level of vibration will always be detected at the rotational speed of the machine, amplitudes at half speed would not usually be expected and these were thought to be created by oil whirl. Oil whirl is known only to occur in machines equipped with pressure lubricated sleeve bearings and operating at relatively high speeds. It occurs at between 3% and 8% below half speed of the machine.

produce a load-carrying film. Molecules of oil adjacent to the journal will tend to stick to it and therefore rotate at machine r.p.m.; the oil molecules in contact with the stationary bearing adhere to it and do not rotate. As a result the oil between the journal and bearing is in shear and tends to rotate at a speed which is the average of the shaft and bearing r.p.m. This is half of turbine speed, less 3%–8% due to friction losses. It should be noted that pressure-lubricated bearings will always contain oil rotating at half machine speed, but under normal circumstances the resulting shear forces are very small and would not be expected to be significant. Should the internal clearances within the bearing become excessive, however, the forces due to the rotating oil film can predominate and in these circumstances the journal can be caused to whirl around the internal surfaces of the bearing. This is oil whirl.

the free end and 0.0065 inches at the driven end once new bearings were fitted. The bearing removed from the driven end of the turbine was mislaid so FIG. 4 shows only the one from the free end. Ship's staff decided to replace the pinion bearings at positions C and D as well as the turbine bearings.

The ship was recommended to inspect the turbine bearings at the first opportunity. This was subsequently carried out and the bearings were found to be excessively worn (FIG. 4). Poker gauge readings show that the turbine shaft was lifted 0.009 inches at

Having thus established a possible cause of the defect as being worn turbine bearings, it was worthwhile, before completing the survey, to attempt to prove that the frequency in question was due to oil whirl. Noting that the oil pressure wedge is pushing the shaft around, if the oil condition itself could be altered (i.e. pressure or temperature), there would be a resulting effect on the rate at which the journal is moved within the bearing. As the oil pressure on a running turbo-alternator cannot be altered it was decided to alter the oil temperature. This was done and the oil temperature from the cooler was reduced from 120°F to 95°F, thus increasing the oil viscosity and therefore increasing its push effect. As the oil temperature was reduced the frequency of vibration caused by the oil whirl increased and the opposite effect occurred when the oil temperature was returned to normal. This experiment proved that the oil condition had a direct effect on the source of the predominant vibration which had first attracted the attention of ship's staff.
