OLYMPUS GAS TURBINES

RECENT PROBLEMS

J. WALKER, B.Sc., R.C.N.C.
(Sea Systems Controllerate)

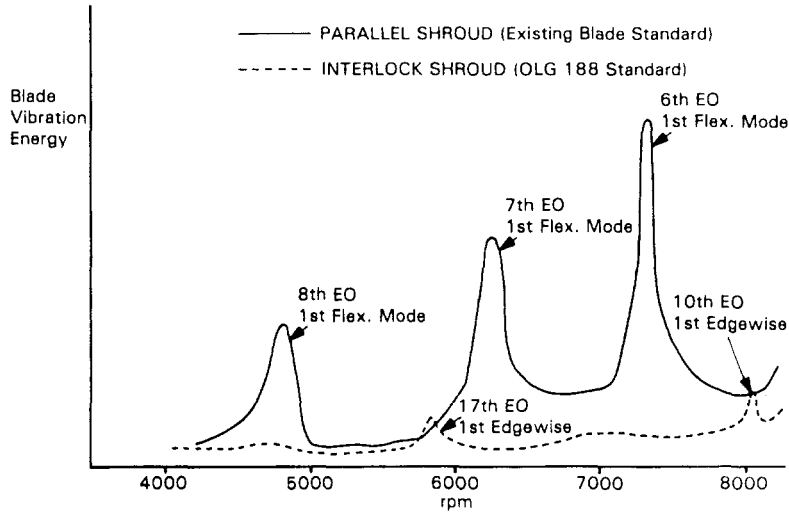
Almost all the Olympus gas turbines in R.N. service feature HP turbine blades to a forged Nimonic 115 standard and failures have been confined to these. The blade has a parallel shroud, and fir tree root attachment to its disc. A vibration characteristic is shown in FIG. 1. Readers will note the high peak at the first flexural mode, at approximately 7350 r.p.m. The resonant frequency at which this occurs will vary slightly from engine to engine and may be excited by sources such as a combustion defect. If the amplitude of vibration is sufficiently high then the ultimate result is a fatigue failure at the fir tree root of the HP turbine rotor blades.

FIG. 1—TYPICAL VIBRATION CHARACTERISTIC OF OLYMPUS HP TURBINE BLADES
EO: HP spool order

The first item has been addressed and has culminated in modification OLG188. This introduces an interlocked shroud and cast inconel blade. Its vibration characteristic has been included in FIG. 1 as a dotted line. The interlocked shroud effectively damps out the 1st flexural mode of vibration and the decreased mass results of course in reduced vibration force. Marine experience of this standard of blade has been rather limited but it is intended that as soon as the new blades become available they will be fitted to all engines during overhaul.

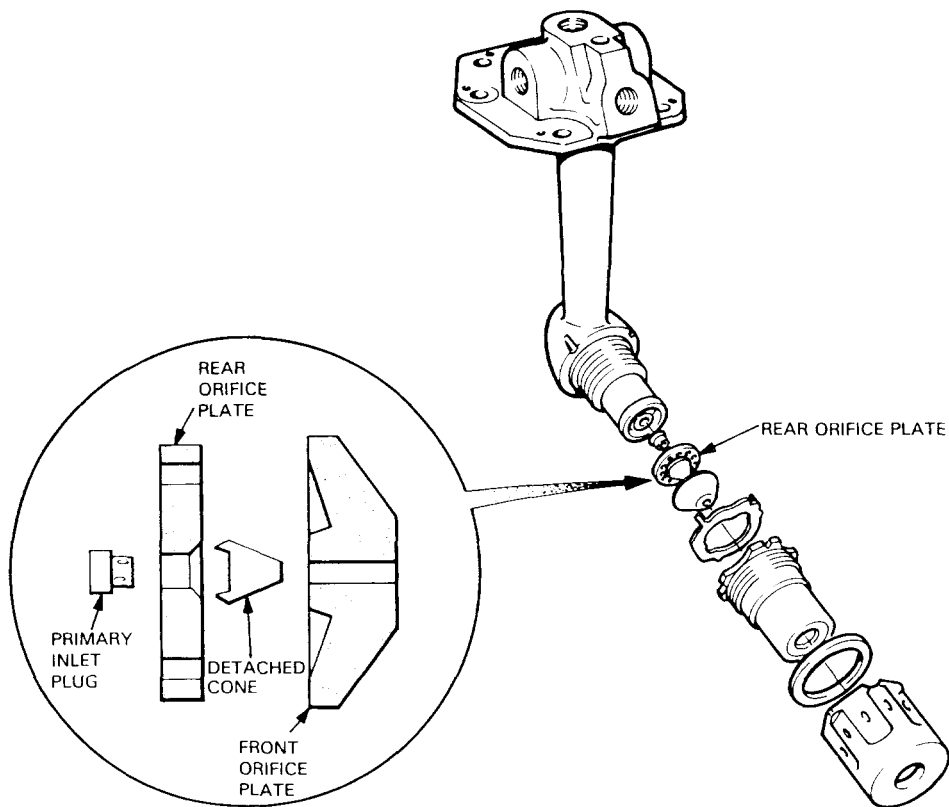
FIG. 2—OLYMPUS BURNER: EXPLODED VIEW, WITH FAILURE MODE

There have been instances of burner atomizer (rear orifice plate) displacement, due to manufacturing errors, resulting in blocked or partially blocked burners. Apart from the recent series of GTCU failures, two failures in 1984 (both in H.M.S. *Newcastle*) were proved to be due to this defect. The burner cone becomes detached from the rear orifice plate in the burner atomizer pack (FIG. 2). An investigation into the cause revealed that there was no positive build check to ensure adequate clearance between atomizer components following lapping on assembly. The resulting interference was sufficient to cause stress corrosion and fracture of the rear orifice plate and displacement of the atomizer cone. It was also found that parts on the extreme of tolerance would interfere. This problem has now been understood by overhaul facilities and the introduction of a 'rock test', to prevent over-stressing of orifice plates, has been introduced. A programme of burner change on a gradual basis has been set up by C-in-C Fleet.

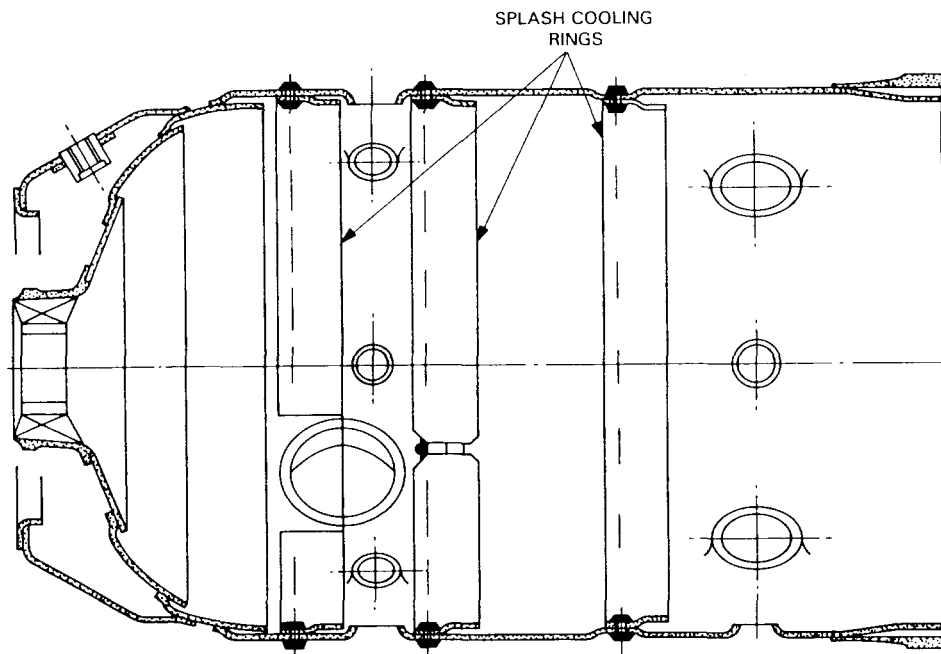
The present design features splash cooling rings riveted to the combustion chamber barrel with the ends of the ring welded to the barrel wall. FIG. 3 shows the details of the combustion chamber splash cooling ring arrangements. Although recognized as 'old technology', there is no reason why the present Phase I chambers cannot stay the full course of 2000 service hours without coming apart, provided the can is made to drawing.

Failures of the splash cooling rings originate due to cracking of the welds retaining the ring ends, followed by flapping of the ring ends within the gas stream. Rivets may fail at this stage and pieces of ring can tear off and become lodged on the nozzle guide vanes. Although turbine damage caused by impact can occur, this is of relatively minor consideration compared to the excitation of HP turbine blades, caused by pressure fluctuations as the disc rotates, leading to eventual blade fatigue failure. The first failure of this type occurred at relatively high combustion chamber hours (1893 hours, of a release life of 2000 hours) and so there was no reason to suspect anything untoward. However a subsequent failure at 711 hours later in the year precipitated a keener interest in this type of failure. Although Rolls-Royce advise a release life of 1500 hours, experience by the Royal Navy has enabled a 2000 hour life to be reasonably expected and this is the adopted R.N. standard.

FIG. 3—PHASE I COMBUSTION CHAMBER: CROSS-SECTION AND INSIDE VIEW

Although convinced that, provided combustion chambers are produced to drawing, then no problems should occur during release life, it was felt prudent to introduce a modification which would provide a 'belt and braces' solution. The result was simplicity itself, namely two extra rivets at the ring ends together with extended end welds. The rework of existing cans (over 800 in service and over 500 in repair loop and spares) is a major logistic problem and will not be concluded for many months. The immediate requirements have been met and the rework programme should provide replacement cans to meet all future MOD requirements. It is also ironical to note that the earlier multiflame standard of combustion chambers was replaced by the current Phase I standard partly due to can flare detachment and HP nozzle guide vane blockage!

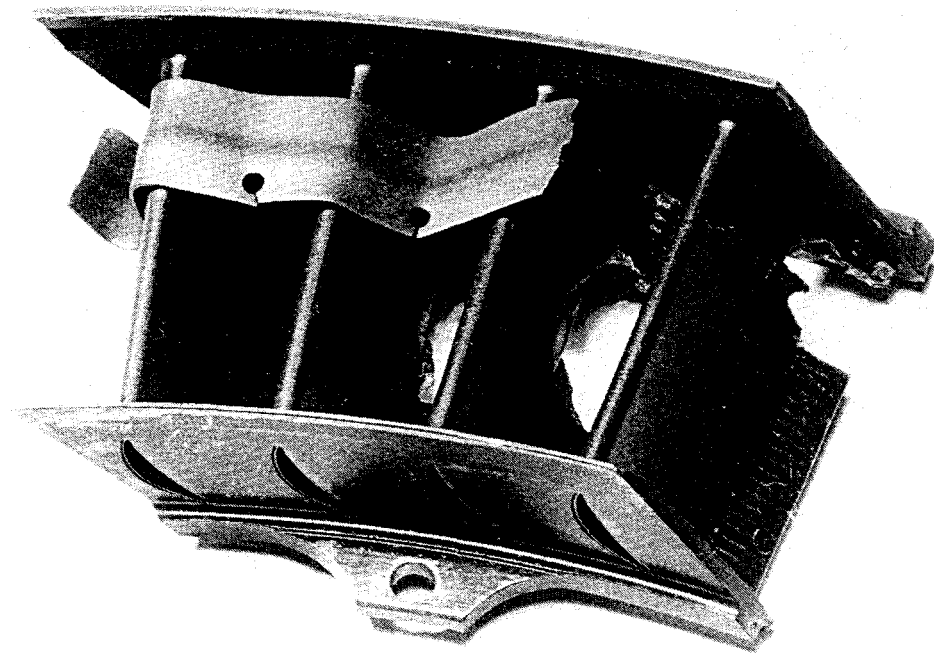
FIG. 4—PORTION OF SPLASH COOLING RING FROM COMBUSTION CHAMBER, ON HP NOZZLE GUIDE VANES IN THE POSITION WHERE MARKS INDICATED IT HAD BEEN LYING

The series of photographs (Figs. 4 to 10) show the cause and effect of an HP turbine blade failure. In this case (H.M.S. *Boxer* engine no. 2017158 at 711 hours) the failure was caused by a detached segment of combustion chamber splash cooling ring lodged against the HPNGVs and subsequent fatigue failure of one HP turbine blade.

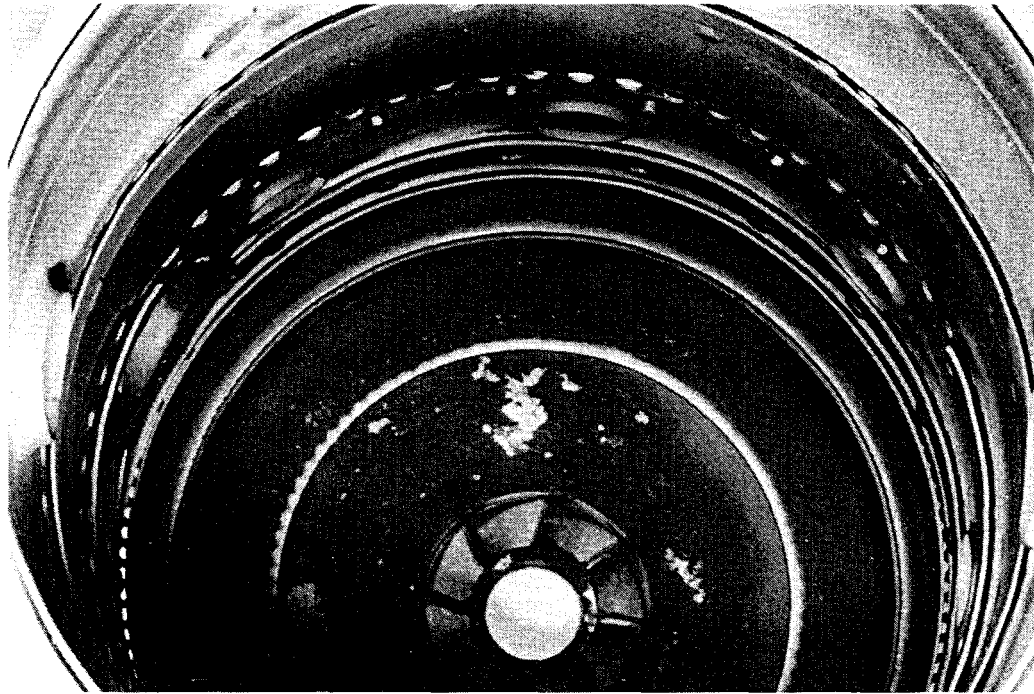
FIG. 5—INSIDE OF COMBUSTION CHAMBER, SHOWING REMAINS OF RIVETS WHERE THE 2ND SPLASH COOLING RING HAS BECOME DETACHED

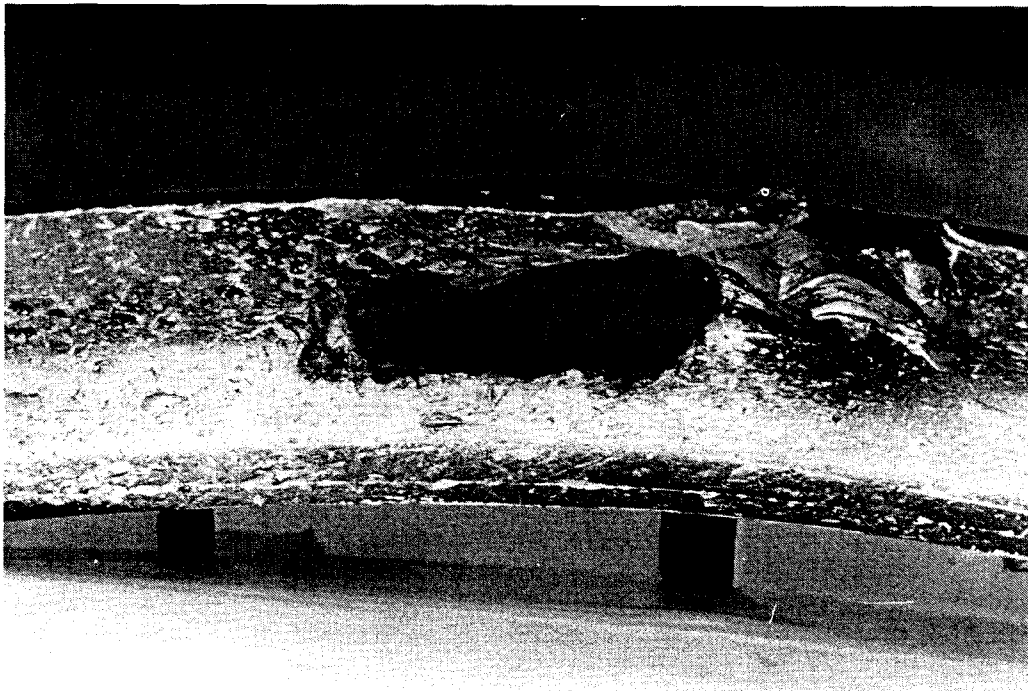
FIG. 6—PUNCTURED HP TURBINE CASING

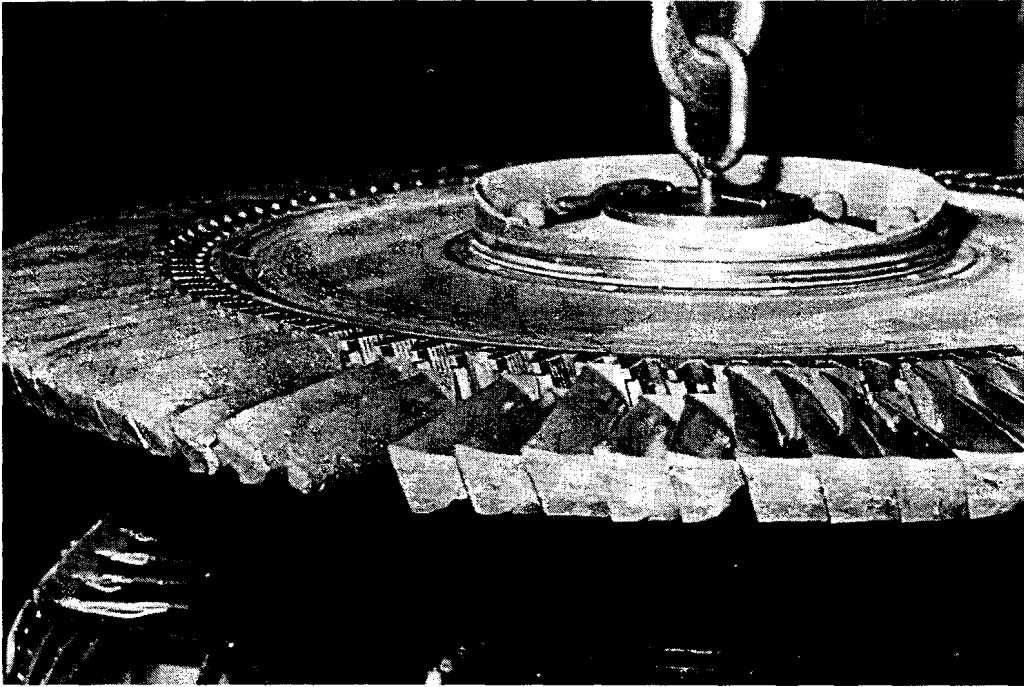
FIG. 7—DAMAGED HP NOZZLE GUIDE VANES

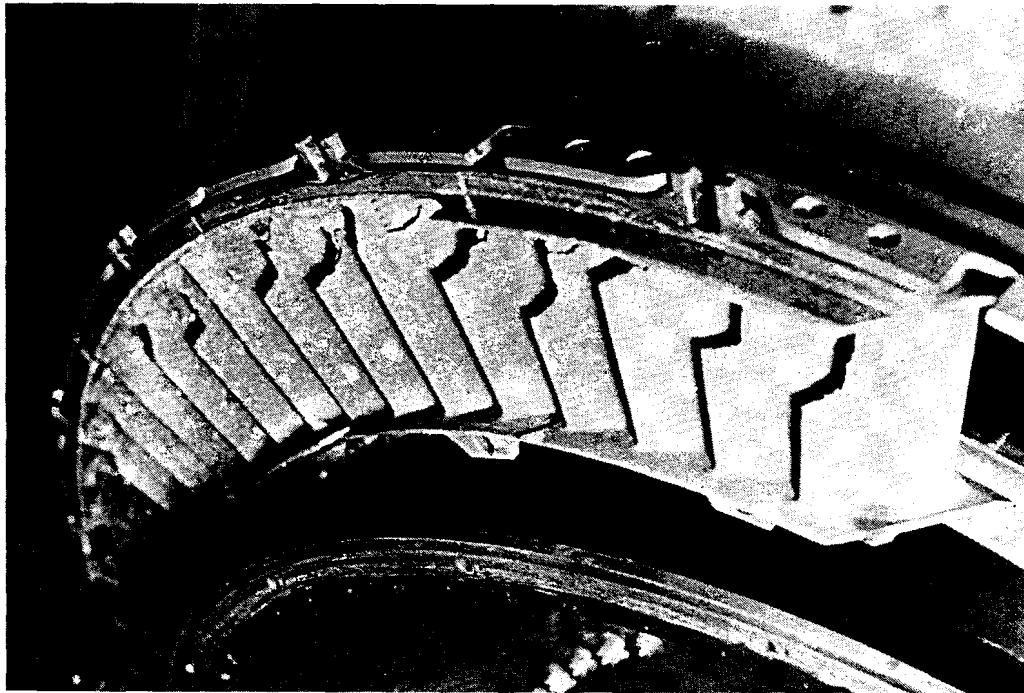
FIG. 8—HP TURBINE DISC BLADE ASSEMBLY, WITH FAILED ROOT IN POSITION

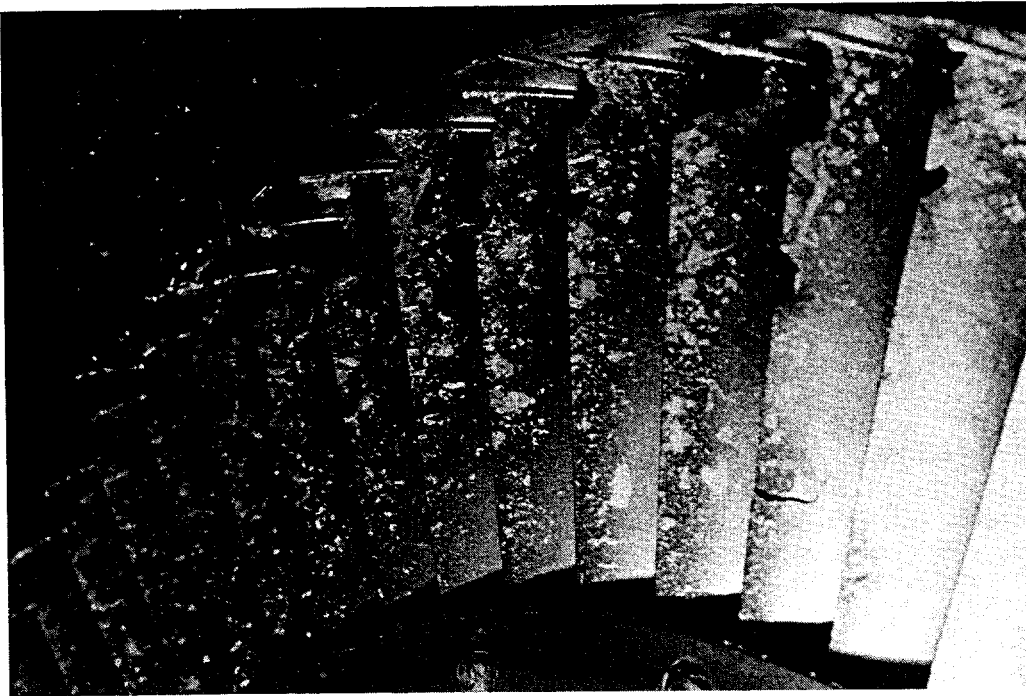
FIG. 9—DAMAGED LP NOZZLE GUIDE VANES

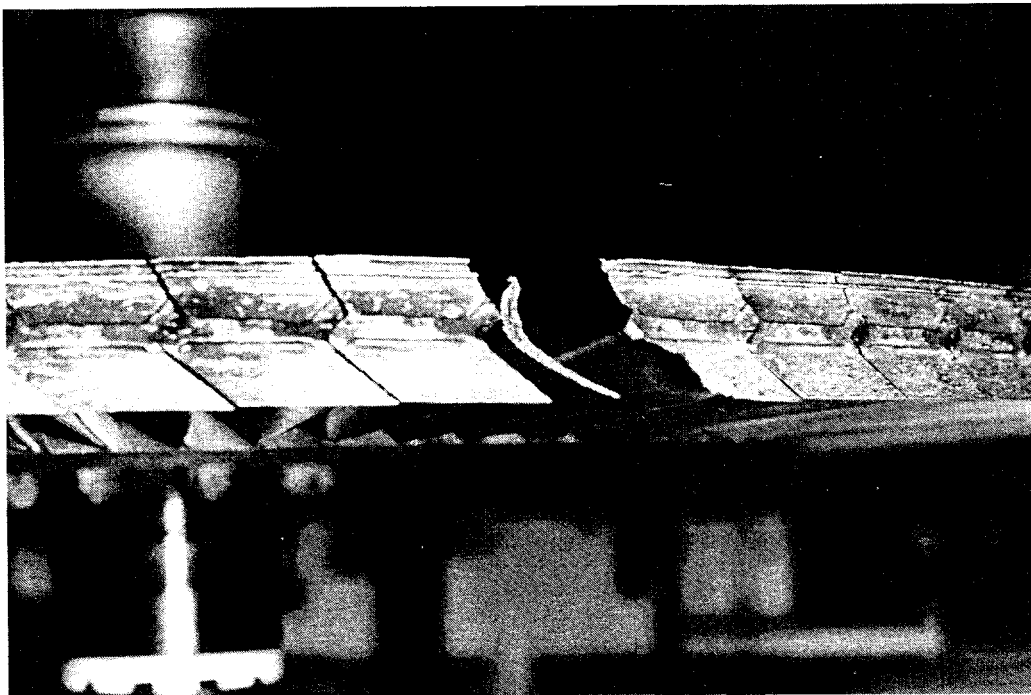
FIG. 10—LP TURBINE BLADE WITH OUTER PLATFORM MISSING
