A VIBRATION ANALYSIS OF A DIESEL GENERATOR

WOMEA(P) A. GILBERT, A.M.I.MAR.E., M.I.PLANT E., R.N.
(*Fleet Vibration Analysis Unit*)

This article is an account of an unprogrammed vibration analysis survey of a Paxman 8YJCAZ 8 cylinder diesel generator in a LEANDER Class frigate. It does not cover all the causes of vibration in diesel engines and the frequencies at which they occur but is intended to show the results which may be achieved using vibration monitoring equipment held on board and the train of thought leading to the analysis and final diagnosis of the defect.

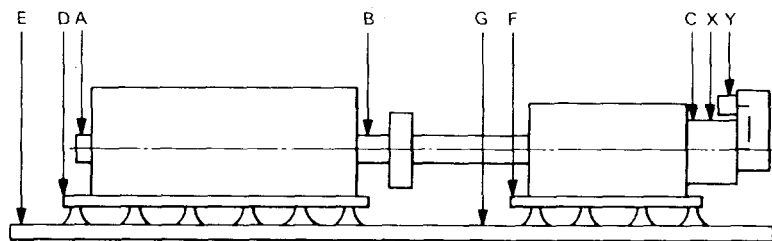
FIG. 1—ENGINE VIBRATION SURVEY POINTS

The engine was run up and loaded to 500 kW on ship's load. Using the IRD 820 Vibration Analyser overall vibration levels (filter out)¹ and Sharp filter, vibration spectra were recorded at points A, B and C (FIG. 1), and Broad filter spectra were recorded at points X and Y using the velocity mode (mm/s peak) in the horizontal vertical and axial planes.

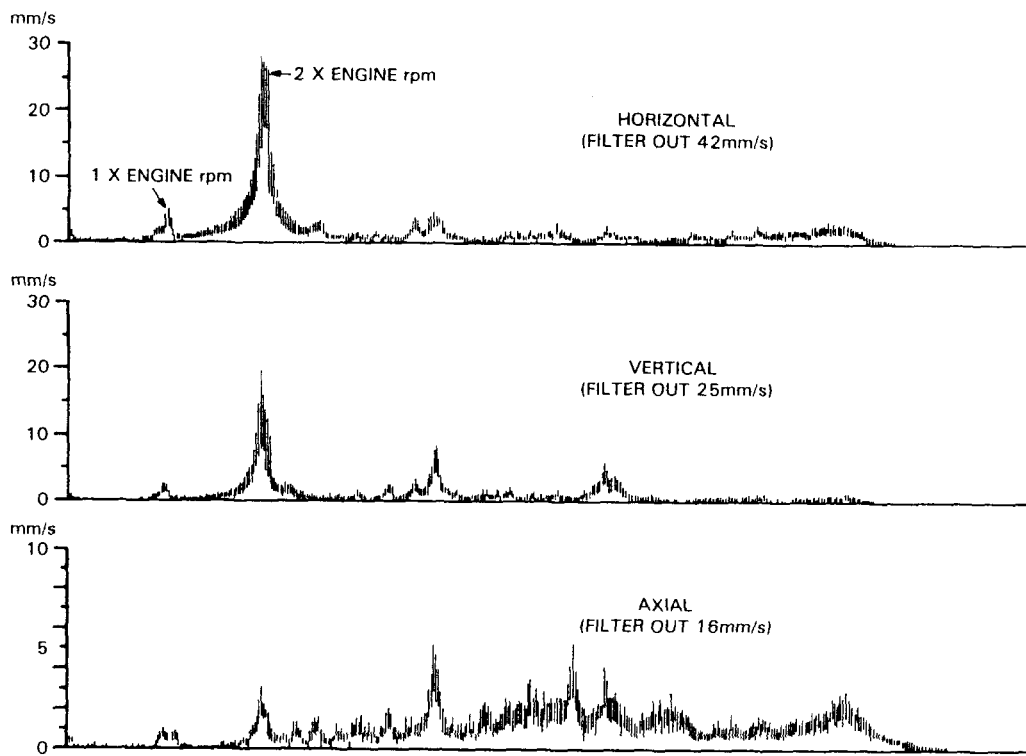
FIG. 2—VIBRATION TRACES AT POSITION B: LOAD 500 kW

The predominant amplitudes and the frequencies at which they occurred were transcribed from the IRD 820 print-outs (as in Figs. 2 and 3) to pre-printed forms (Figs. 4 and 5). Tabulating the data in this manner showed that the highest vibration amplitudes recorded, 35 mm/s at point B horizontal with the engine on load and 30 mm/s with the engine on no load, occurred at a frequency of 2.4K c.p.m. ($2 \times$ engine speed). As the high vibration amplitudes occurred both on and off load and after comparing this data with previous vibration surveys and data from similar engines on other ships, it was diagnosed that the engine had suffered damage-failure to the secondary balance equipment, confirming the quick diagnosis. Experience has shown that similar vibration levels may be encountered at $2 \times$ fundamental frequency on this type of engine after rebuild if the secondary balance weight driven gear is out of phase with the driving gear wheel. A telephone call from Hull to Portsmouth had eliminated this possibility prior to the quick look diagnosis as the engine had been surveyed some 3 months before and all vibration levels had been satisfactory.

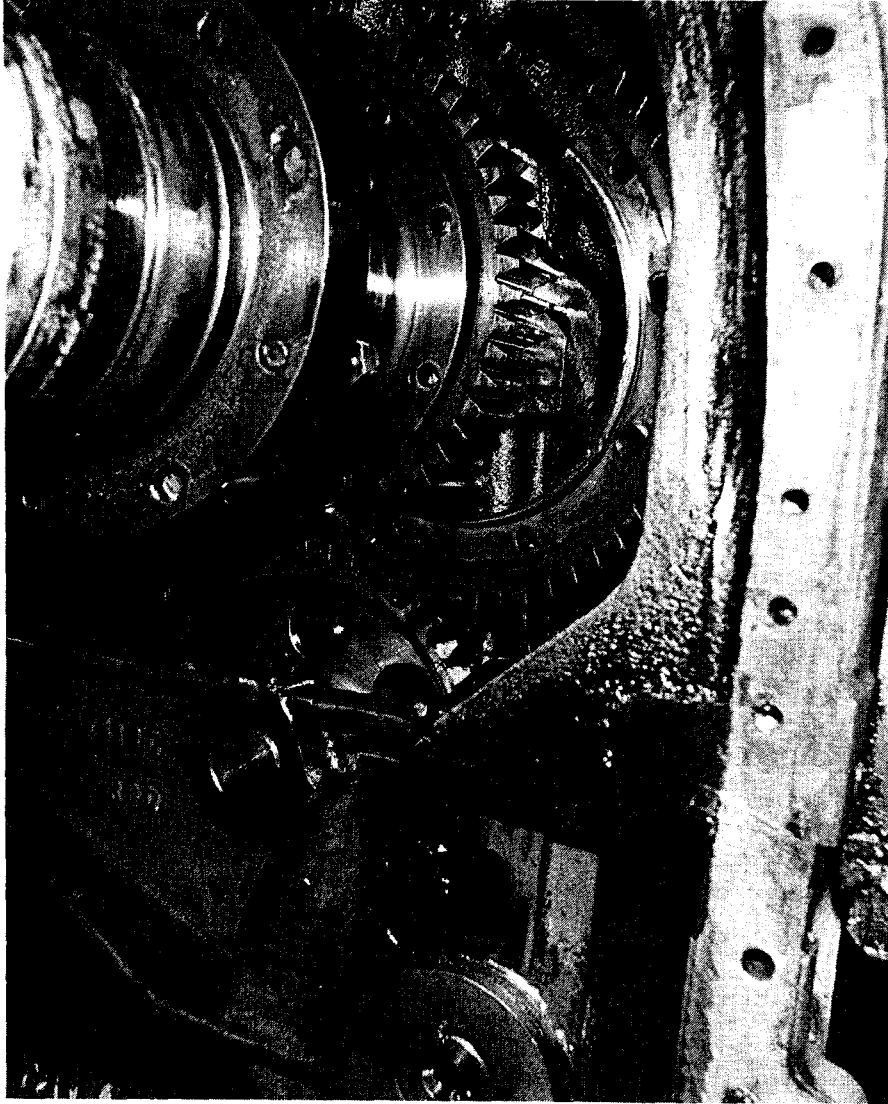
- (a) All split gear wheel fastenings had sheared.
- (b) Half the split gear wheel secondary balance weight drive had fouled the gear train (FIG. 6).
- (c) All vibration damper fastenings had sheared (FIG. 6), allowing the torsional vibration damper to float on the crankshaft and causing damage-wear to the crankshaft end cover (FIG. 7).

Further feedback after metallurgical examination of the failed damper and secondary balance gear securing bolts recommended that the bolts be replaced using quality assured items.

FIG. 6—SHOWING FAILED FASTENINGS ON FREE END SPLIT GEAR WHEEL, THE SECONDARY BALANCE WEIGHT DRIVE, AND FAILED FASTENINGS ON TORSIONAL VIBRATION DAMPER. THE SPLIT GEAR WHEEL HAS FOULED THE SECONDARY BALANCE WEIGHT DRIVE TRAIN. THE DAMPER HAS BECOME DETACHED AND MOVED FORWARD ON THE CRANKSHAFT

- (a) The secondary weights and associated gearing be inspected for looseness, wear or damage.
- (b) The secondary balance weight brackets be examined for damage/cracking.
- (c) The sump be inspected for debris.

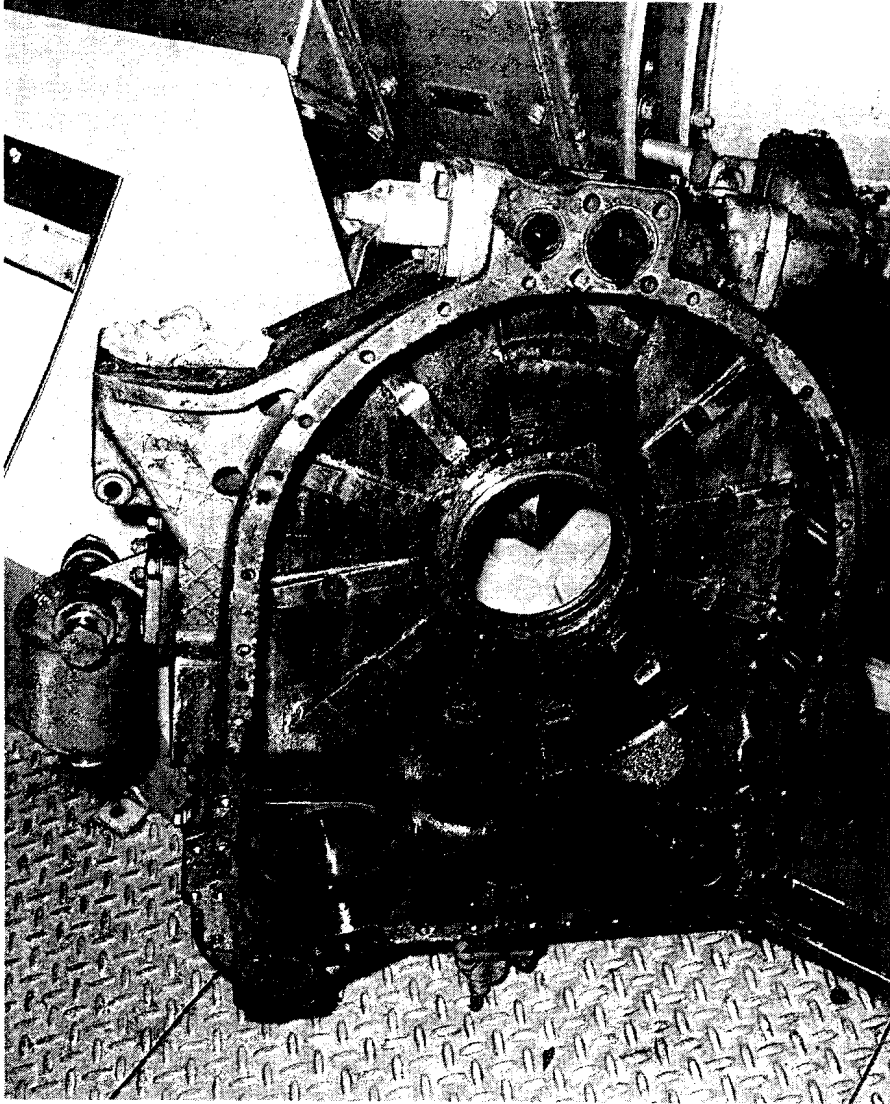
FIG. 7—SHOWING DAMAGE TO END COVER CAUSED BY DAMPER BECOMING DETACHED FROM THE CRANKSHAFT
