H.M.S. 'INVINCIBLE'

## MARINE GAS TURBINE EXPERIENCE IN THE FALKLANDS WAR

COMMANDER P. W. W. RIDLEY, B.SC.(ENG)., C.ENG., M.I.MECH.E., R.N.  
(Sea Systems Controllerate)

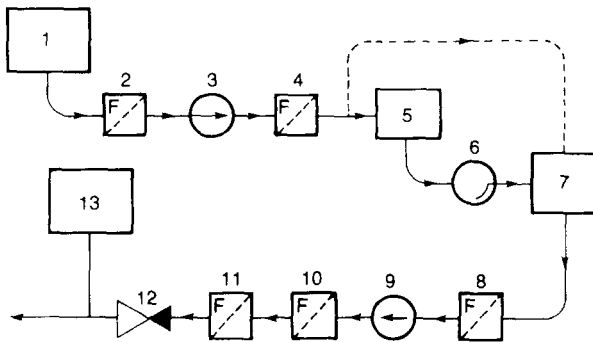
FIG. 1—TYPICAL FUEL SUPPLY SYSTEM IN A MODERN FRIGATE

- (a) In some ships, gas turbine High Pressure Fuel Shut Off Cocks (HPSOCs) became temporarily jammed, their moving parts having become 'gummed up' by a thin veneer of the fuel degradation products described above. (Ships engineering staffs soon developed a successful technique for the removal of HPSOCs for stripping and cleaning by bathing the offending components in trichlorethylene. In practice there was always sufficient warning of trouble for interference with operations to be avoided.)
- (b) In other ships, elements in the coalescer-filter water separators frequently became blocked and had to be changed.
- (c) No ship suffered both the above effects.

It is now evident that where coalescers were becoming blocked with particulate matter, they were protecting the HPSOCs and other on-engine fuel system components. This effect occurred almost exclusively in later ships with the more up-to-date coalescers, of a nominal filtration size of one micron. It is true that in most cases coalescers in the earlier ships had been updated by fitting new, finer coalescer elements, but it has since been found that it is easy unknowingly to fit these incorrectly so that fuel can leak past the elements, to the extent that in one or two ships the entire coalescing system has now been found to have been completely bypassed.

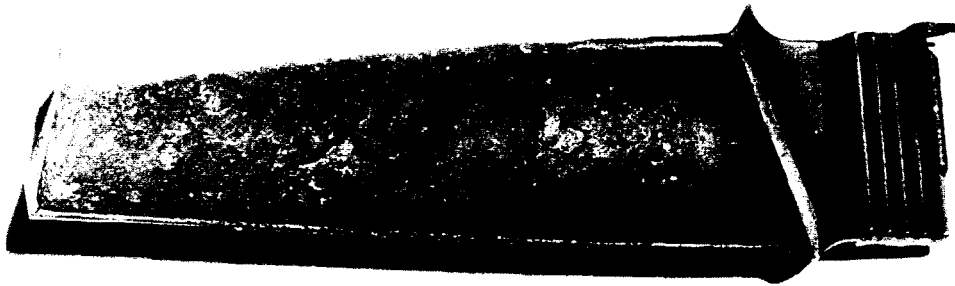
FIG. 2—H.P. TURBINE BLADE OF NIMONIC 115 (CLEANED)  
from H.M.S. 'Alacrity'

the hot end. FIGS. 2 and 3 show wrought Nimonic 115 HP turbine blades from two separate Olympus gas turbines taken from two ships of different classes, with differently positioned intakes. Corrosion due to low temperature sulphidation has spread further up the blades than has previously been experienced, particularly on Olympus engines<sup>3</sup>. This and other evidence has added a great deal of weight to the proposal to change to cast INCO 738

HP turbine blades in Olympus. (It should perhaps be made clear that no wrought blade has come anywhere near failure as the result of corrosion, but merely that the blade rejection rate when refitting engines from the first ships to return has been high.)

The factors likely to have led to increased blade corrosion have already been mentioned:

- (a) Contamination of fuel with salt water due to leakage bypassing coalescers.
- (b) The effects of rough weather.
- (c) Possible leakage of air intake filter bypass doors.
- (d) Prolonged running at low powers, when filtration can be inefficient due to low air velocities.

It is now believed that the first of these is likely to have had the most direct influence. As might be expected, none of the engines in the newer frigates and destroyers has yet become due for replacement and, with one exception, the H.P. turbines examined have come from ships with older, less efficient fuel purification systems without in-line centrifuging and with coalescers which may well have been partially bypassed or leaking. H.M.S. *Alacrity* (FIG. 2) is such a ship. The exception is H.M.S. *Glasgow* (FIG. 3) which suffered some damage, as exemplified by FIGS. 5 and 6, and in which there must have been a greater chance of leaking air filter bypass doors due to shock.

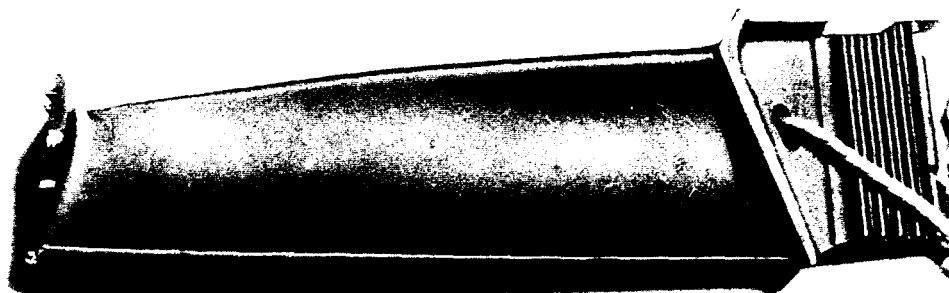
FIG. 4—H.P. TURBINE BLADE OF CAST INCO 738  
from engine trial at R.A.E., Pyestock

In contrast, FIG. 4 shows a pack aluminized INCO 738 H.P. turbine blade from an Olympus engine after it had run for over 4500 hours at all powers in the Marine Wing of the Royal Aircraft Establishment at Pyestock. Long periods with heavy salt water injection were included. The H.P. turbines of the Tyne RM1C and also the next R.N. engine, the Rolls-Royce SM1A<sup>4</sup>, already employ cast INCO 738 blades as standard.

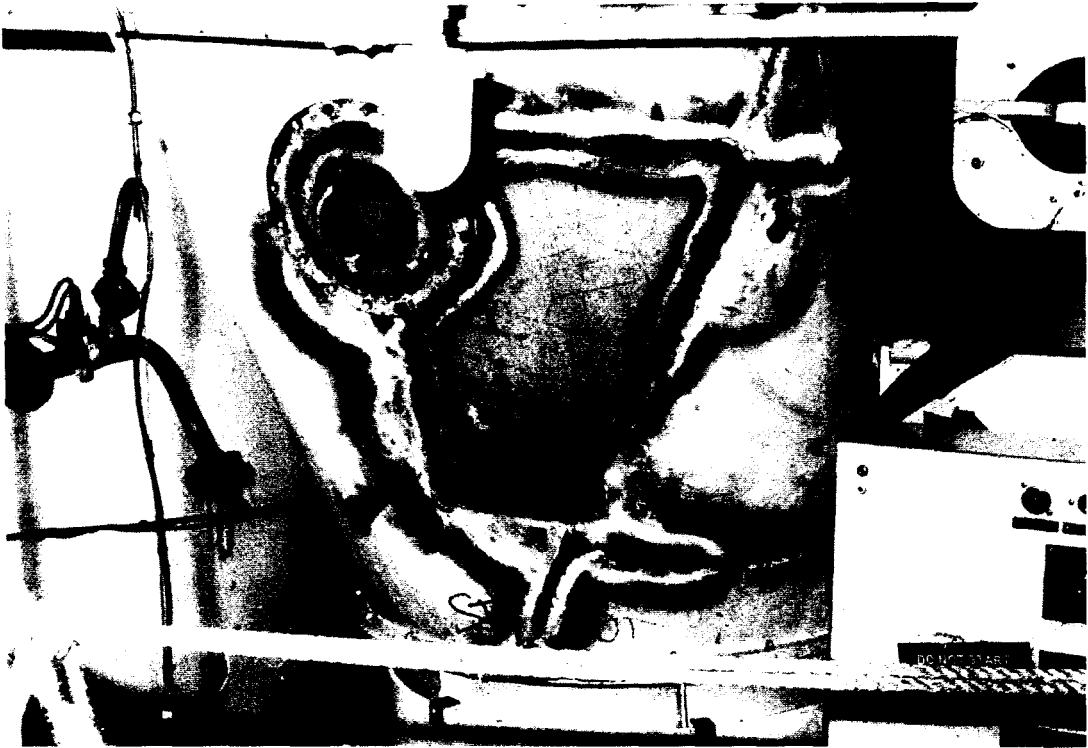
FIG. 5—H.M.S. 'GLASGOW': WELDED REPAIR OF TYNE INTAKE
