CRACKING IN R.N. SURFACE SHIPS

K. FOULGER, B.SC.(ENG.), C.ENG., M.I.MECH.E., F.R.I.N.A., R.C.N.C.
(Chief Naval Architect, Sea Systems Controlierate)

D. W. CHALMERS, O.B.E., C.ENG., F.R.I.N.A., R.C.N.C.
(Sea Systems Controlierate)

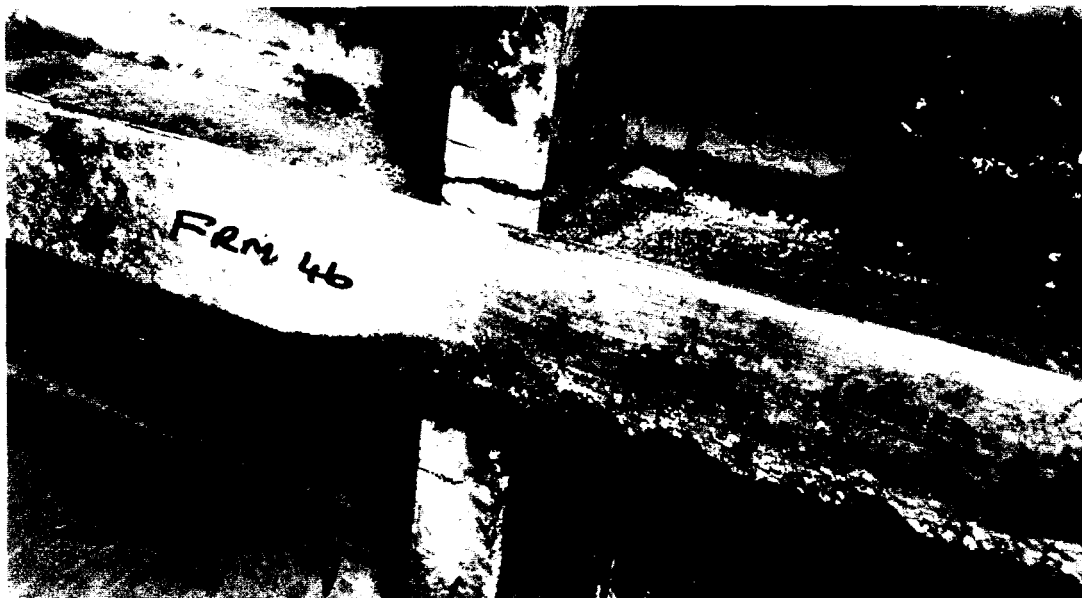
One WHITBY Class (H.M.S. *Torquay*) and seven ROTHESAY Class are still in service with the R.N.; all are over 20 years old and it is 28 years since *Torquay* first commissioned. The structure of these ships is very light, the ROTHESAYS being slightly heavier than WHITBYS. They were designed and built in the late 1940s and early 1950s to provide quick replacements for some of the many wartime ships reaching the end of their useful lives. Because of the very light structure, and especially the lack of plating reinforcement around the boiler uptakes and downtakes in 1 deck, they have always suffered some cracking and indeed were strengthened by adding deep girders under 1 deck either side of the funnel. Unfortunately, because it was a common problem, cracks were repaired as they occurred by welding (Figs. 1 to 3) or by fitting doublers, and the significance of the accumulating fatigue damage was not appreciated at the time. The severe cracking at sea which occurred in *Lowestoft* in November 1982 brought the problem to the fore but after consideration the discovery of similar incipient cracking in almost all ships of the class was only to be expected. Repairs consist of renewing fatigue-damaged plate and this is being done as rapidly as possible. The problem is exacerbated by the extensive corrosion in the machinery spaces of some of the class which causes an increase in stresses and a speeding up of the rate of fatigue damage. These ships are therefore nearing the end of their fatigue lives but the state of their structure is being continuously monitored and assessed.

FIG. 1—'ROTHESAY' CLASS: TYPICAL FATIGUE CRACK IN I DECK GIRDER (H.M.S. 'PLYMOUTH')

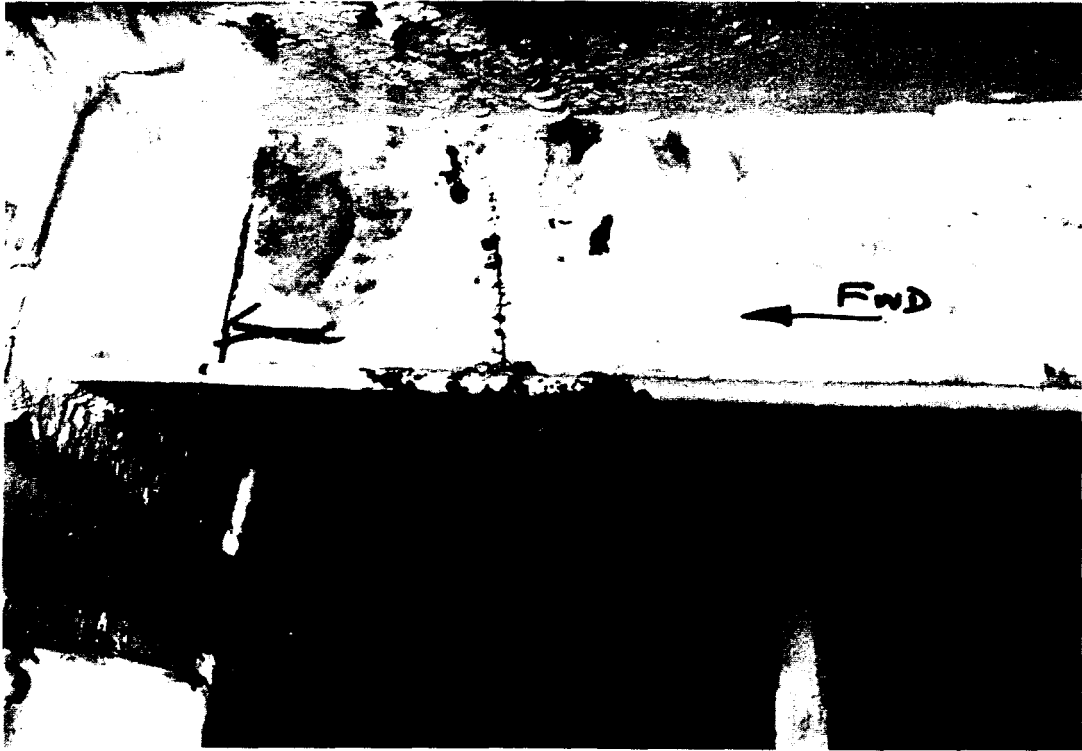
FIG. 3—'ROTHESAY' CLASS: FAILURE OF WELD REPAIR IN 1 DECK GIRDER (H.M.S. 'PLYMOUTH')

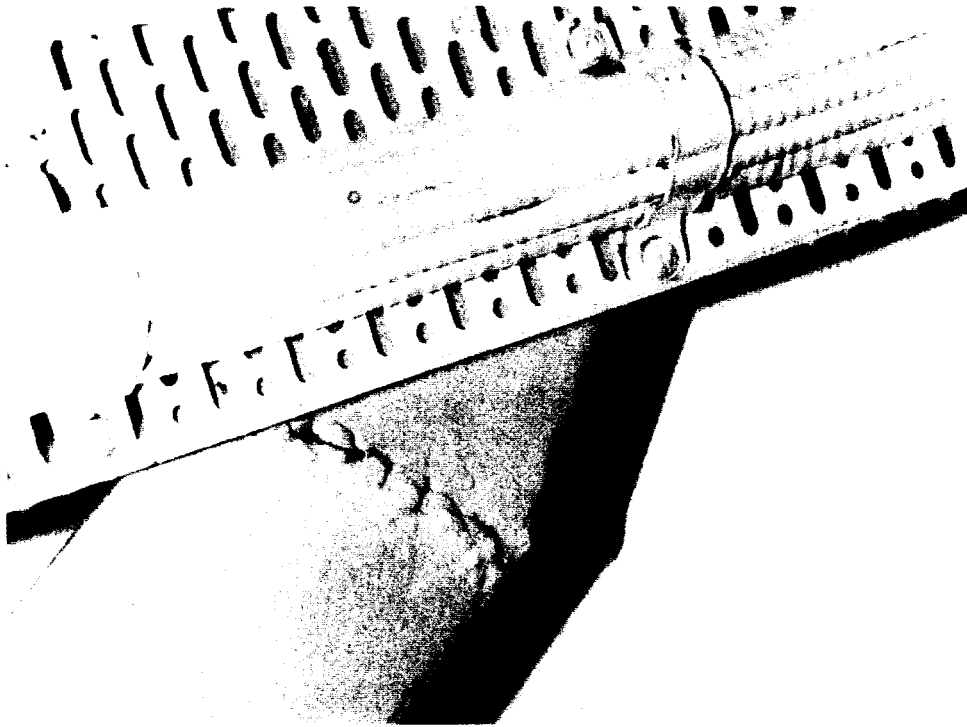
Two of the Batch I ships have suffered a minor crack in a girder in 01 deck (FIG. 4). This crack is due to a poor design detail in a complex arrangement of structure around the many penetrations for machinery access and removal. The structure was assumed by the designers not to contribute to the overall strength. The crack is of little importance and will not extend to be dangerous. The design has been changed to eliminate the detail in later ships. Type 22s have also suffered cracking around the ends of bilge keels; this is due to poor alignment of structure and is being cured by fitting thick plate inserts in the hull in way of bilge keel ends.

FIG. 4—H.M.S. 'BRILLIANT': FATIGUE CRACK IN 01 DECK GIRDER AT CRANKED CONNECTION (LOOKING UP AT DECKHEAD)
