MARINE GAS TURBINES

A REVIEW

COMMANDER J. M. KINGSLAND, C.ENG., M.I.MECH.E., R.N.
(*Ship Department*)

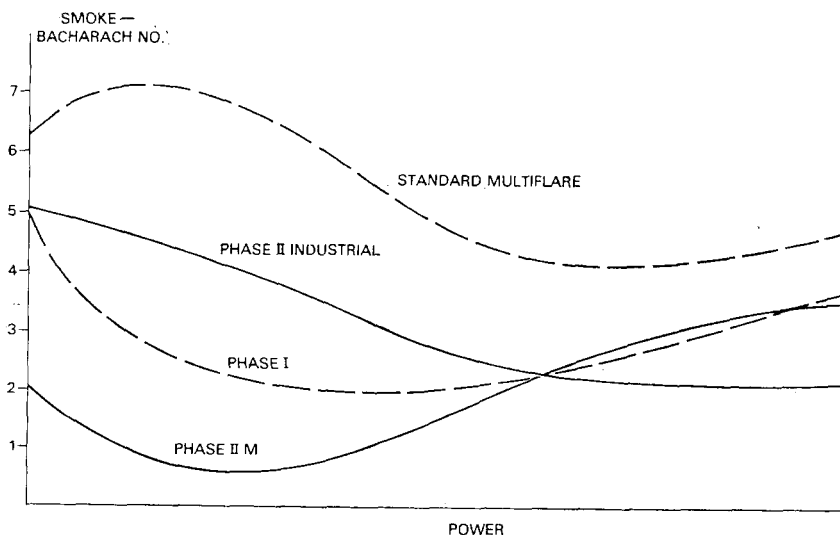
FIG. 3—OLYMPUS SMOKE LEVELS

The first was quickly overcome, and has ceased to be a serious problem. The smoke level of the standard multiflare can with the original burner was very bad, and there has been intensive development to cure this, allied to improvements to extend can life. Smoke levels achieved by different can standards and burners are shown in FIG. 3. A modified burner, known as the 'EX' burner, gave greatly improved smoke performance, but brought with it the need for fuel system modifications to control deceleration rates and prevent flame-out which would otherwise occur with the 'EX' burner.

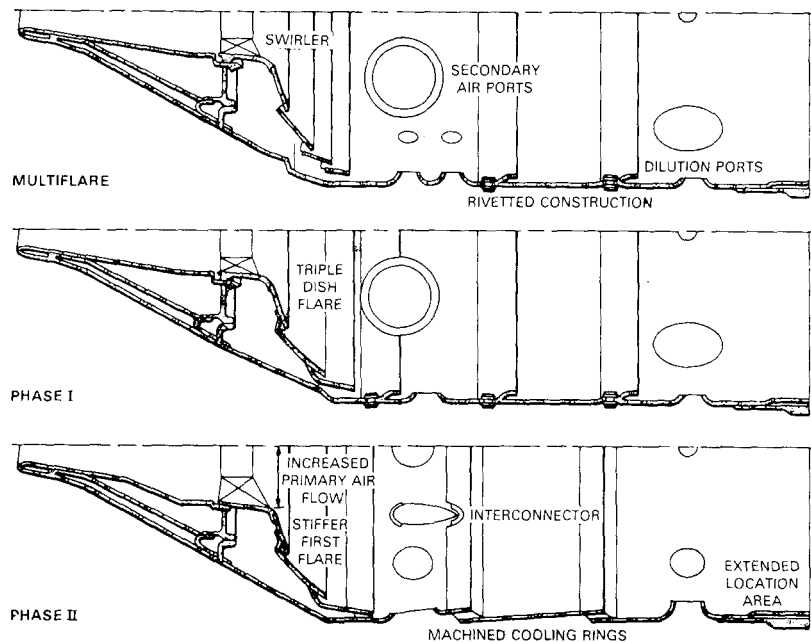
FIG. 4—OLYMPUS COMBUSTION CAN STANDARDS

Combustion can life has been improved from 1000 hours with the original standard to 2500 hours with a developed can referred to as 'Phase I'. The latter, in combination with the 'EX' burner, gives generally smoke free operation, though black smoke is just visible at full power and, at idling, obnoxious white vaporous smoke is emitted. Further development has given a 'Phase IIM' can with no visible smoke at all, and the potential for greatly improved life even with severe high-power operation. Unfortunately the improvements in low-power combustion efficiency have brought with them problems with starting and handling which it has not proved possible to eliminate by simple changes to the fuel system and swirler geometry. This line of development has been abandoned, though it is possible that a similar industrial standard of can could be considered for R.N. use after further experience ashore and proving with the marine fuel control and starting systems. The prize of eliminating the need for *in-situ* can changes is particularly attractive for the CAH, where Olympus usage is expected to be at least twice that in COGOG ships. The standards of can referred to are illustrated in FIG. 4.

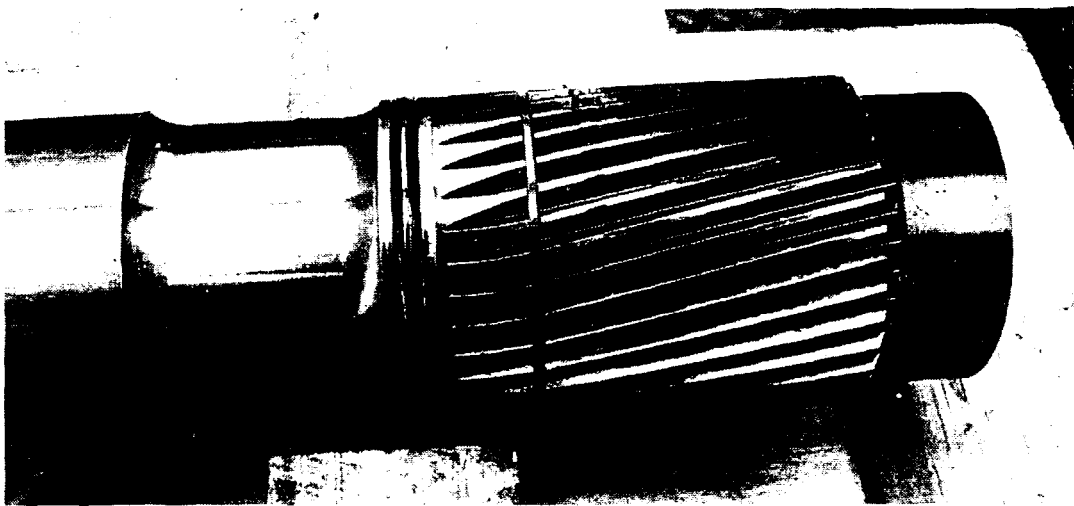
FIG. 5—TYNE LP COUPLING SHAFT: SPLINE FRETAGE

Typical damage to the LP coupling shaft helical splines and steady bearing are shown in FIGS. 5 and 6. These defects have come to light during planned strip,

and have not resulted in failures in service. Such defects would clearly lead to scrapping of otherwise serviceable components; repair schemes and redesign involving lengthening and nitriding of splines and improved lubrication have been developed to cure the problems.

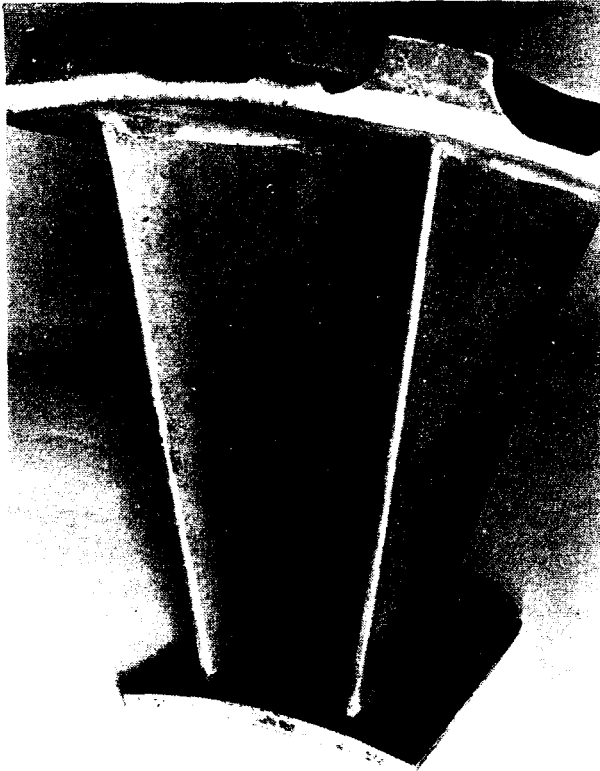
FIG. 7—TYNE INLET GUIDE VANE: CRACKING

Stator blading at the compressor inlet and outlet of the Tyne has experienced life-limiting defects. The hollow inlet guide vanes (IGVs) develop cracks along their length, shown in FIG. 7. This has been cured by the insertion of a dampening wire inside the leading edge and by exterior glass bead peening. More dramatic is the severe fretting of outlet guide vane (OGV) locating platforms illustrated in FIG. 8, which could eventually lead to detachment and secondary damage. This is caused by flow disturbance created upstream by the intermediate casing support struts very close to the OGVs. An interim modification to dampen the OGV root platforms by injection of Silkoset compound between the roots and the stator is proving successful. A more fundamental modification that removes the excitation by cutting back the struts is now being developed.

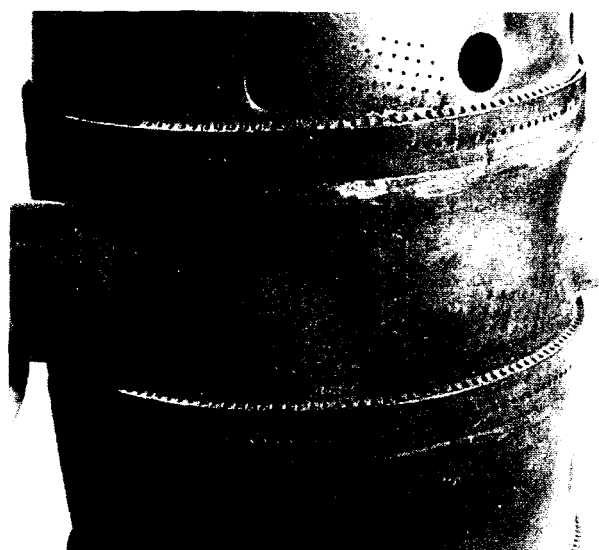
FIG. 9—TYNE C263 COMBUSTION CAN: CRACKING

The higher temperatures experienced in the RMIC Tyne have produced new problems in the combustor flame tubes and HP nozzle guide vanes. Flame tube distortion is being experienced in the standard Nimonic 75 material, which the stronger C263 being evaluated as an alternative has failed to cure, as shown in FIG. 9. Nimonic 86 and thermal barrier coatings are proving likely solutions. HP nozzle guide vanes, made in cast X40 cobalt alloy,
