FLEET EXPERIENCE WITH VA TECHNIQUES

LIEUTENANT B. W. BRAZIER, C.ENG., M.I.MAR.E., R.N.

The Fleet Vibration Analysis Unit (FVAU)

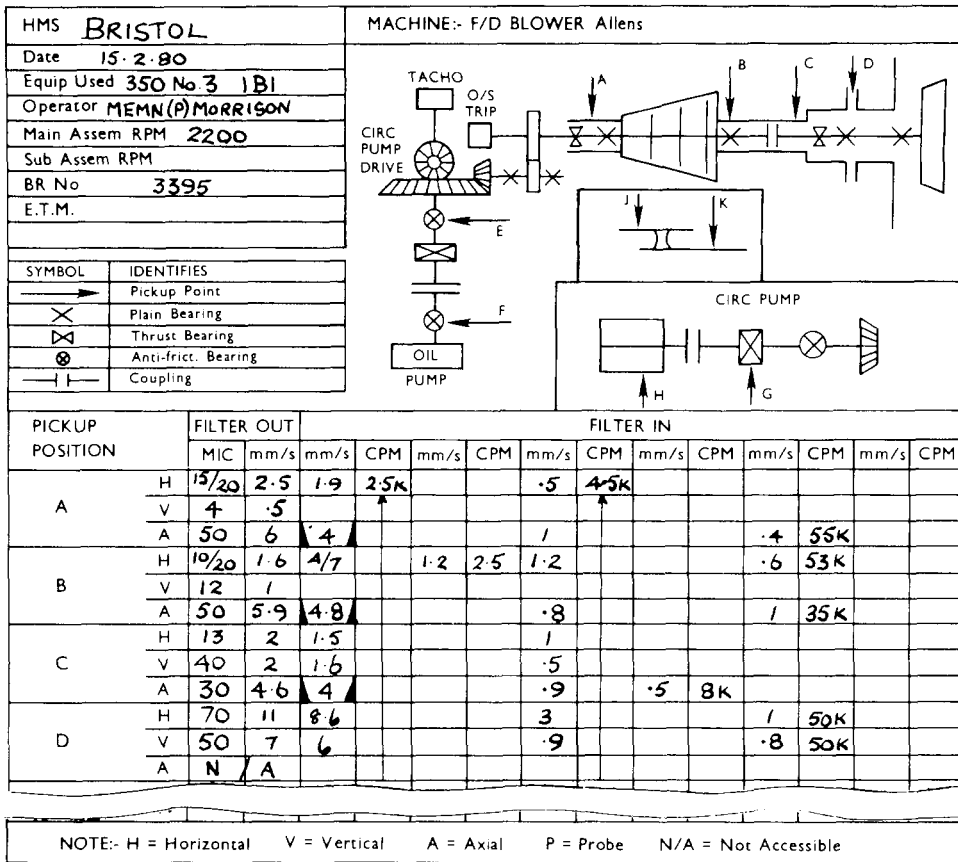
FIG. 3 shows a data sheet from an actual survey carried out on a forced-draught blower in H.M.S. *Bristol*. The high axial readings recorded at a frequency of 2.5k were thought to be caused by misalignment. This conclusion was reached because:

- (a) in the vast majority of cases where high axial vibrations are experienced, the cause is misalignment;
- (b) it was well known that the turbine rotor had been renewed and a new epicyclic gearbox had been fitted after finding that the locating pin in the old one had cracked its mounting plate.

Although it was realized that high axial readings can be caused by unbalance particularly with overhung rotors, it is good practice to check alignment first. As a result of this survey, the alignment of the turbine to the impeller shaft was checked and found to be satisfactory.

A further vibration analysis survey was then carried out producing similar high axial readings. Although the diagnosis still indicated that the blower was suffering from misalignment, the fact that the readings were higher at the blower end increased the possibility that the impeller was bent or out of balance. This had not been considered previously because the impeller was known to be in a good state before the turbine and gearbox change and had not been disturbed. The end of the story was that a foreign bolt was found to be embedded in dirt in the impeller inner annulus. The result of the vibration analysis survey after the removal of the bolt is shown in FIG. 4.

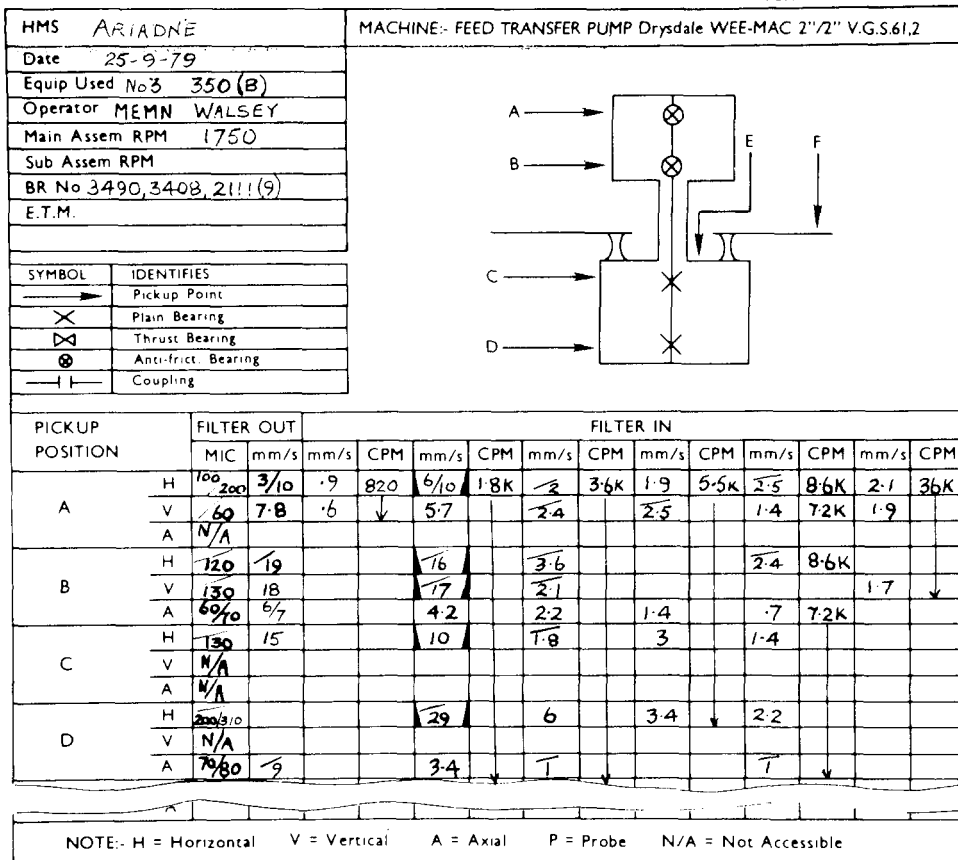
FIG. 5 shows many high radial readings recorded throughout the feed transfer pump during the pre-refit survey of H.M.S. *Ariadne*. As a result, the ship was recommended at the first opportunity to:

When the machine was opened, the pump shaft was found to be very worn but the motor was in good condition despite the high readings at points A and B. The analyst had been proved correct in deciding that these high vibration levels were transmitted from the defective pump. This is very common in centre-mounted vertical pumps of this type. FIG. 6 shows the survey readings after repair.

- (a) check the security and condition of the impeller;
- (b) check the top bearing bush and lantern ring for damage and wear;
- (c) check the pump shaft for damage and wear;
- (d) rebalance the motor and pump.
