MARINE GEARBOX EXPLOSIONS

A REVIEW

COMMANDER M. D. COOPER, C.ENG., F.I.MAR.E., R.N.
(*Ship Department*)

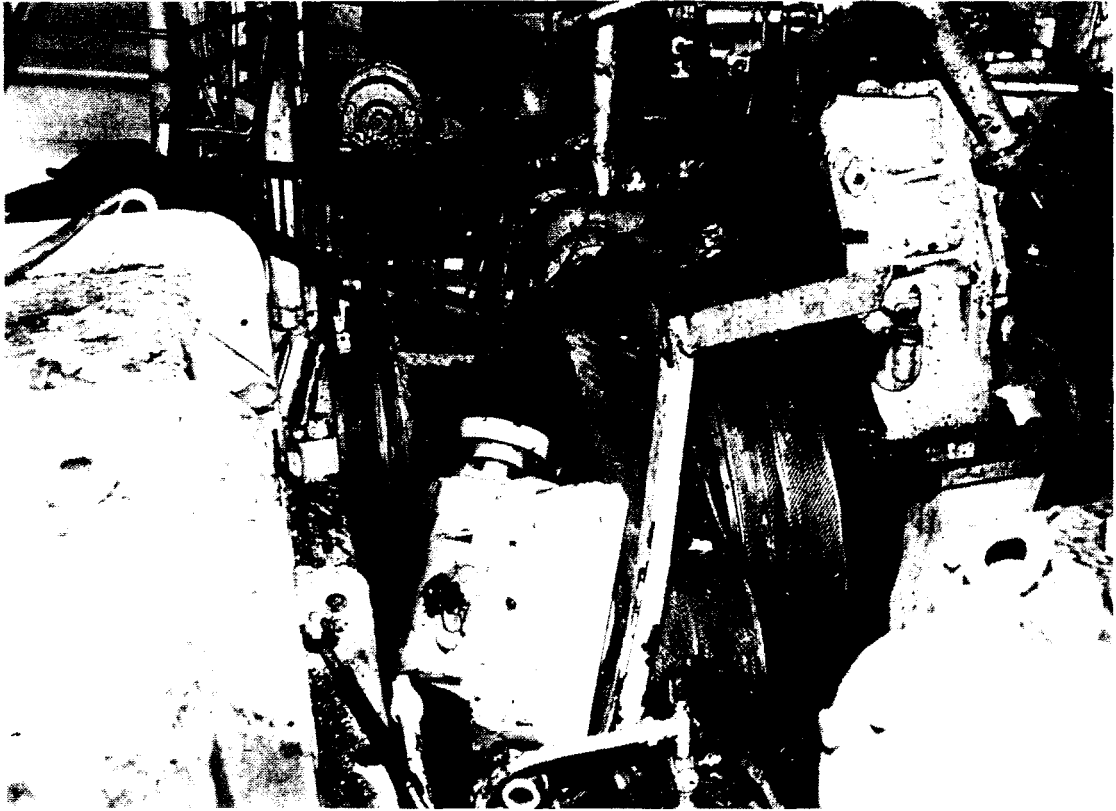
FIG. 1—'SEATRIN NEW YORK' GEARBOX

5	S.S. <i>Seatrain New York</i>	The owners supplied MOD(N) with reports and excellent pictures of this dramatic incident where a pinion came to rest beside a boiler. The watchkeepers noted a reduction in revs and a slight rumble prior to violent explosion followed by fire. The cause was either a coupling bolt failure or a gear rim may have come off its spider.
6	H.M.S. <i>Hampshire</i>	During sea trials following a refit a changeover was being made from gas turbine to steam turbine drive. This drill involves closing one oil supply valve for the fluid couplings associated with each gas turbine, i.e. four valves in all. By mischance, the padlock key for one of the fluid coupling supply valves fitted

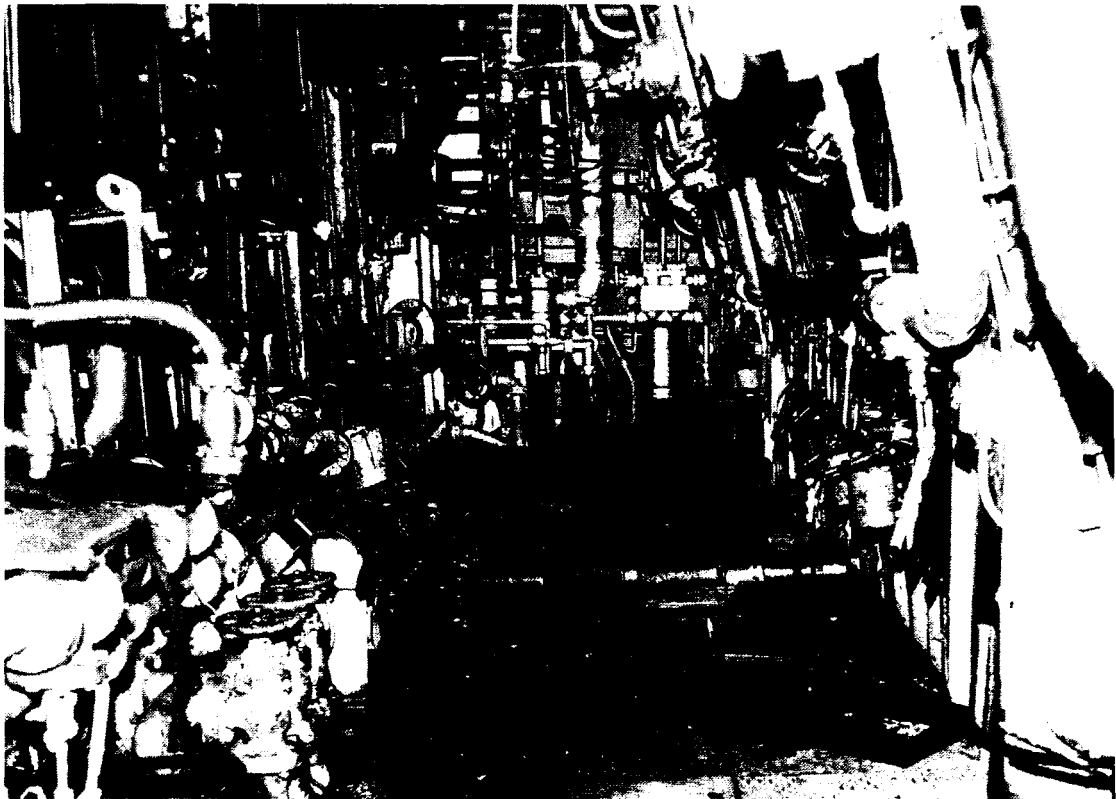
FIG. 2—'SEATRIN NEW YORK' FIREROOM

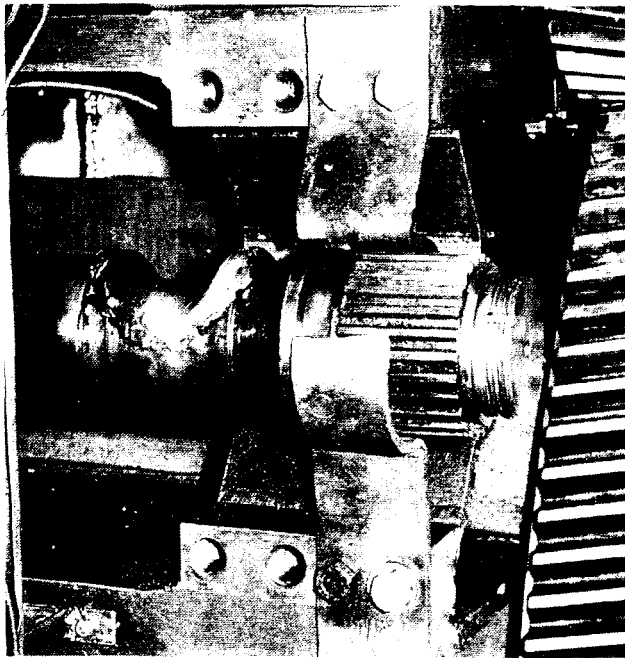
FIG. 3a—H.M.S. 'ZULU' JACKSHAFT BEARING JOURNAL

A better documented example of oil ignition contained within the gearcase is that in H.M.S. *Zulu* (FIG. 3) when a lightly-loaded steam-turbine jackshaft bearing failed. Popping noises and discharge of smoke through joints were reported, followed several minutes later by a heavy grinding noise. 'Flashing' or 'sparking' at some distance away from the bearing in distress, visible through clutch inspection sight ports, was also reported.

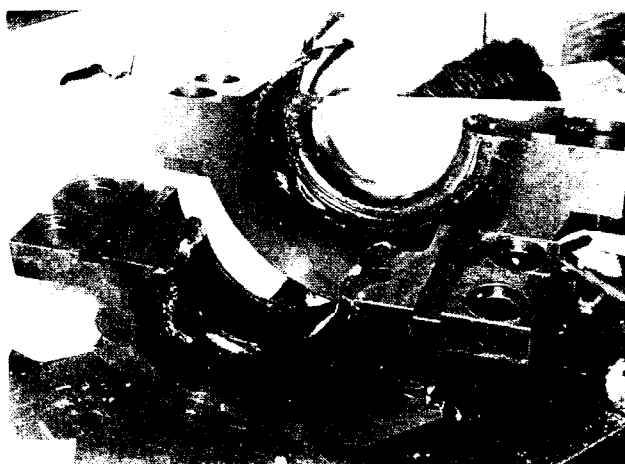
FIG. 3b—H.M.S. 'ZULU' JACKSHAFT BEARING HOUSING
