# NOTES FROM SEA

## RUDDER REPLACEMENT AFLOAT

## IRON-IN-STEAM FIRE

## **Y.100 MAIN TURBINE ROTOR JOURNAL DAMAGE**

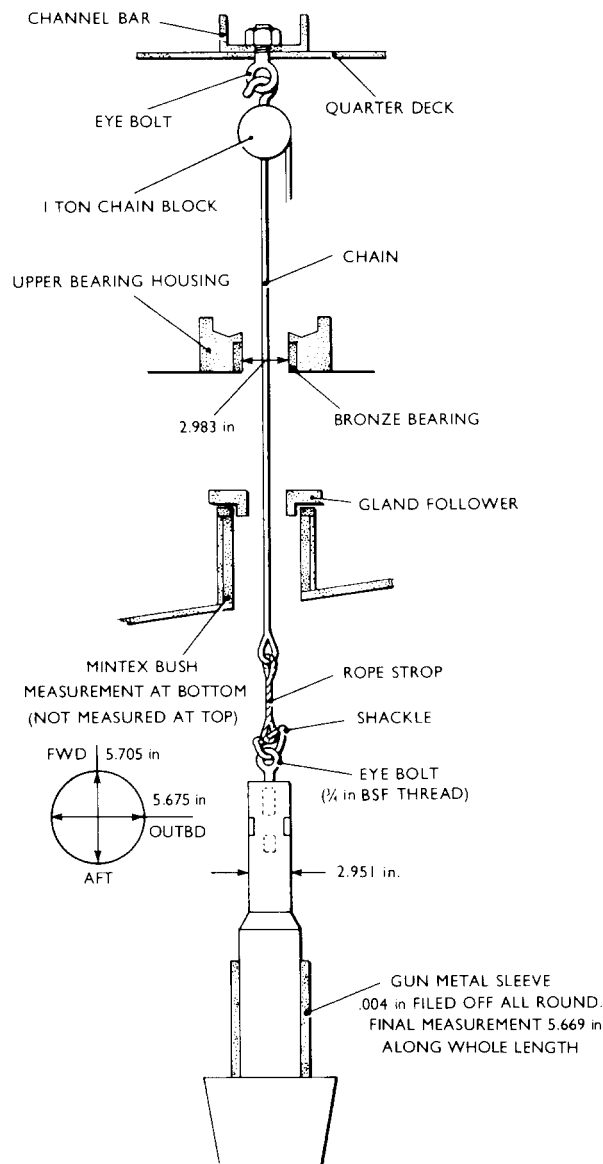
The new rudder was conveyed from Wales by a Type 42 destroyer and finally arrived underslung from a Lynx helicopter. After unpacking and measuring the new rudder, a hole was drilled in the top of the stock (using an industrial heavy-duty electric drill) and tapped to take a  $\frac{3}{4}$ -inch BSW eye-bolt.

The upper keyway in the new rudder was found to be only roughly machined. This was faired with a hammer and chisel and finish with a scraper and fine file. Also two new keyways were manufactured using the base's lathe.
