FAILURE MECHANISM FOR WHITE METAL BEARINGS

R. D. BARER, B.A.Sc., M.S.

(Defence Research Establishment, Pacific)
(Victoria, B.C.)

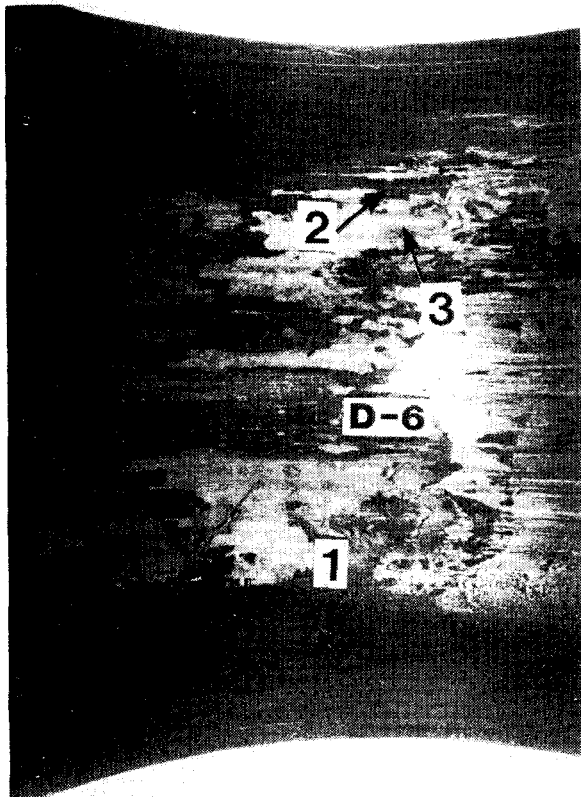
FIG. 2—WIPED BEARING D6
 Arrow 1—Non-wiped but stained area
 Arrow 2—Black oxide area
 Arrow 3—Light greyish area from which
 black oxide scale has been lifted

On examination when the gearing was opened up, it was found that the D6 bearing was wiped, FIG. 2, and that some of the smeared-off babbit metal had accumulated in the recessed area. It was also found that the secondary pinion forward bearing (C6) was wiped in similar fashion.

0.001 inches depth. Chemical analysis confirmed that the black areas were tin oxide. Incidentally, tin oxide is known to be hard and abrasive, and some light scoring of the journals at C6 and D6 confirmed this. It was noted that in the area of the wipe there were dark areas (arrow 2) and lighter areas (arrow 3). The dark areas, practically black, had some tendency to blister slightly and a thin black scale could also be lifted off with a knife blade, leaving the lighter area (arrow 3). Samples of the thin black scale and the lighter area (of arrow 3) were mounted and examined under a microscope. FIG. 4 shows the microstructure of the black scale which is almost wholly tin oxide and has a thickness of 0.002 inches. FIG. 5 shows the microstructure of the lighter area, and it may be noted that it has some oxide in it, possibly 5 per cent. One might have expected this area (once the black scale is removed) to be reasonably good bearing metal, even if melted and solidified again. Close examination of bearing C6 which had wiped at some earlier period showed a small worn area (FIG. 6, arrow 4) where the babbitt metal was tending to break-up by fatigue. This finding suggests that babbitt from beneath the black scale may not be suitable for continued service probably because the oxide and dross weaken the babbitt. The bearing should be re-metalled or replaced.

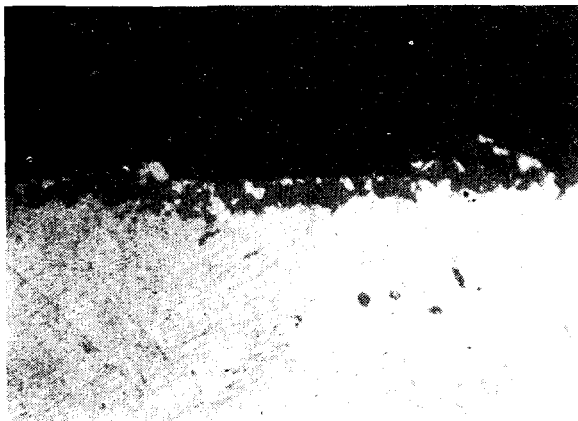
FIG. 3—MICROSTRUCTURE OF AREA INDICATED
 BY ARROW 1 IN FIG. 1.
 DEPTH OF OXIDE APPROX. 0.0007 IN.

All metal surfaces in the gear box had a brownish stain, presumably dating back to the period when the EP oil (3 GP 358) was used. Analysis of the brown stain removed from the steel bearing shell showed it to be hydrated iron oxide. An area of the stain on the babbit surface was examined under the microscope. The structure shown in FIG. 3 indicates a corrosive attack on the babbit to about

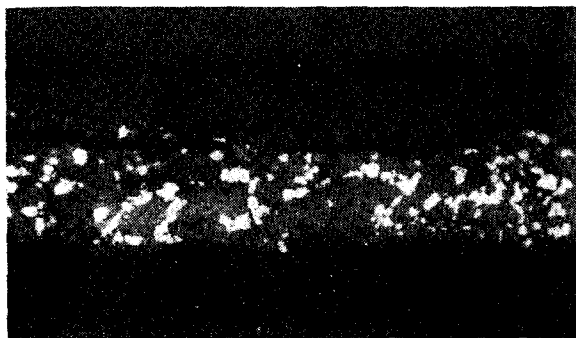
FIG. 4—MICROSTRUCTURE OF BLACK SCALE SHOWN BY ARROW 2 IN FIG. 1. TIN OXIDE LAYER IS APPROX. 0.002 IN. THICK

- (d) this clearance and temperature rise must be a borderline situation because most bearings seem to have survived;
 - (e) however, for bearing C6 and D6 the temperature rise was sufficient to cause further reaction with the babbitt producing additional thickness of tin oxide (shown in FIG. 4);

- (f) the expansion resulting from the additional tin oxide would further restrict the clearance, leading to further temperature increase;
 - (g) it is suspected that a slight expansion of the journal also contributes to a reduced clearance when running hot;

Based on the above sequence, this unit recommended that suitable clearances had to be ensured for continued service reliability. Stained bearings of adequate clearance were not a problem.

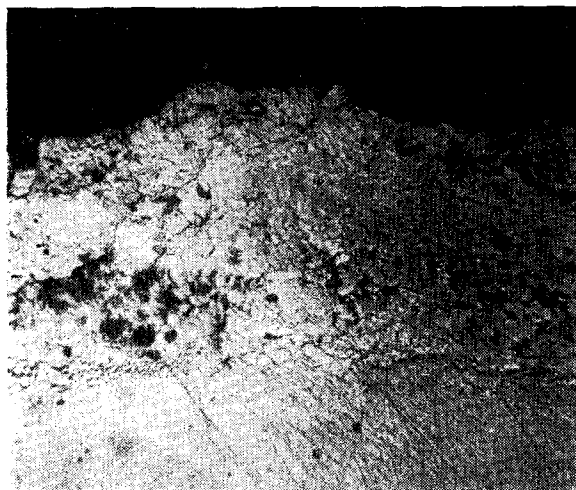
FIG. 5—MICROSTRUCTURE OF AREA UNDER BLACK SCALE SHOWN BY ARROW 3 IN FIG. 1

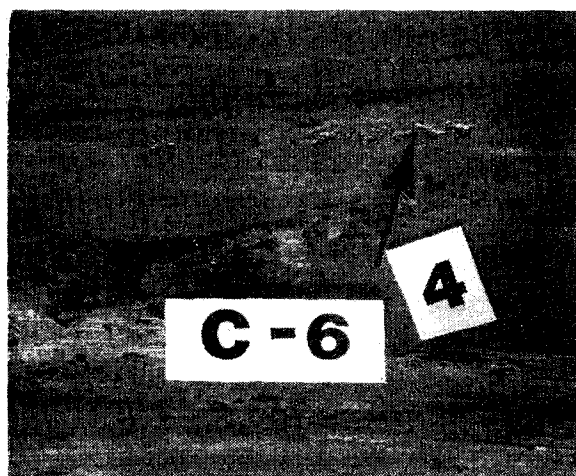
FIG. 6—PORTION OF WIPED BEARING C6 SHOWING SOME BREAK-UP BY FATIGUE

- (j) with continued service of the damaged bearing, the partly weakened lighter area (of arrow 3) where it experiences bearing wear tends to break-up by fatigue (as in FIG. 6).
