CORROSION ENGINEERING

THE WEAK SPOT?

J. CHAMBERLAIN, AND B. E. PROTHEROE

(*R.N.E.C., Manadon*)

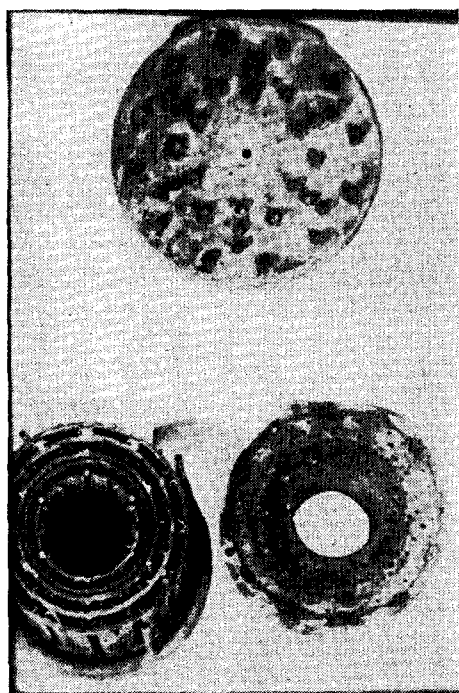
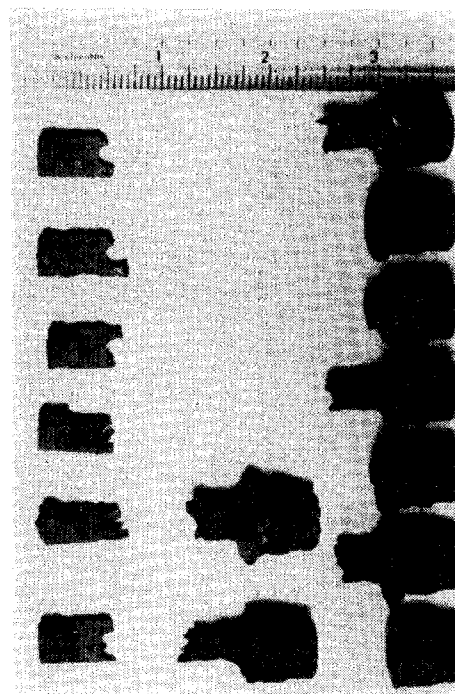
However, the mistakes made in 1763 still occur in modern engineering practice. In the sea-water-cooled evaporator of a modern ship, the copper-based end fittings were secured with steel bolts. FIGS. 1 and 2 show the end fitting and the remains of the bolts.

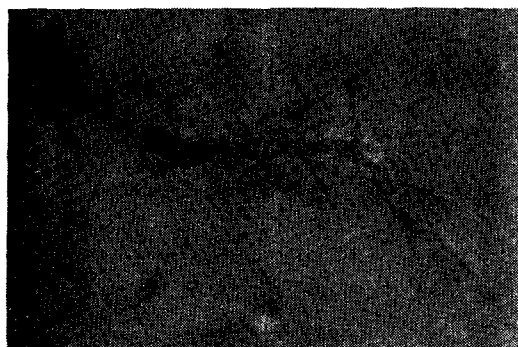
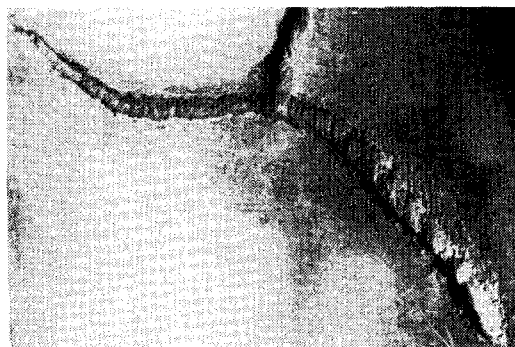
Similarly, when the propeller shafts of H.M.S. *Ark Royal* were removed during a major refit, it was found that residual casting porosity had developed into a crack in the copper-based liner on one of the steel shafts. Sea-water had entered the crack and a corrosion trough, corresponding to the shape of the crack, had penetrated up to an eighth of the way through the wall of the shaft (FIGS. 3 and 4).

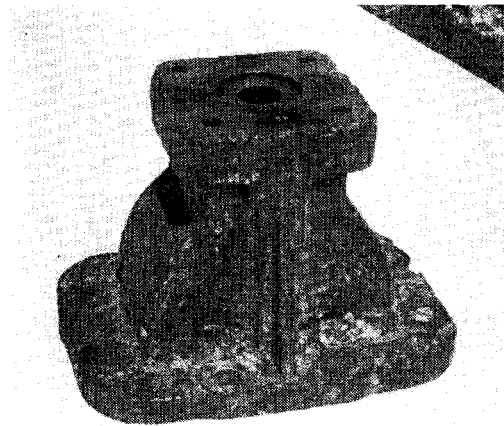
FIG. 6

An example of designed galvanic corrosion is shown by the oil valve (FIG. 6). The aluminium-alloy casing has bronze inserts to take the spindle and the securing bolts for the valve cover. Although this arrangement appears to be most unsatisfactory, no corrosion has occurred at this point as only three parts of the cell are present—the gasket and valve cover effectively preventing the electrolyte reaching the metals. At the flange, however, where brass bolts secured the two halves of the valve, the free access of sea-water completed the cell causing severe galvanic corrosion of the aluminium.

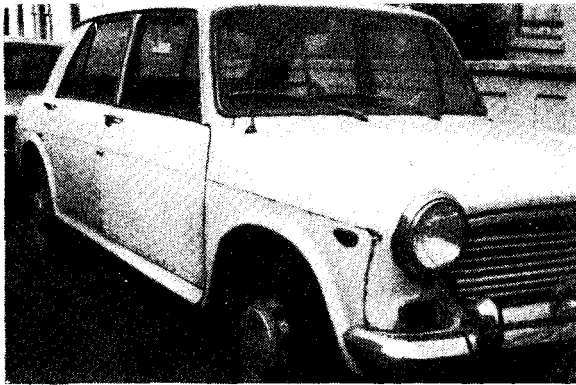
This type of corrosion is prominent on the bodywork of modern cars. The vehicle shown in FIG. 8 exhibits corrosion at crevices in the spot-welded seams, in the bottom of the doors where the outer and inner panels overlap, and behind the headlights. (The use of this illustration does not imply that the make of vehicle shown is worse or better than others in this respect; the problem is common to all makes of car.)

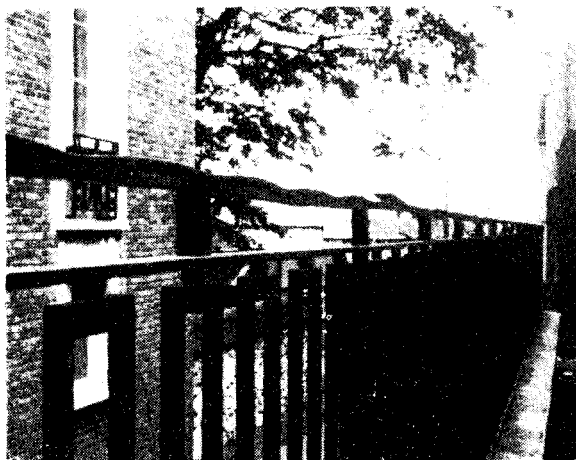
FIG. 9

The loss of metal due to corrosion is not the only problem that occurs in the crevice cell: the corrosion products are often voluminous and in the restricted region of the crevice produce stresses of sufficient magnitude to cause plastic deformation of the surrounding structure. The amount of plastic deformation that can occur is clearly shown in FIG. 9, where the top section of a riveted railing has been deformed between the rivets by the cell that developed between the two sections of the railings.

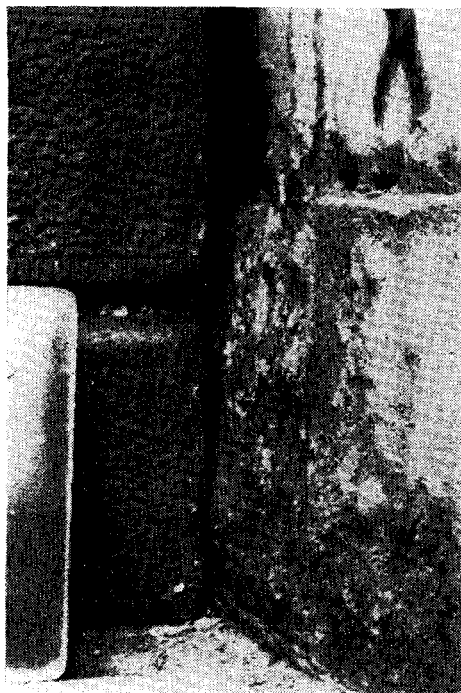
FIG. 11

Many otherwise excellent designs are ruined by a lack of access to maintain the completed structure, the maintenance staff being presented with situations where repairs, repainting, or even inspection could only be carried out by 'freaks'. Such a problem is posed by the buttress of the railway bridge (FIG. 11). It is difficult to see behind the buttress and even more difficult to carry out preventive maintenance. The extensive corrosion that has occurred in the steel beam and plate is clearly seen; what has occurred behind the buttress . . . ?

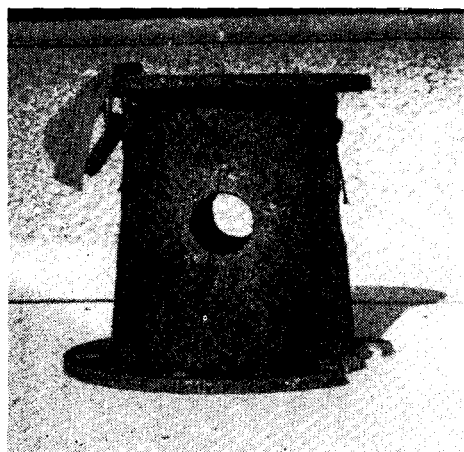
FIG. 14

A final pitfall for designers is the lack of compatibility between the roles of different parts of a completed installation, especially where different design offices are involved. Often little thought seems to be given to the hazards presented by the functions of adjacent units which are entirely satisfactory as separate entities. The aluminium aerial-support (FIG. 14) was quite adequate for the designed task, until it was placed just behind the funnel of a ship; here, acid products from burnt fuel oil removed the paint, whilst carbon deposits from 'black smoke' coated it with an effective cathode. Corrosion soon rendered the assembly unsafe.

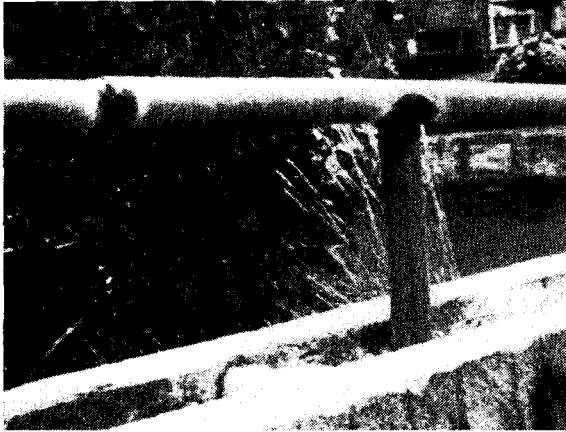
FIG. 15

An elementary example of this occurred on the welded railing surrounding a coastal car park (FIG. 15). Although the designer has selected galvanized-steel tube for the construction, which would be expected to give a maintenance-free life of about fifteen years, the welding has burnt off the zinc finish leaving unprotected areas. The lack of post-weld protection has resulted in sacrificial corrosion of the zinc on the adjacent pipe, steadily removing the zinc from the whole railing.

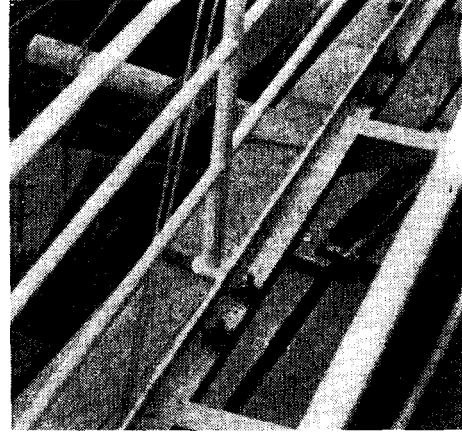
FIG. 16

A similar course of events has occurred on the gantry shown in FIG. 16; severe rusting ensued when post-weld protection was omitted around studs welded to the painted gantry.

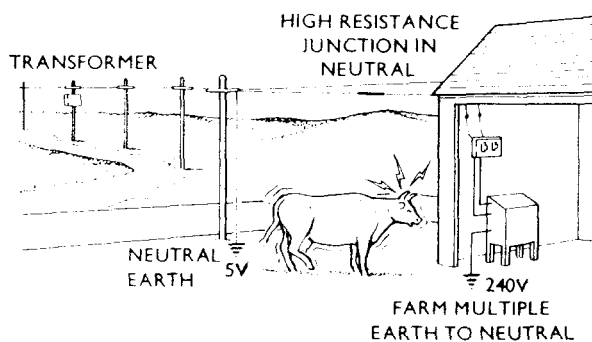
FIG. 17

it was found that the fault lay in an overhead power line feeding the farm (2). The system is sketched in FIG. 17. The power to the farm was drawn from a transformer some distance away, but the neutral line was earthed at a pole adjacent to the farmyard. The aluminium neutral power cable was joined to the farm's copper cables at a point between the buildings and the earthed pole. (The use of such bimetallic connections in the open is contrary to SWEB codes of practice.) Despite the grease packing and wrappings to protect the joint, corrosion occurred; this increased the resistance of the line until it became easier for the return to be made via the multiple earth on the farm equipment and the earth on the pole. A potential drop of some 240 volts was set up across the farmyard. Cows easily detected the small potential difference

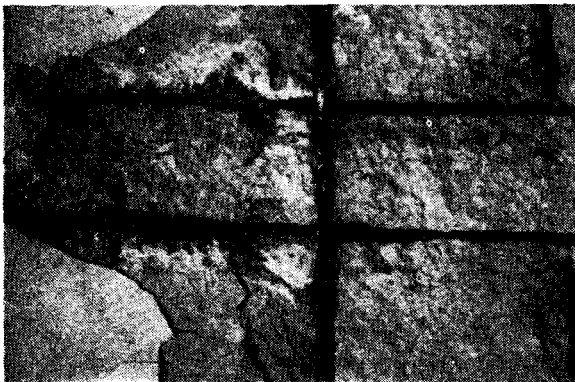
The construction industry, in which most of the erection occurs in the open, presents many corrosion hazards. Prominent among the problems is the spalling of concrete due to rusting of reinforcing wires. The initial highly-alkaline conditions in the concrete are to some extent self-inhibiting, but as reaction with atmospheric carbon dioxide proceeds the alkalinity falls, and corrosion ensues. The corrosion products generate tensile stresses in the concrete which lead to cracking or even spalling. FIG. 18 illustrates the spalling of reinforced concrete on a jetty in Bermuda. The problem is overcome by ensuring that there is an adequate thickness of dense concrete overlying the reinforcing wire, or by using galvanized wire (FIG. 19), or polymer impregnated concrete.

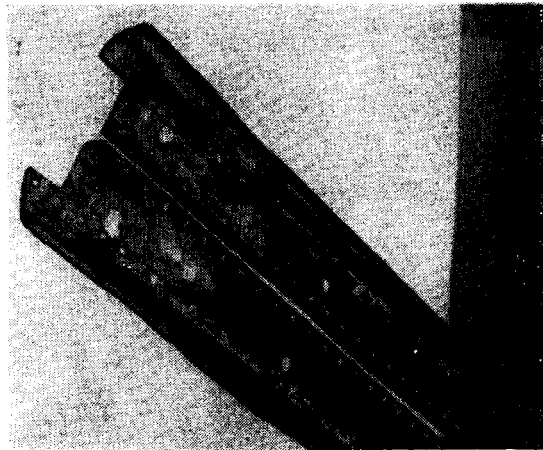
FIG. 20 shows a section taken from a helicopter which received no maintenance while being transported for four days on the open deck of a ship. Severe corrosion has occurred where steel bolts pass through the magnesium-alloy sections, rendering the aircraft unflyable.
