R.M.N. COASTAL MINESWEEPERS EXTENSION OF LIFE

LIEUTENANT B. E. FARROW, R.N., C.ENG., M.R.I.N.A.

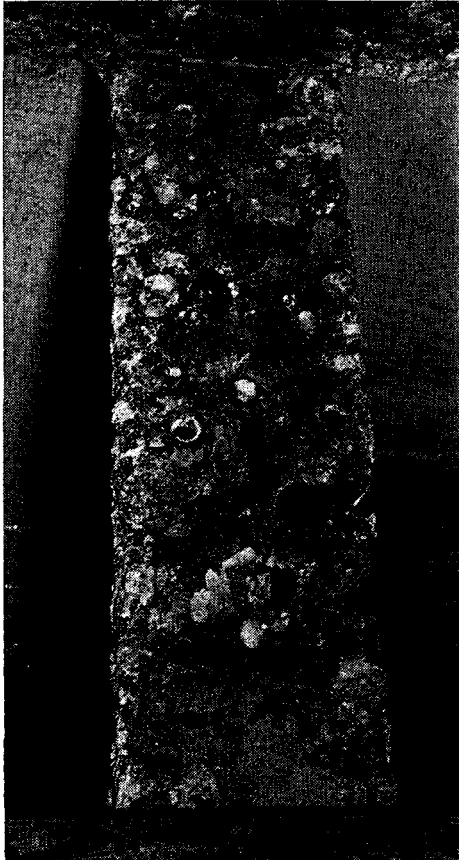
FIG. 2—TYPICAL CONDITION OF FRAME LINER

The frame itself is generally in good condition but the majority of liners have been renewed; in this case very little of the $\frac{1}{4}$ -in. plate remains.

To combat the corrosion that has taken place generally, all exposed aluminium soleplates, stringer plates and frame liners that have been renewed are coated with epoxy resin (Araldite) providing an electrically inert barrier that protects the material from further corrosion far more efficiently than any conventional paint or preservative coating.

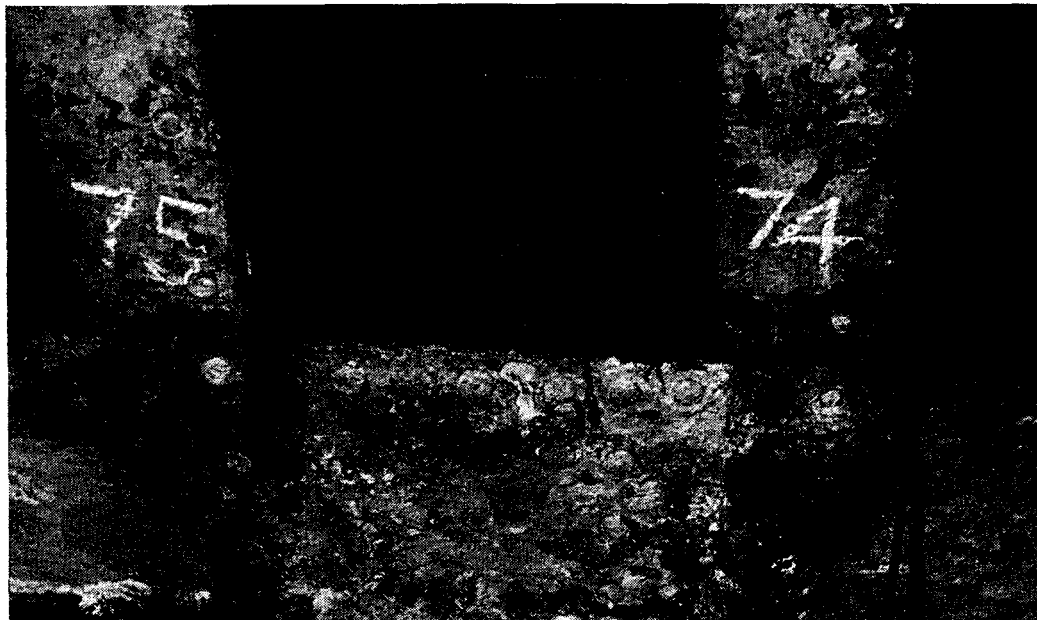
- (c) Rivets have also been very badly attacked and in most cases have been reduced to solid lumps of HAO. FIGS. 4 and 5 give some idea of the consistency of this defect. The reason for this is that Grade 6 rivets were coupled with Grade 6 plating when the ship was first built. No consideration was given to the work hardness that would occur on the rivet during the hardening up process. Changing the material state of the rivets gave in effect a combination of dissimilar materials. Even though they were both aluminium, an electrical potential difference existed between them and when immersed in sea-water produced active corrosion cells. The rivets being the anodic material in the combination became sacrificial and were corroded away.

FIG. 4—DOUBLER BUTTSTRAP

Completely corroded away together with the associated rivets.

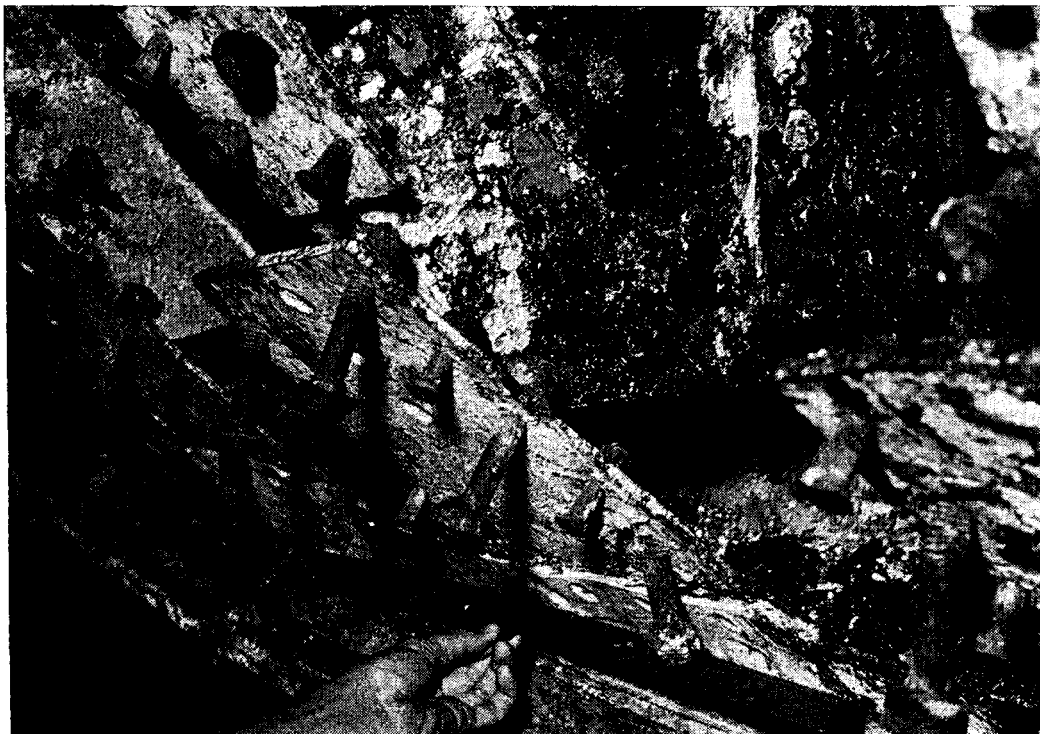
The bulky corrosion products have caused an enormous amount of damage to adjacent structure. FIG. 6 shows the distortion that has occurred at the keel plate angle. Far more serious consequences between the keelpate and keel can be seen in FIG. 7; these have been forced apart by a deposit approximately three inches thick. As the lower palms of the 'A' brackets are secured at this point, the mystery of the serious shaft misalignments which have occurred frequently over recent years is solved.

FIG. 6—SECTION OF KEEL ANGLE
Distortion due to build-up of HAO between aluminium and hull planking.

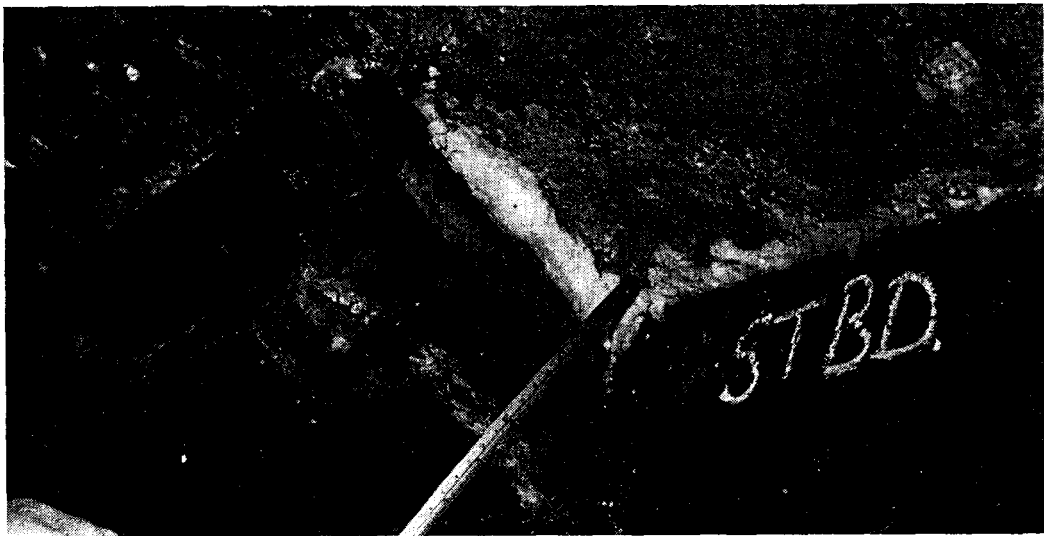
Similar damage has also occurred to the hull planking for the same reasons. FIG. 8 illustrates how the timber has been forced away from the stringer plate and frame liner, etc. resulting in the fastenings being pulled through the timber. Although the physical condition of the timber is good, in the majority of cases the damage is so bad that renewal is the only solution. When complete, approximately 80 per cent. of the planking below the waterline will have been replaced.

FIG. 8—SECTION OF GARBOARD STRAKE
HAO deposits are forcing it away from the keel-plate and pulling the securing bolts through.
