PAPER OF TRANSACTIONS NO. CLXXI

## Notes on Salving a Gold Dredge,

BY MR. F. G. BUTT (MEMBER).

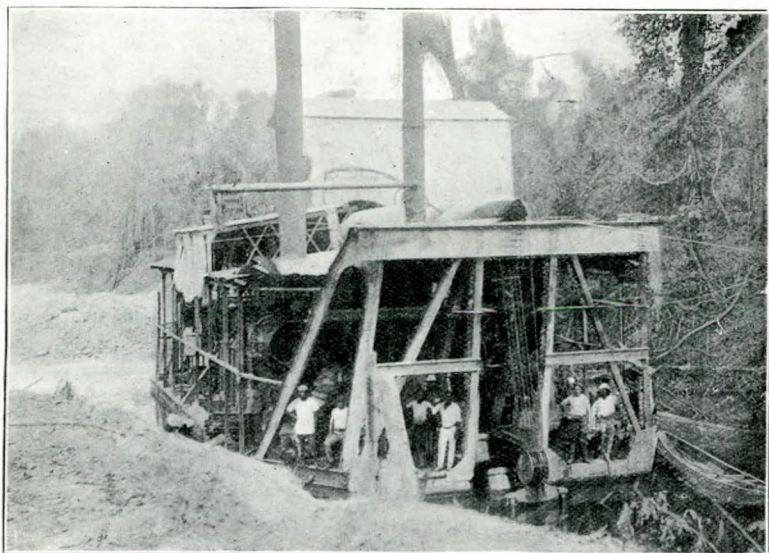
FIG. 1.

stout tree. And then all available hands were put on, and the wire set up as tight as possible. Another wire was passed round the elevator ladder and set up with a pair of 5 ton chain blocks, and a set of  $2\frac{1}{2}$  in. rope treble purchase blocks made fast to the derrick forward which is shown on the photograph. When we had got all these up we felt fairly sure that the dredge would not capsize, as by this time we were on the bottom on the starboard side.
