THE BLACKENING OF WHITE METAL BEARINGS

J. J. DUNFORD, B.Sc., R.C.N.C.
(*Ship Department*)

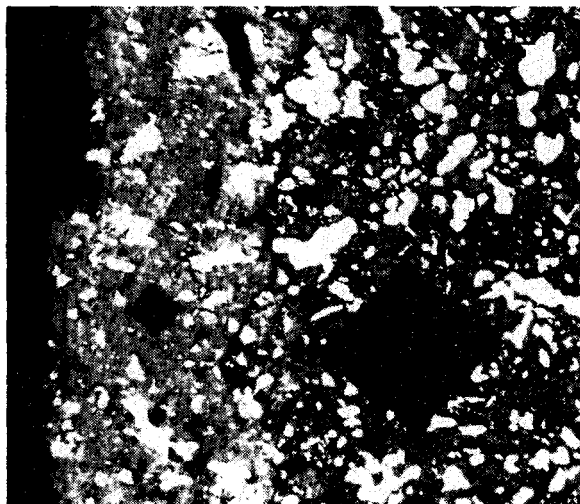
FIG. 2—SECTION THROUGH CORRODED SURFACE ($\times 200$)

A journal bearing severely corroded in this manner is shown in FIG. 1. A magnified view of a cross section through an undisturbed region of corrosion is shown in FIG. 2. These photographs reveal many of the features of this type of attack and the cross section in particular warrants detailed attention. The photograph can be divided into three regions: the dark strip on the left which is the background; the lighter corroded layer extending for about 20 mm, and the rest of the picture to the right which shows the structure of the unaffected white metal. The difference in hardness of the two regions can be judged from the size of the diamond indentations made by the microhardness tests.

The major constituent of white metal is tin, which forms the dark background in the right-hand section. The tin is strengthened by two main alloying elements, antimony (Sb) and copper, (Cu) which combine together to form the intermetallic compounds (SbSn) and (Cu_6Sn_5) which show up as white spots. It can be seen from the presence of these white spots in the corroded layer that the attack takes the form of progressive corrosion of the tin to form tin oxides leaving the intermetallic compounds unaffected.

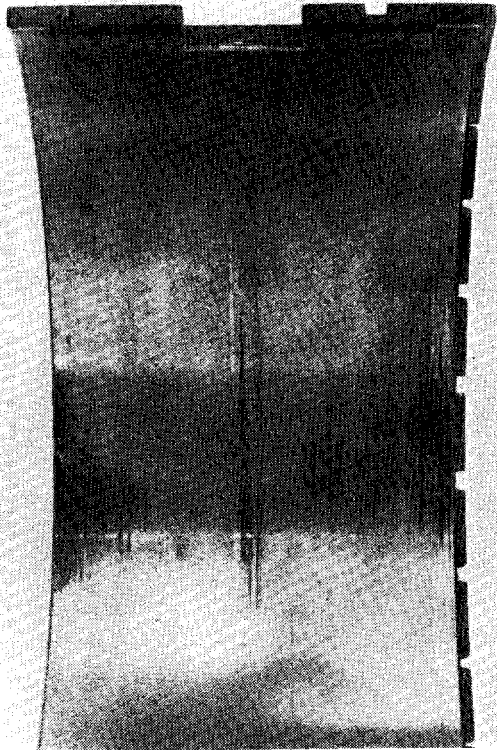
FIG. 3—LIGHT POLISHING OF LOADED REGION

The depth and appearance of the corrosion varied significantly, as can be seen from FIGS. 3–7. The first of these is not corrosion but shows the typical polishing marks where the shaft has rubbed during start-up and shut-down. FIG. 4 shows the early stages of corrosion, typical of that found in GMDs, which has caused a dulling of the surface of the bottom half of the bearing with some regions showing obvious blackening due to corrosion to a depth of about 0.001 in. The speckling at the edge of the dark region is typical, and it can be seen that the corrosion in this

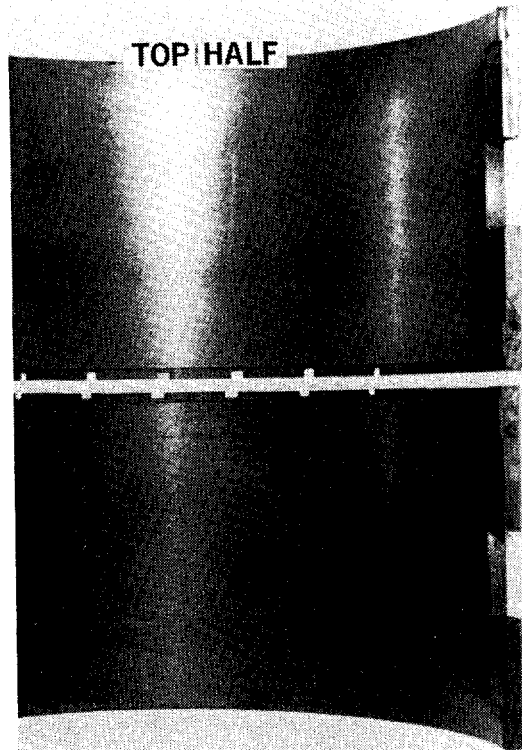
FIG. 4—EARLY STAGES OF CORROSION ON BEARING REMOVED FROM A GMD AFTER 5400 HOURS RUNNING

example is confined to the bottom half of the bearing: the top half still retaining an unmarked surface despite nearly 6000 hours in service. A more advanced stage is depicted in FIG. 5, a bearing which had been in service for less than two years. Here the corrosion has covered the entire surface of the bearing to a depth of about 0.003 in. with an even and surprisingly smooth black layer. A small square of white metal, revealed by scraping off the corrosion product, gives a good contrast. FIG. 6 shows a bearing removed from a *Leander* Class frigate. The colour of this bearing was most unusual for such an advanced state of corrosion, being a mottled light grey rather than the more common matt black. This layer was found to vary in thickness between 0.005 and 0.008 in. and another bearing from the same gearbox, in otherwise similar condition, was showing signs of flaking. FIG. 7 shows a main thrust pad on which patches of hard black tin oxide had started to form.

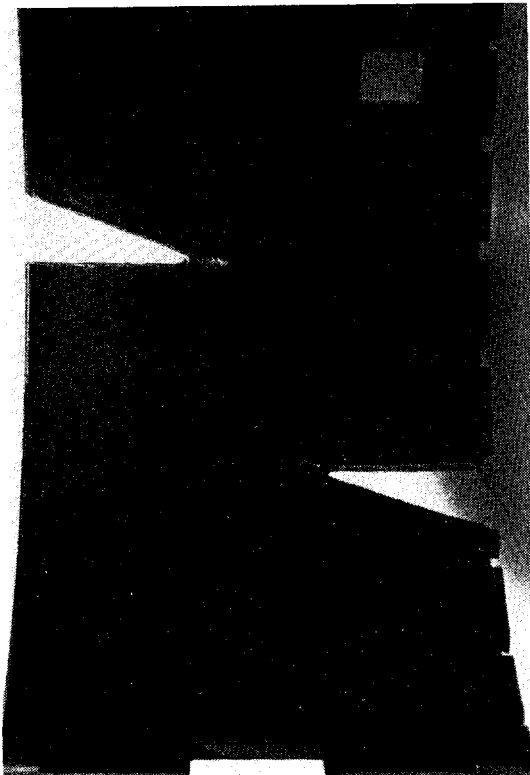
FIG. 5—TYPICAL SMOOTH BLACK SURFACE CAUSED BY CORROSION TO DEPTH OF ABOUT 0.003 INCHES

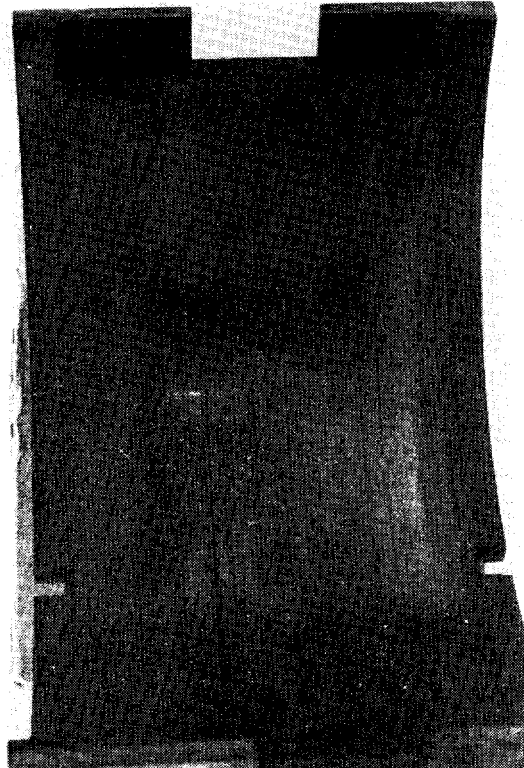
FIG. 6—LIGHTER CORROSION PRODUCTS ON A BEARING FROM A 'LEANDER' CLASS FRIGATE

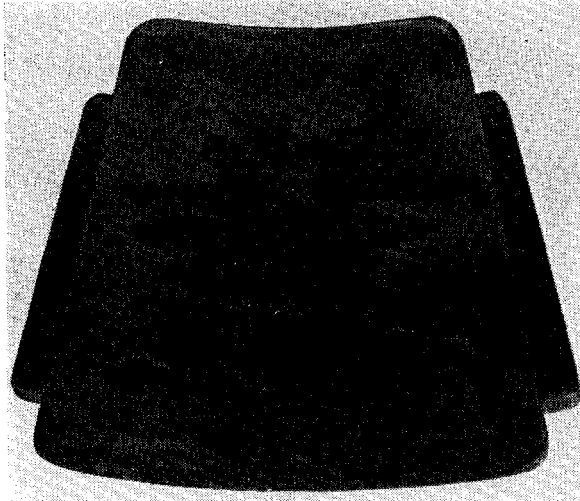
FIG. 7—PATCHY CORROSION ON MAIN THRUST PAD

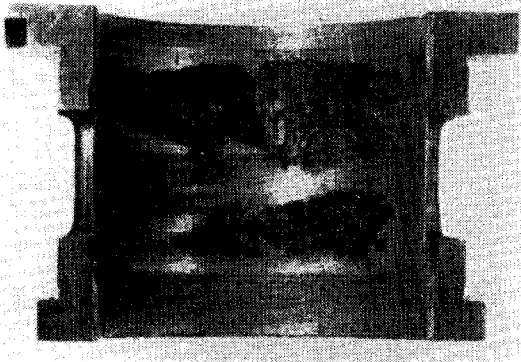
This form of corrosion has been affecting the Royal Navy since 1959 when a turbo-alternator bearing in a Type 14 frigate was found blackened after a fatigue failure (FIG. 8). After several other attacks, a D.C.I. on the subject was issued in 1963 and later revised in 1966. This revision forms the basis of the current instructions in BR3001 (Art. 1316). Although the problem continued to affect the fleet, it faded from prominence in the Ship Department and, when the two bearing failures were reported in 1975, the problem was at first thought to be a new one.

FIG. 8—BLACKENING THOUGHT TO HAVE FOLLOWED FATIGUE FAILURE—TYPE 14 TURBO ALTERNATOR 1959

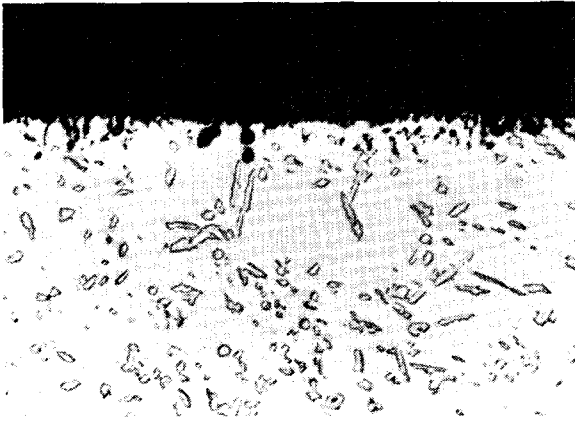
FIG. 9—PITS FORMED BY CORROSION OF HIGH-SPEED THRUST BEARING AFTER 800 HOURS ($\times 120$)

The records also revealed that corrosion had often been reported on bearings which had suffered damage through fatigue. In some cases it is clear that the corrosion has been aggravated by the conditions of high local temperature generated by the fatigue failure (FIG. 8). In other cases the order of occurrence is less clear and the possibility that the presence of a corrosion pit may reduce the fatigue resistance of the bearing cannot be ignored (FIG. 9).

The first objective of the research was to reproduce the corrosion that had been noticed on a small high-speed thrust bearing removed from H.M.S. *Bristol* (FIG. 9). The design duty of the bearing was 2.81 MN/m² (407 psi) at a mean sliding speed of 78 m/s (258 ft/s). The estimated maximum temperature on the surface of the pads was 134°C although the highest temperature in service was measured as 157°C. This discrepancy, which could be due to misalignment or to slight differences in pad height, was not thought to be remarkable by the bearing designers. The pads had run for some 800 hours in the ship at various conditions of load. A sample of oil drawn directly from the ship's system was used for the first series of runs, and the load on the test rig was adjusted to give surface temperatures equal to the maximum ship condition. The pads were inspected after just 12 hours of running and found to be already showing signs of blackening on the trailing edges (the hottest region). A photograph of the four pads is shown as FIG. 11 and contains two unused pads for comparison purposes. The test was terminated after a total of 80 hours by which time the entire surface was covered with a hard deposit.

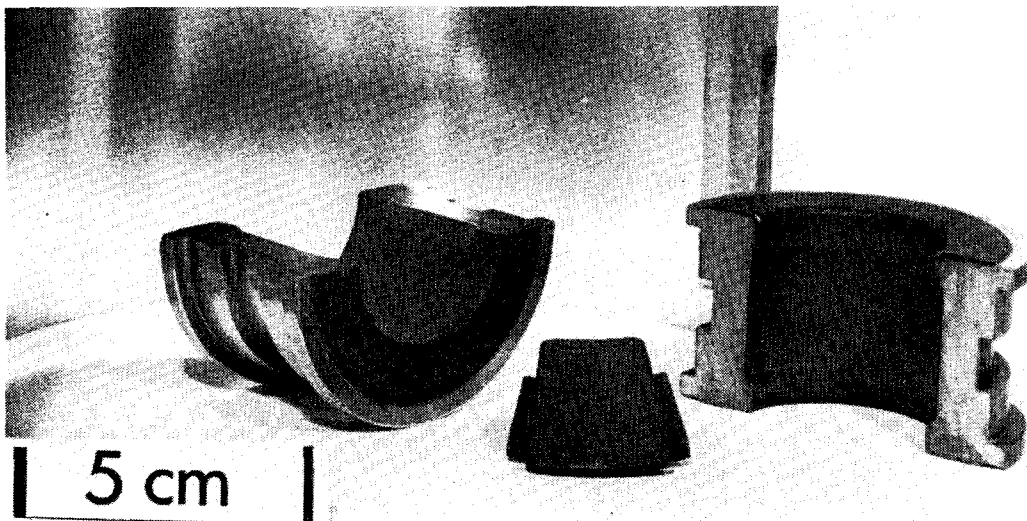
Although attention has been directed towards the main transmission system, corrosion does occur in other types of equipment. As the title of Ref. (1) suggests, main steam turbines have suffered in the past and in the course of this enquiry corrosion has also been reported in G6 gas turbines, in steam turbo alternators and in a fuel-pump gearbox. No failures have been reported in auxiliary equipments although the corrosion in the fuel pump was quite severe as can be seen from FIG. 10 where the two halves of the thick-walled brass-backed journal bearing and a small thrust pad from the pump are contrasted against an unused thin-walled gearbox bearing.

FIG. 10—CORRODED FUEL PUMP BEARING

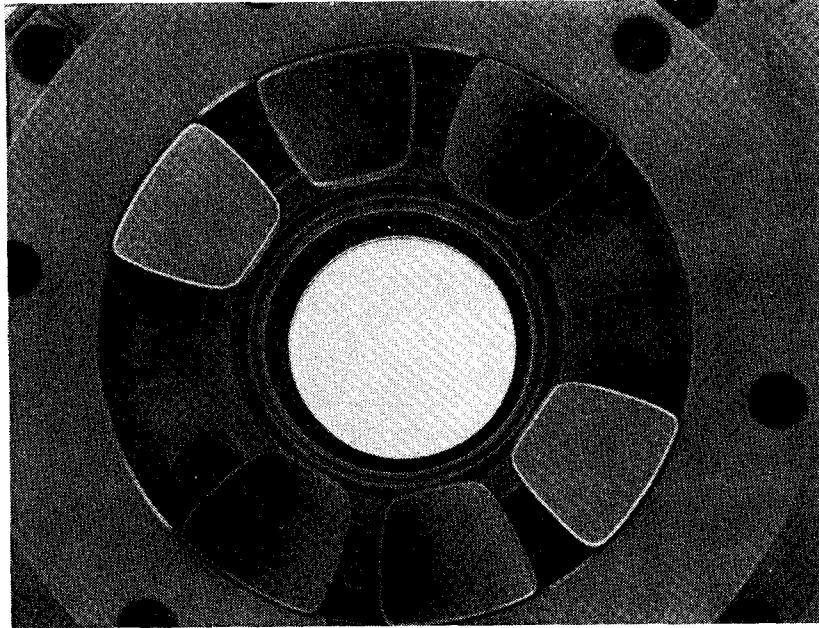
FIG. 11—ONSET OF CORROSION ON WHITE METAL TEST PADS AFTER 12 HOURS RUNNING
Reproduced by permission of the Glacier Metal Company Limited

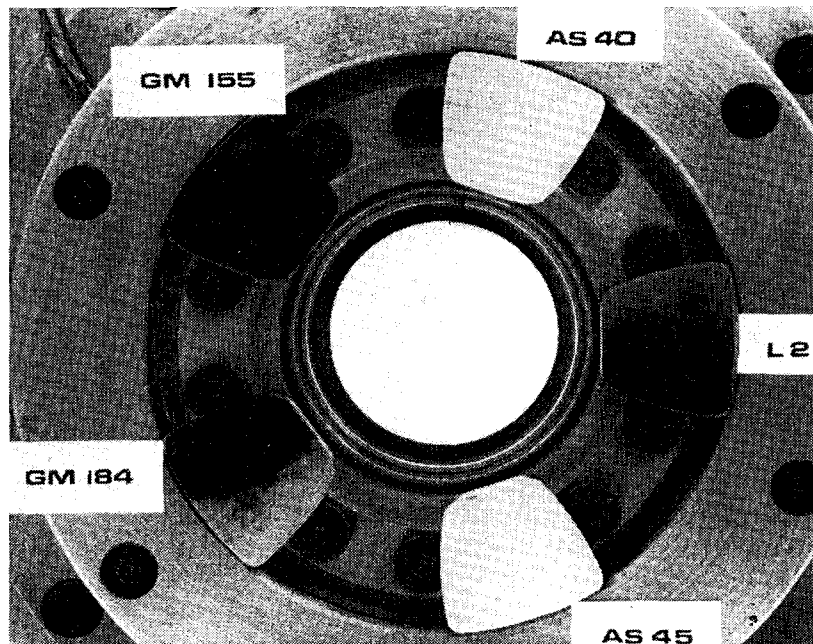
FIG. 12—CONDITION OF WHITE METAL, L2, AND OTHER BEARING ALLOYS
 AFTER 80 HOURS RUNNING
Reproduced by permission of the Glacier Metal Company Limited

The final series of tests investigated the resistance to corrosion of four other bearing alloys, two, GM155 and GM184, based on lead and two aluminium-tin alloys AS40 and AS45. As can be seen from FIG. 12, the lead-based pads suffered even worse corrosion than the normal white metal (L2) but the aluminium tin (which had been developed for high-strength applications in diesel engines) suffered no corrosion in the eighty hours run. One of the materials (AS45) is currently undergoing further trials in a service application.
