# IN SITU REPAIR OF TURBINE ROTOR THRUST-COLLARS

ENGINEER LIEUTENANT D. R. CLARK, R.N.

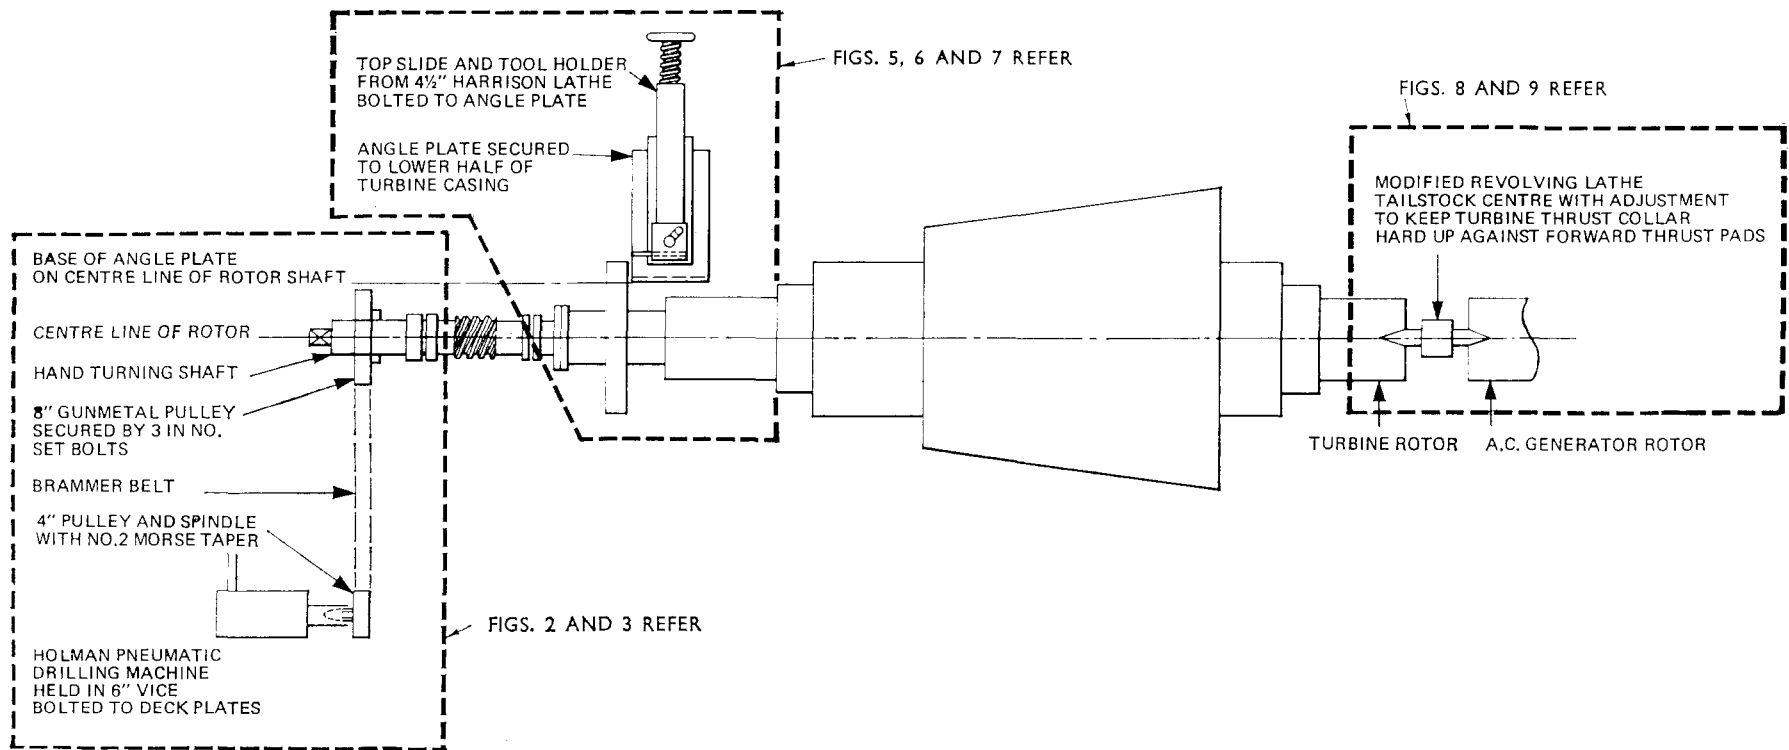
FIG. 1—LAYOUT OF TURBO GENERATOR FOR MACHINING OF THRUST-COLLAR

While carrying out routine planned maintenance in a submarine, severe scoring of the aftermost face of the thrust-collars of both turbo generator turbine rotors was discovered. The depth of scoring was estimated to be between 0.010 and 0.020 inches on the port rotor and between 0.040 and 0.060 inches on the starboard rotor.

Method (a) was discarded as requiring a docking plus a very complicated hull insert re-weld in wake of an already complicated job. Method (b) was discarded because of the added complexity. Both these methods would have been costly in time, manpower, and money; it was, therefore, decided to attempt method (c) and machine the damaged thrust-collars with the turbine rotors resting in their lower-half journal bearings.

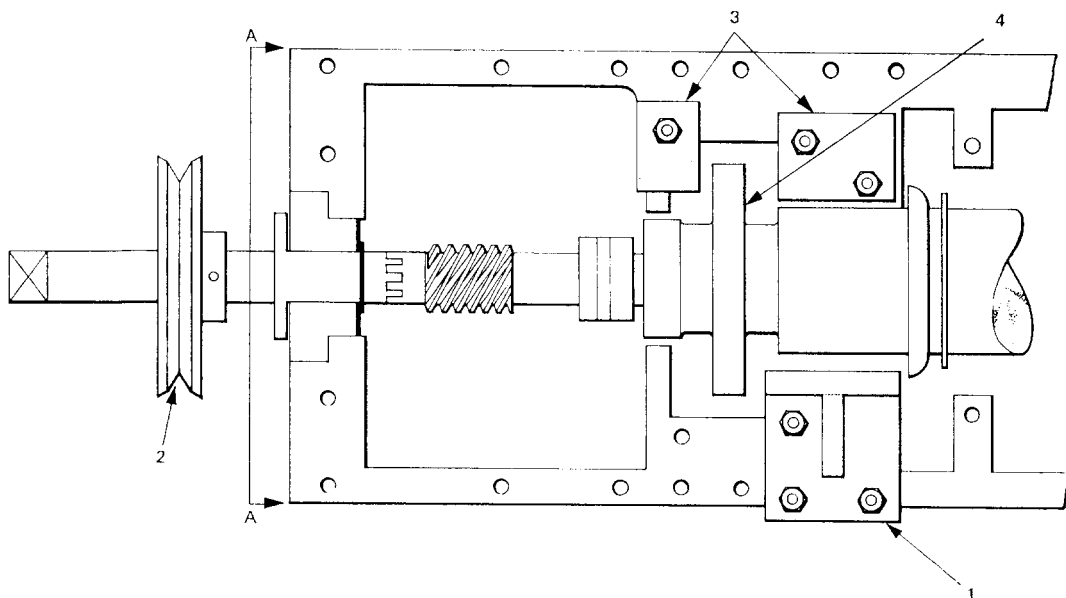
FIG. 4—PLAN OF ROTOR SHAFT AND BEARING HOUSING

- (1) BRACKET TO CARRY LATHE TOP-SLIDE
- (2) PULLY SECURED TO SHAFT
- (3) PLATES PREVENTING ROTATION OF BEARING AND THRUST-PAD CARRIER
- (4) DAMAGED THRUST-COLLAR FACE

(b) See FIGS. 4, 5, 6, and 7

A  $\frac{5}{8}$ -inch-thick mild steel angle-plate,  $8\frac{1}{2}$  inches high  $\times$   $6\frac{1}{2}$  inches deep  $\times$   $5\frac{3}{4}$  inches wide with a suitable stiffener, was manufactured. The dimensions of the angle-plate and holding-down bolt-hole positions were chosen:

- (i) To suit a top slide and tool post of a  $4\frac{1}{2}$ -inch Harrison lathe.
- (ii) To locate the final tool position directly in line with vertical centre line of the turbine rotor shaft, at the same time keeping the whole assembly as rigid as possible.
- (iii) To utilize the forward shaft journal top-half bearing securing stud-hole positions and bearing/governor support housing cover stud-
