# MAIN ENGINE FAILURE H.M.S. NAIAD

LIEUTENANT COMMANDER J. S. GOLDIE, R.N.,  
C.ENG., M.I.MECH.E., M.R.I.N.A.

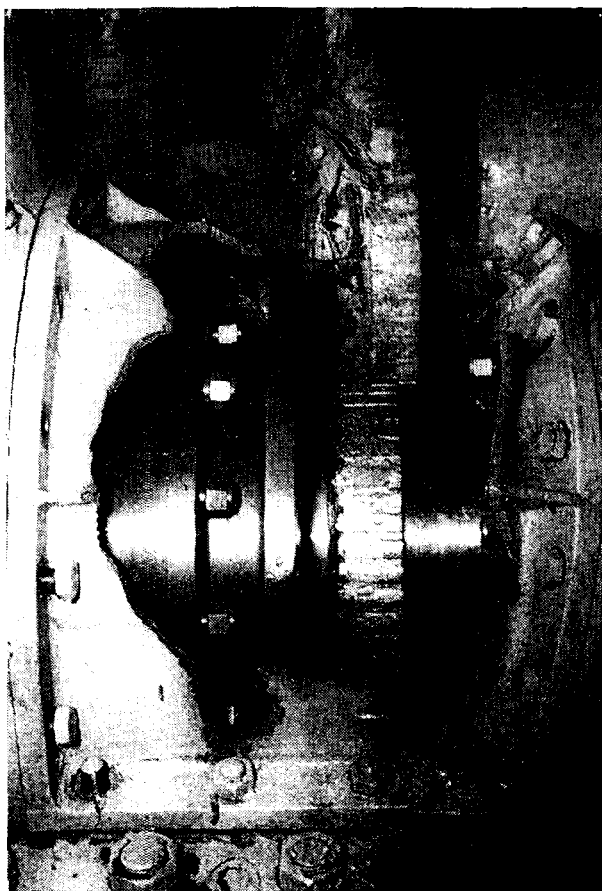
FIG. 1—FORWARD END OF THE COUPLING SHOWING THE FAILED SAFETY TEETH

The first indication that something was wrong was a heavy vibration on the starboard side of the engine room. Initially the EOW thought that it was being caused by a failure of the controls of the starboard stabilizer and therefore centralized the fins and sent the MEM to stop the motors. The MEM noticed that it was the starboard turbine casing which was vibrating and straightway returned to the control platform and closed the manoeuvring valve. As steam came off the engine the coupling cover exploded, scattering bits of the coupling and its housing across the after end of the engine room. In this manner both the membranes of the metastream and the safety teeth of the coupling failed and left a free running turbine.

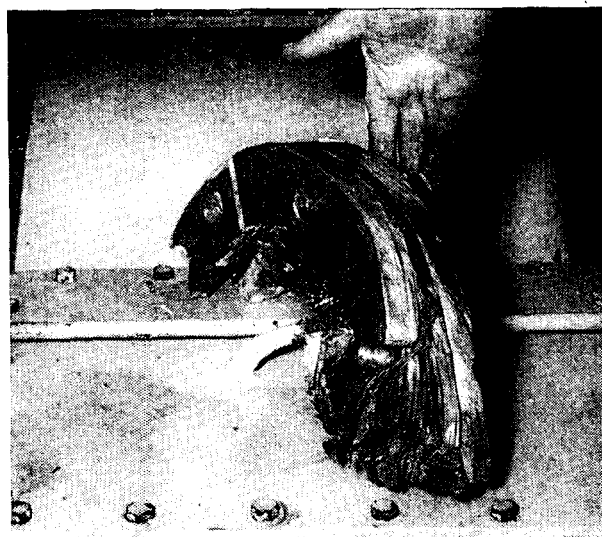
FIG. 2—SECTION OF THE METASTREAM COUPLING SHOWING THE SHEARED BOLTS

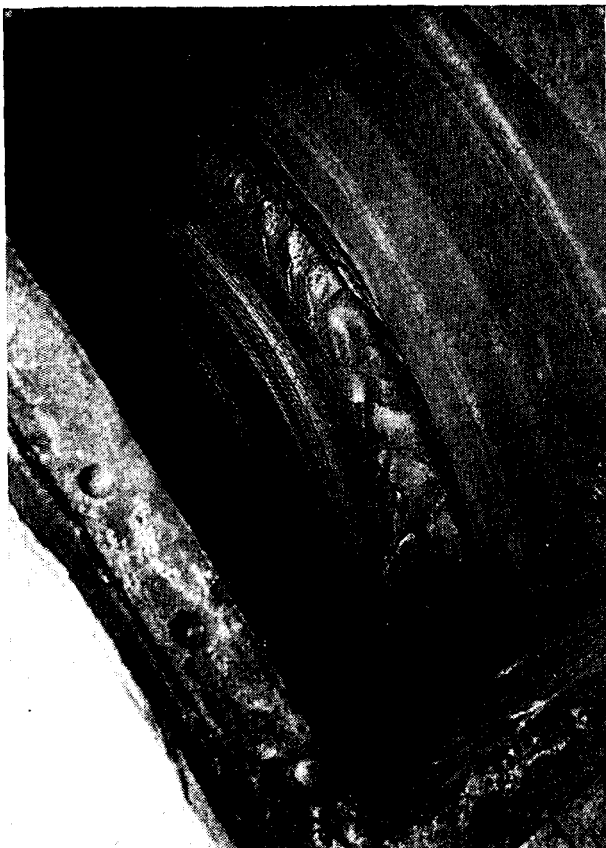
Despite the fact that steam was already being removed from the turbine at the moment of failure, acceleration was immediate and catastrophic. The last two rows of blades stripped from the rotor and flying metal chewed up the condenser tube nest in a spectacular manner.

FIG. 3—AHEAD TURBINE SHOWING THE 7TH AND 8TH STAGES AND THE INTERVENING DIAPHRAGM

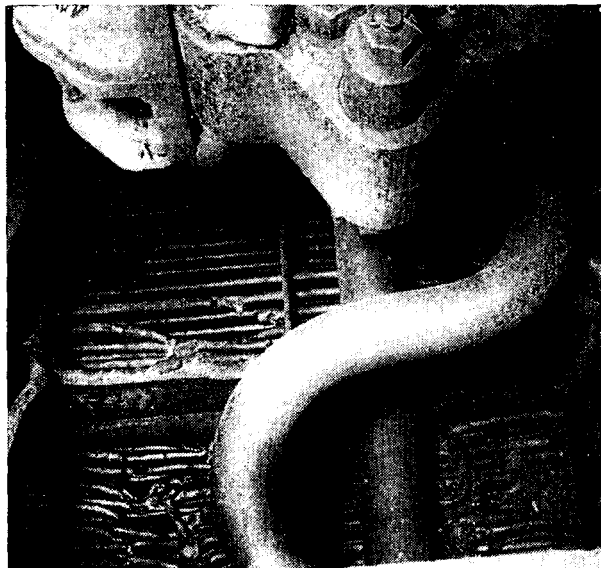
FIG. 4—CONDENSER SHOWING SOME OF THE DAMAGED TUBES

The third effect of the damage was the obvious contamination of the feed system. It will be appreciated from the example shown in FIG. 4 that, from the instant of the explosion and the resultant overspeed, the starboard extraction pump would have been

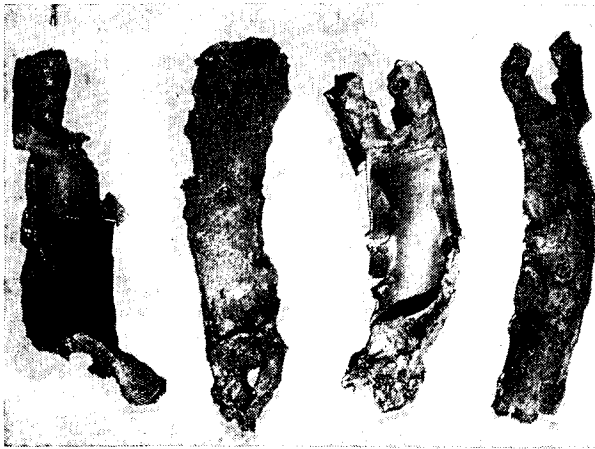
FIG. 5—SELECTION OF TURBINE BLADES REMOVED FROM THE STARBOARD CONDENSER
