## UNDERWATER REPLACEMENT OF A C-P PROPELLER BLADE

COMMANDER B. H. LAWSON, R.N., C.ENG., M.I.MECH.E., M.I.MAR.E.

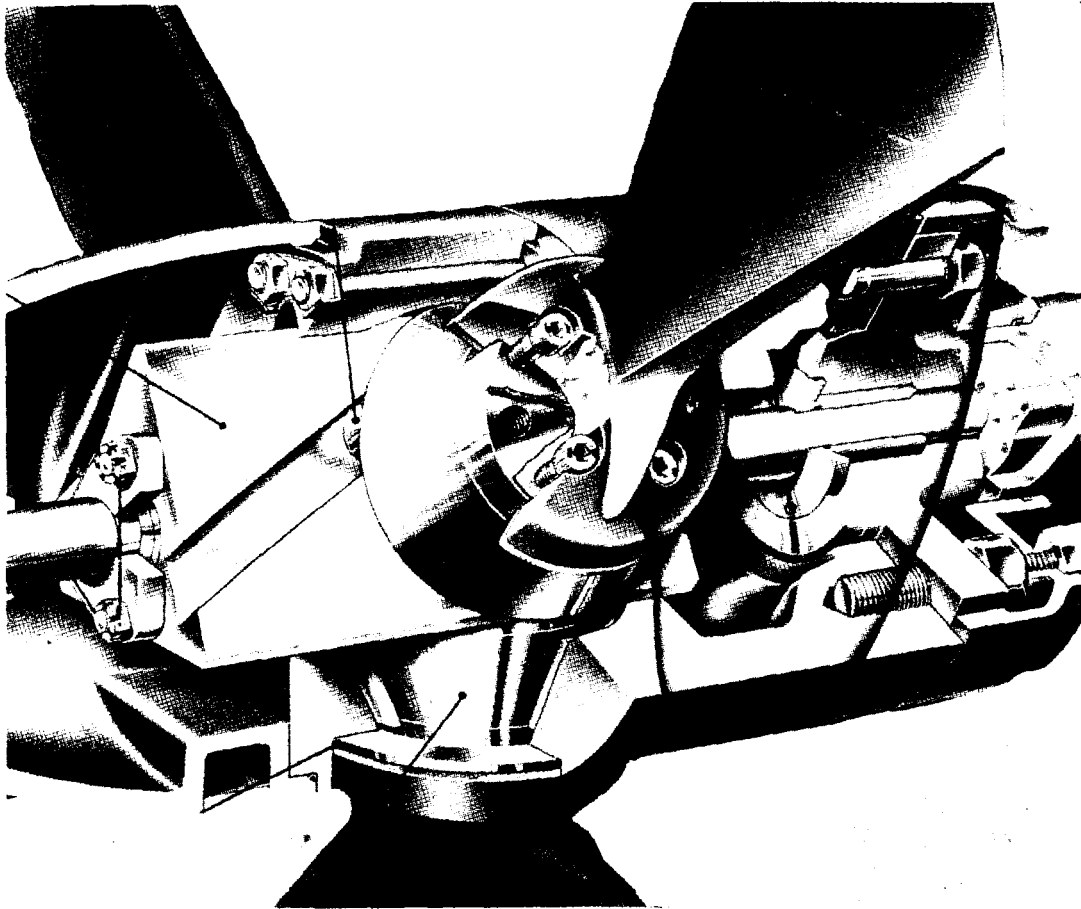
FIG. 1—SECTION OF PROPELLER SHOWING BLADE SECURING BOLTS

Investigation showed that of the six 'Unbrako' bolts securing the blade to the root, the forward three had sheared flush with the root while the after three had had their heads torn off. The thrust ring, 'O' seals and blade root washer and packing had been lost but, with the exception of the washer and packing, spares were available on board.

Finally the bolts were torqued up, the operation of the pitch motor was checked and its performance over the manoeuvre from full ahead to full astern was compared with that of the starboard one. The bolts were locked by the simple expedient of hammering nails of the appropriate interference fit

between the heads and the recesses and after a two-hour sea trial the recesses were sealed by caulking with lead pellets.

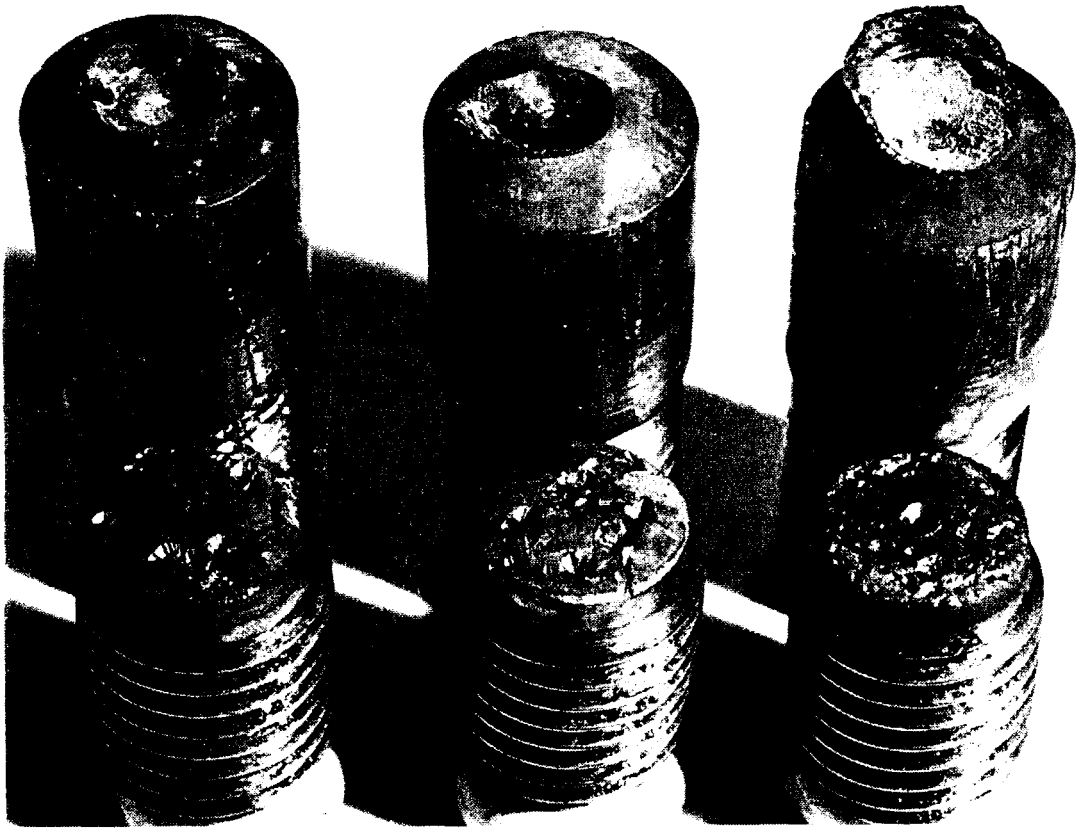
FIG. 2—FRACTURED SAMPLES OF BOLT SHOWING LOCATIONS OF FAILURE

The report by the Central Dockyard Laboratory attributed the bolt failure generally to corrosion fatigue and excessive undercutting at the termination of the threaded portion, this being coincident with the site of failure of the three forward bolts, and a sharp corner under the bolt head at the point where the three after bolts failed. The material was found to conform to the specification BS233 CA104 and no merit was seen in a change of material.

Subsequently reference was made to the manufacturer and a change of bolt design was evolved. The adverse features highlighted in CDL's report were

eliminated and the bolt head was changed to a male hexagon in lieu of the socket type.

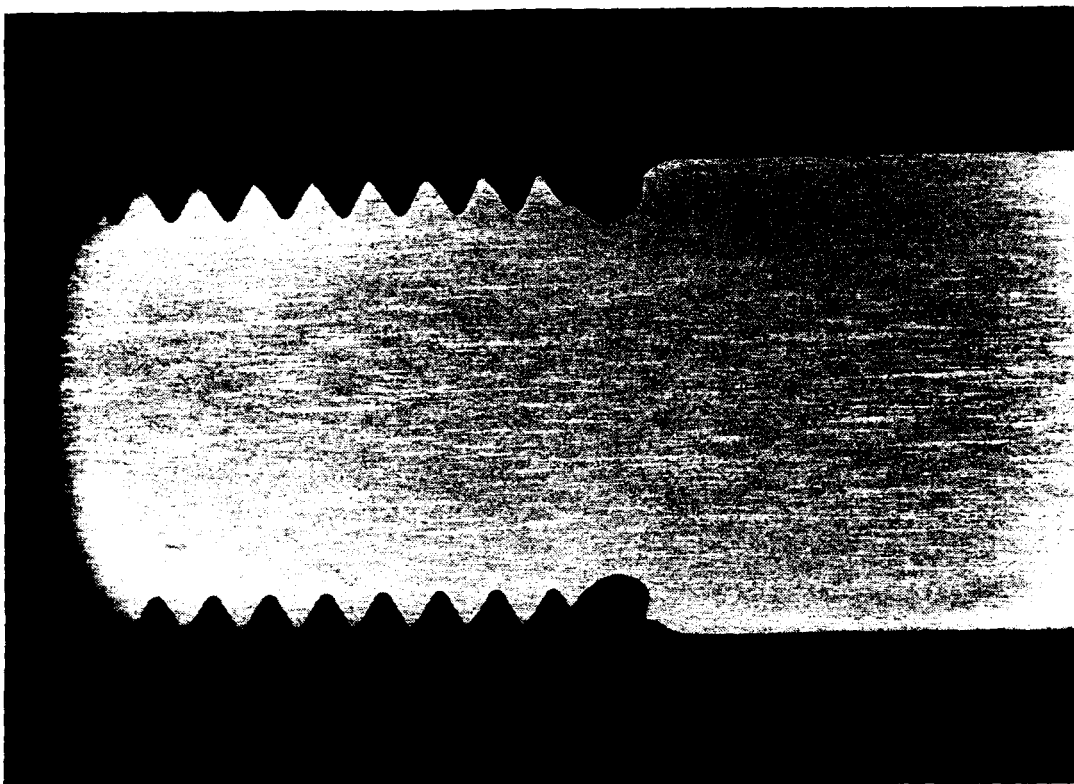
FIG. 3—MACROSECTION SHOWING AMOUNT OF UNDER-CUTTING AT SITE OF FAILURE IN SOME BOLTS (X 2)
