NOTES FROM SEA

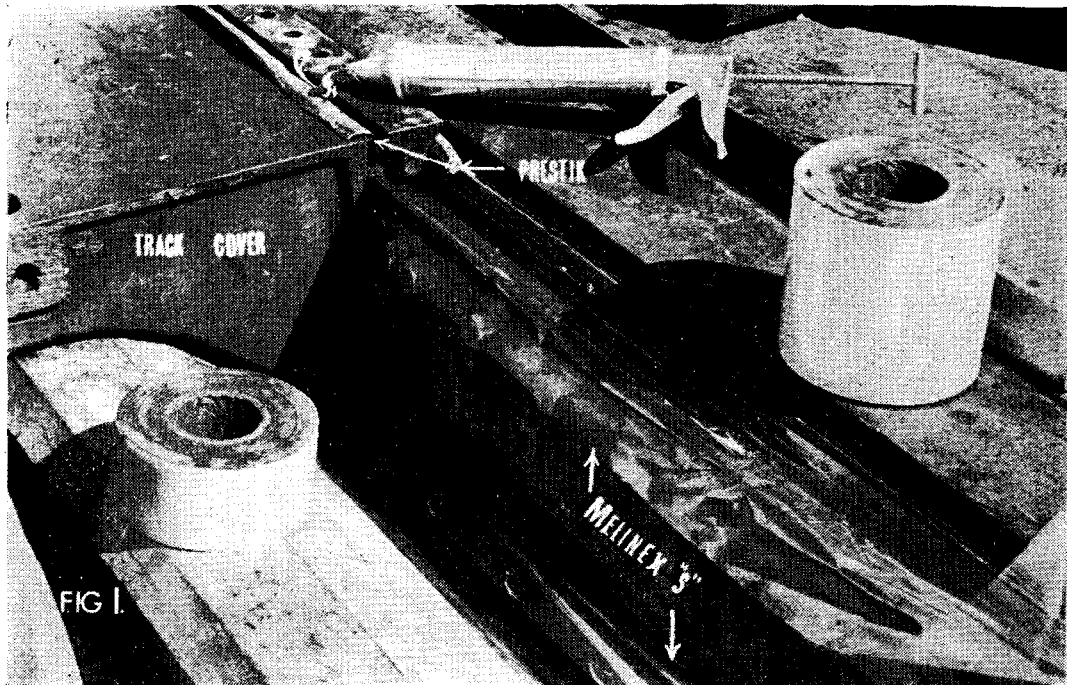
FIG. 1

Following relatively short periods in service, severe corrosion of catapult track covers and support rails had frequently led to seizure of the mating parts and the necessity of using near destructive force to achieve separation.

Earlier attempts to eliminate or reduce the problem by the application of varying types of grease and anti-seizure agents had been largely unsuccessful due to the severity of the environmental conditions whereby the units were exposed to sea water, steam, aviation fuel and strong detergent solutions such as Slix, used during deck cleaning following aircraft fuel spillages.

The Devonport Dockyard Laboratory who had been taking an active interest in this problem carried their investigations further and with D.G. Ships' support decided to repeat the technique of fitting an insulating membrane between the mating parts, limiting the film thickness to 0.002 in. and additionally preventing access of flight deck effluents by sealing the covers and retaining bars at their junction with the flight deck.

Reduction in film thickness carried with it a requirement to find a polyester type material with good heat resisting and high strength qualities. Melinex 'S', manufactured by I.C.I. Ltd., met these requirements and had the added advantage of being available in strip form and a thickness range of 0.00025 in. to 0.0075 in.

The upper and lower support rails and corresponding surfaces of the track covers were cleaned with white spirit and liberally coated with molybdenum disulphide grease. Polyester film 6 in. wide for the upper rail and 3 in. wide for the lower rails, was placed in position and the covers carefully lowered and located (FIG. 1). Prestik sealing strips of flat and round sections were used to seal the gaps between the track retaining bars and the flight deck being finally caulked and topped with gum mastic in order to prevent the ingress of flight deck spillages (FIG. 2).

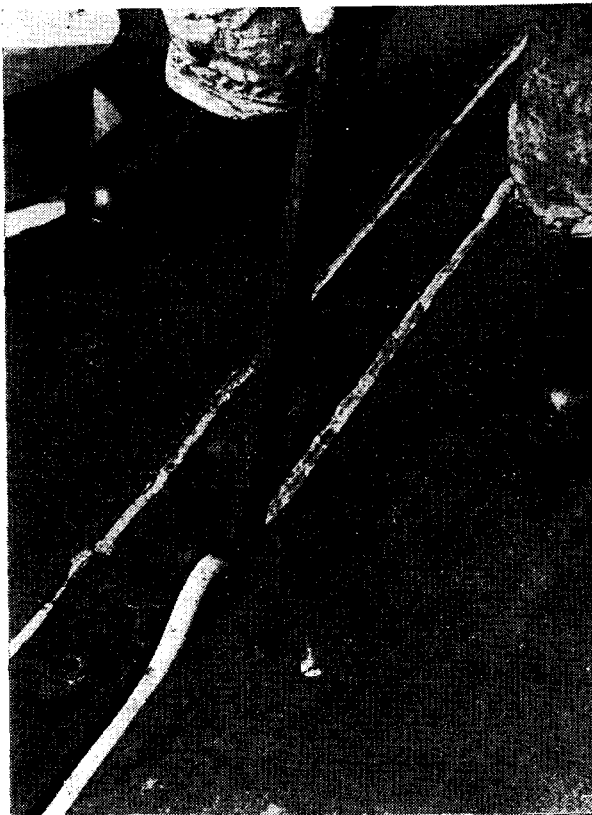
FIG. 2—CAULKING REMAINING GAP BETWEEN
RETAINING BAR AND FLIGHT DECK
