# BOILER DAMAGE EVALUATION

## FOLLOWING AN INCIPIENT STEAM-STEEL REACTION

L. P. JUDSON, L.I.M.

*(R.N.Z.N. Naval Research Laboratory Metallurgy Section)*

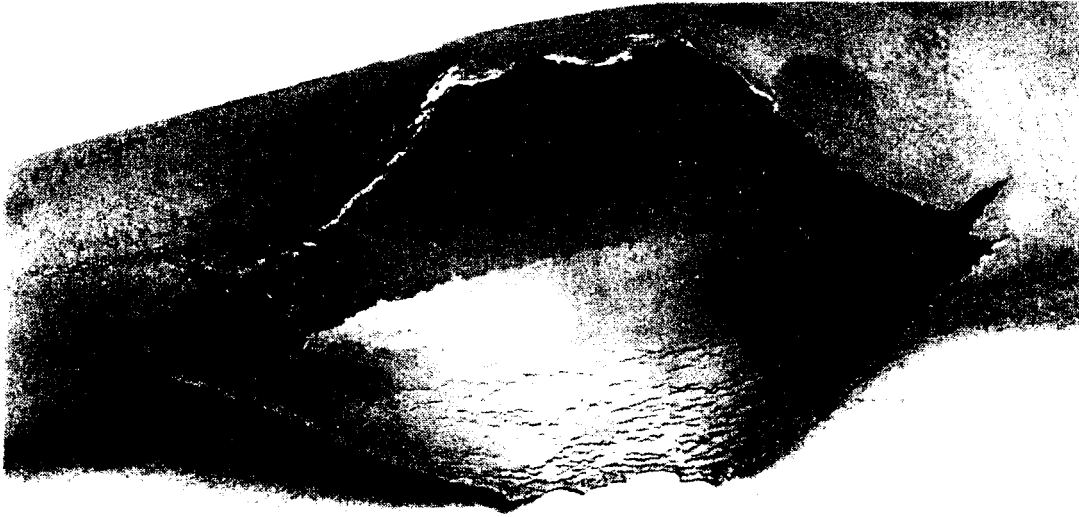
FIG. 3—DETAILED VIEW OF THE BURST TUBE A.8

Note the intergranular disintegration and the heavy scale of the inner surface opposite the split.

A close-up photograph of the failure, taken before any testing, is shown in FIG. 3. The fracture was typical of a high temperature creep failure showing characteristics of inter-granular disintegration of the material, whose creep resistance was reduced by overheating, to a stage when the steam pressure could no longer be supported. Also there was a heavy tenacious scale present on the inner surface of the tube, opposite the split.

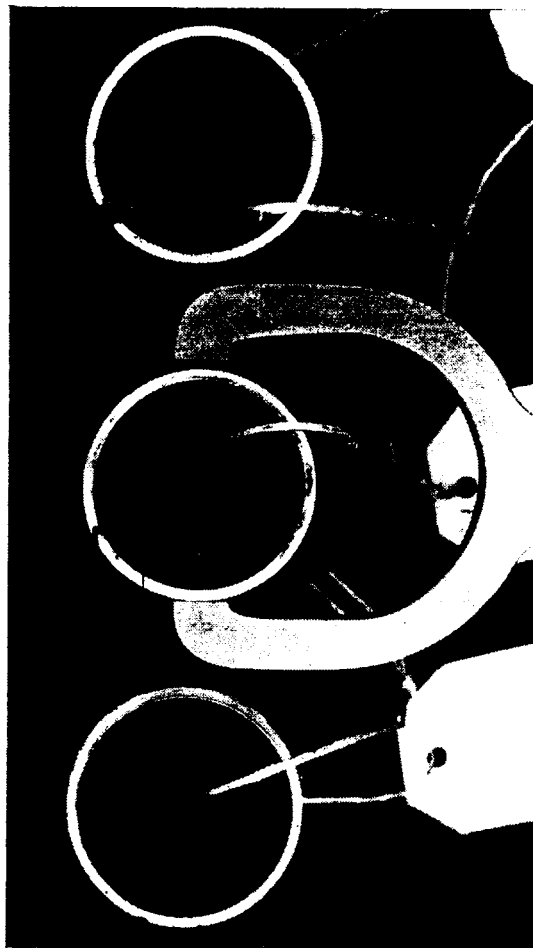
The samples failed to pass the flattening and expanding tests and exhibited features in the failures worthy of note. In the sample taken from below the failure, the expanding test showed a discontinuity in the form of an offset along the line of fracture which was indicative of a fault in the material, possibly a non-metallic inclusion or lamination. The expanding test on the sample from above the split revealed a mode of failure characteristic of embrittlement.

FIG. 5—EXPANDING TEST RESULTS, TUBE A.8, ILLUSTRATING THE DIFFERENT CHARACTERISTICS OF THE FAILURES ABOVE AND BELOW THE BURST

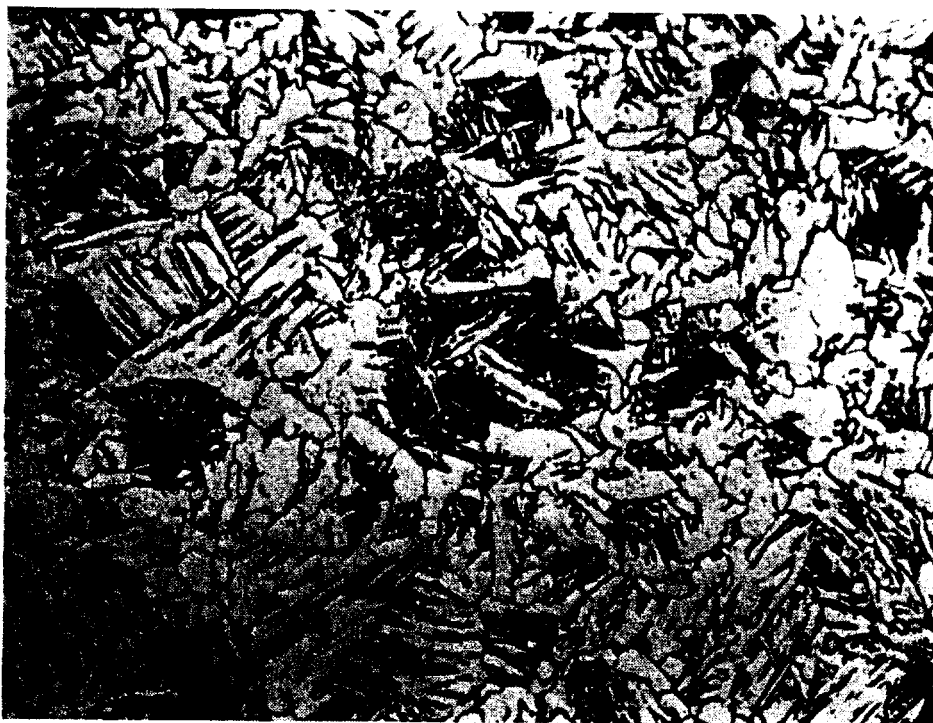
Above the fracture the structure was of an acicular nature. (See FIG. 6). This structure can only be achieved by heating this steel to a temperature in the region of 800 degrees C and this must be followed by a severe quench from above 700 degrees C.

FIG. 6—PHOTOMICROGRAPH OF THE MICROSTRUCTURE OF TUBE A.8, 12 INCHES ABOVE THE BURST ( $\times 500$ )  
The acicular pattern is typical of heating in the region of 860 degrees C, followed by severe quenching from above 700 degrees C.

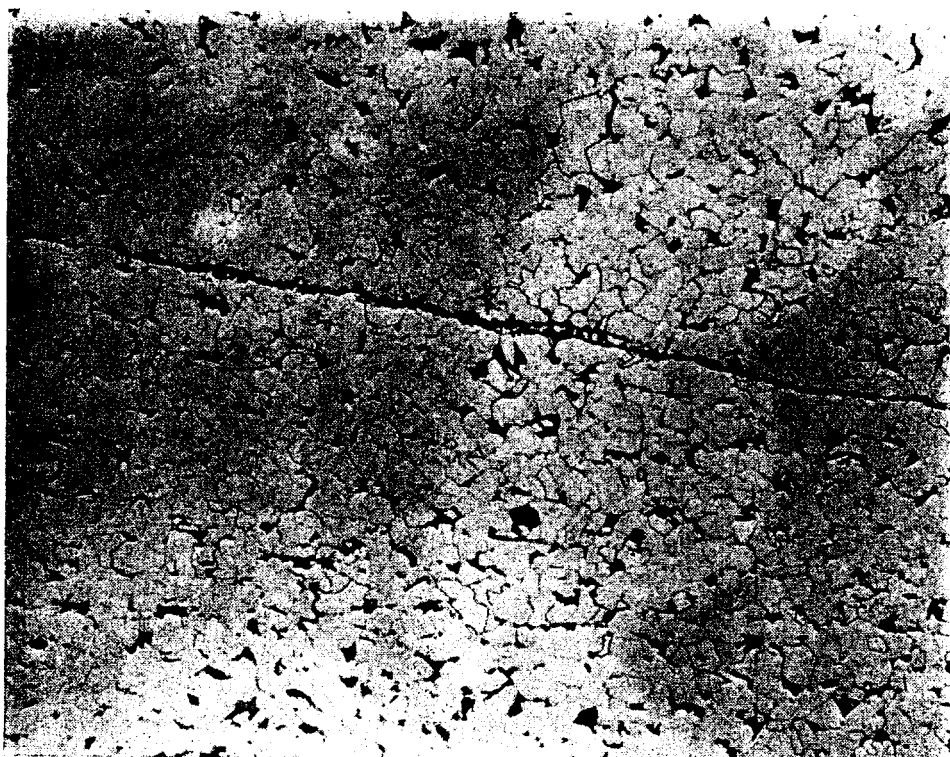
There were also some lines of non-metallic inclusions, which are clearly illustrated in FIG. 7.

FIG. 7—PHOTOMICROGRAPH SHOWING NON-METALLIC INCLUSION AND THE STRUCTURE OF THE TUBE A.8, 12 INCHES BELOW THE BURST ( $\times 100$ )

Below the fracture the structure, as expected in this instance, was typical of a normalized steel, with a tendency to banding which is due to the manufacturing processes. However, there were indications of the presence of laminations which have already been described and illustrated in FIG. 7. The presence of the lamination could have contributed towards the failure but micro-examination of a complete cross-section of the tube confirmed that no fracture had propagated from this defect which, in fact, was directly opposite the rupture, and therefore had not influenced the failure in any way whatsoever.

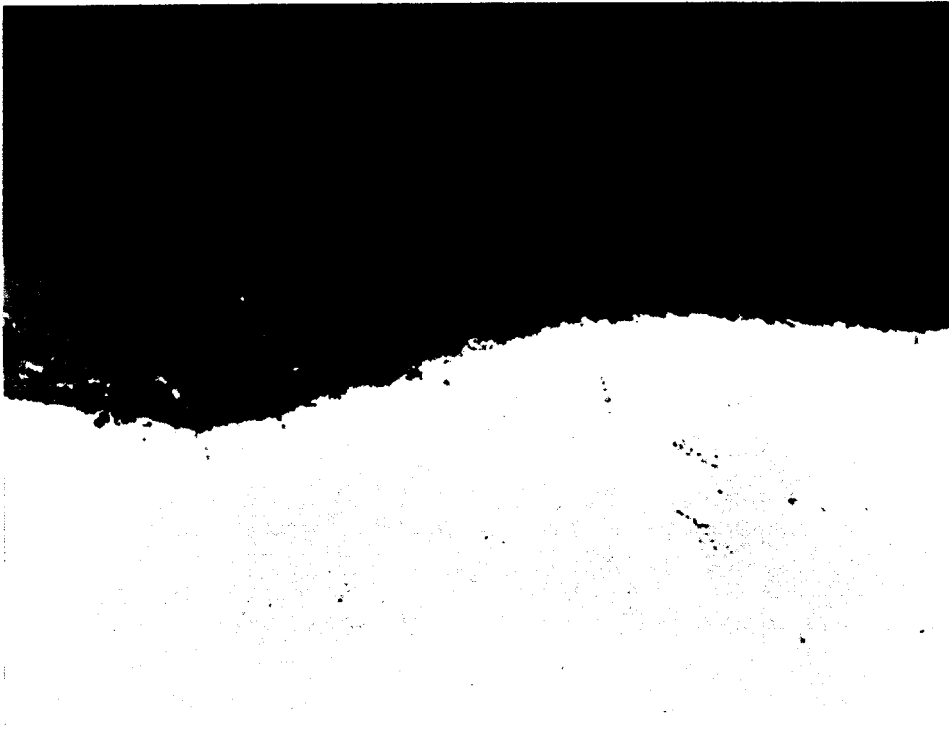
- (a) The temperature attained in the upper portions of the tubes was excessive to the extent that re-crystallization of sound metal occurred and a burning reaction on the water-side as well as the fire-side tube surfaces had commenced.
- (b) The heavy scale would render these tubes unserviceable because of the consequent decrease in heat transfer characteristics.
- (c) The scale formation on the bore of the tube was excessive and did not seem to be compatible with either the short time that the furnace had been in service or the normal operating temperatures. However, this heavy scaling effect may be attributed to the steam-iron reaction.

FIG. 8—SCALE ON THE WATER SIDE OF TUBE A.17 SHOWING INTER-CRYSTALLINE ATTACK AND THE HEAVY SCALE (0.003 IN.). SOME UNBURNT METAL CAN STILL BE SEEN ENTRAPPED IN THE SCALE ( $\times 200$ )

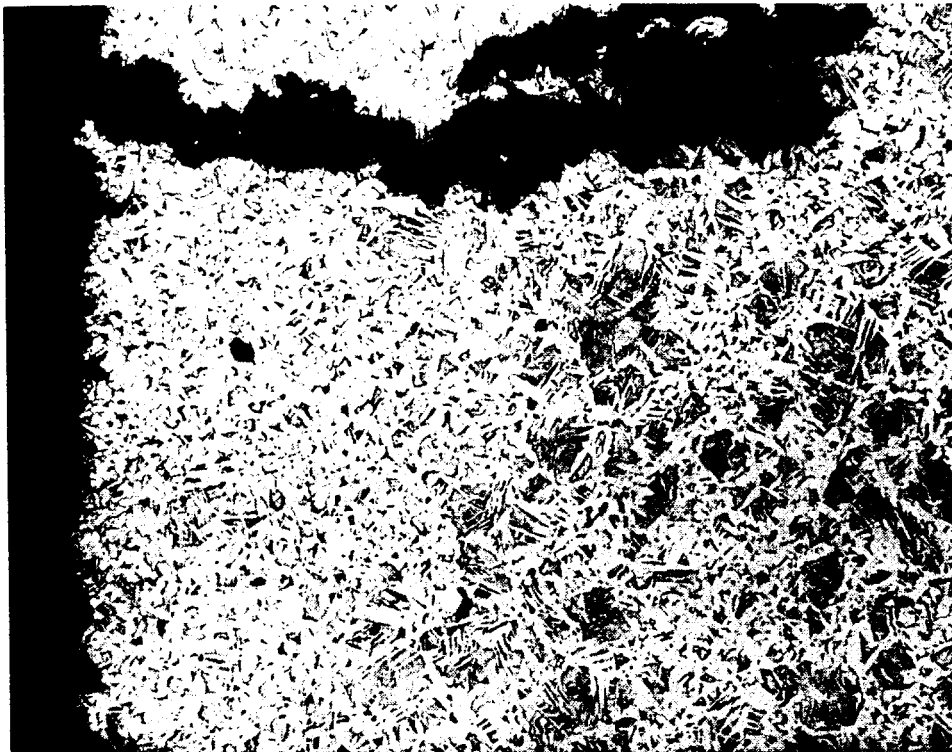
FIG. 9—TUBE A.6 AS QUENCHED STRUCTURE WITH CRACK 0.030 IN. DEEP EMANATING FROM THE BORE OF THE TUBE ( $\times 100$ )

A metallographic sample was taken longitudinally through several of the cracks. The photomicrograph, FIG. 9, illustrates one of the cracks discovered (approximately 0.030 in. in depth) and also shows the change in metallographic structure.

The structure of A.6 may be considered as representative of the state of tube A.8 immediately prior to rupture. The deep cracks emanating from the bore have been widened by creep and by the burning action as the cracks propagated.

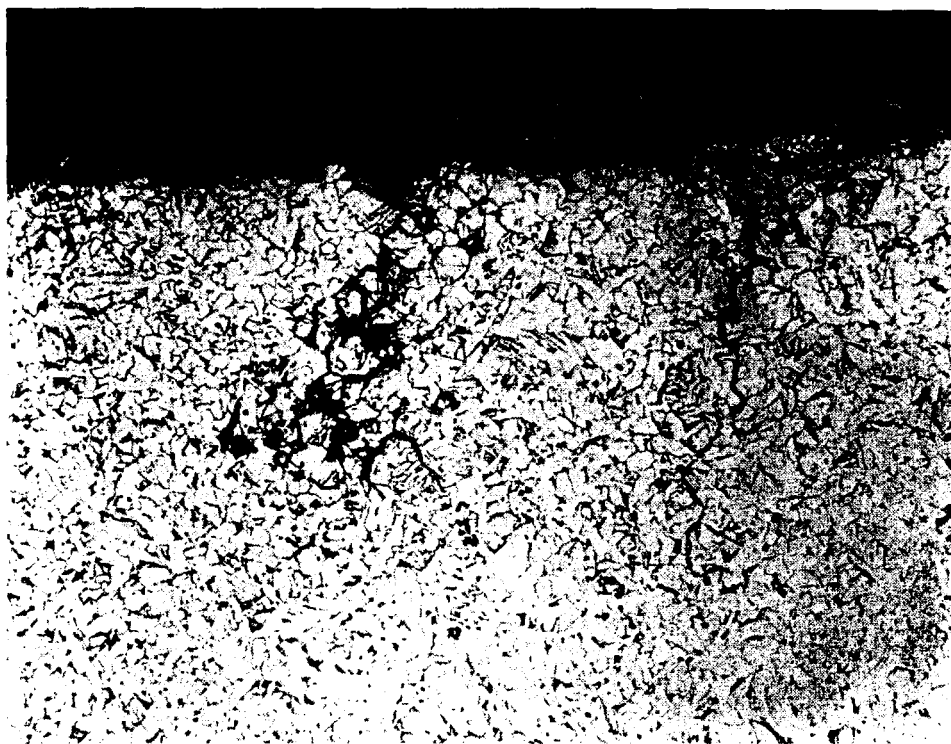
Micro-examination showed the sub-surface structure to be of an 'as quenched' acicular type. There were several deep intercrystalline and some transcrystalline cracks emanating from the bore (FIG. 10).

FIG. 10—SECTION THROUGH THE EXPOSED SIDE OF TUBE S.W.17 SHOWING INTER-CRYSTALLINE CRACKS EMANATING FROM THE BORE ( $\times 100$ )

From the examination it was clearly seen that the part of the tube exposed to the combustion chamber had been severely overheated and quenched. The tube had been starved of water with resultant burning of iron to give the severe scale and the liberated nascent hydrogen diffused into the metal with eventual inter and transcrystalline cracking.

The decision to replace all water-wall studded tubes was based on the consideration that all studded tubes imbedded in the water walls of the fire box had suffered similar or a greater degree of damage.

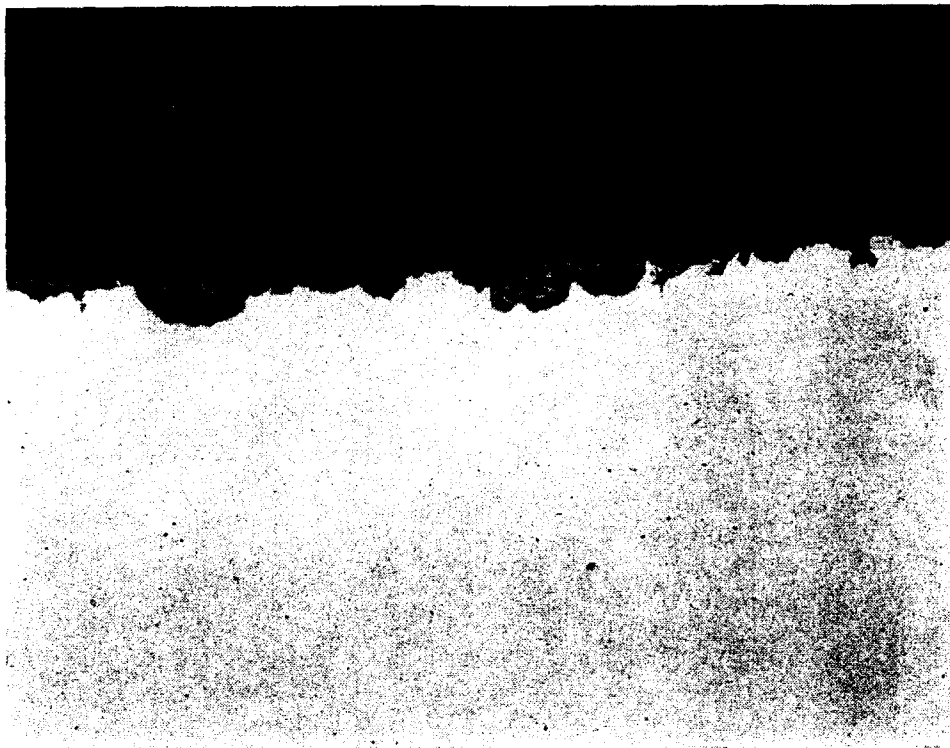
FIG. 11—MICROPHOTOGRAPH ILLUSTRATING THE SCALE AND ATTACK ON THE BORE OF TUBE B.B.37, ATTRIBUTABLE TO THE IRON-STEAM REACTION ( $\times 100$ )

steam. The temperature attained by this tube must have been in excess of 700 degrees C as shown by the evidence of the steam iron reaction. The attack on the bore is clearly shown in FIG. 11.

As this tube exhibited internal attack and was also subjected to nascent hydrogen, possibly creating conditions of residual stressing, it was considered that the entire saturated pass was suspect and should be removed.

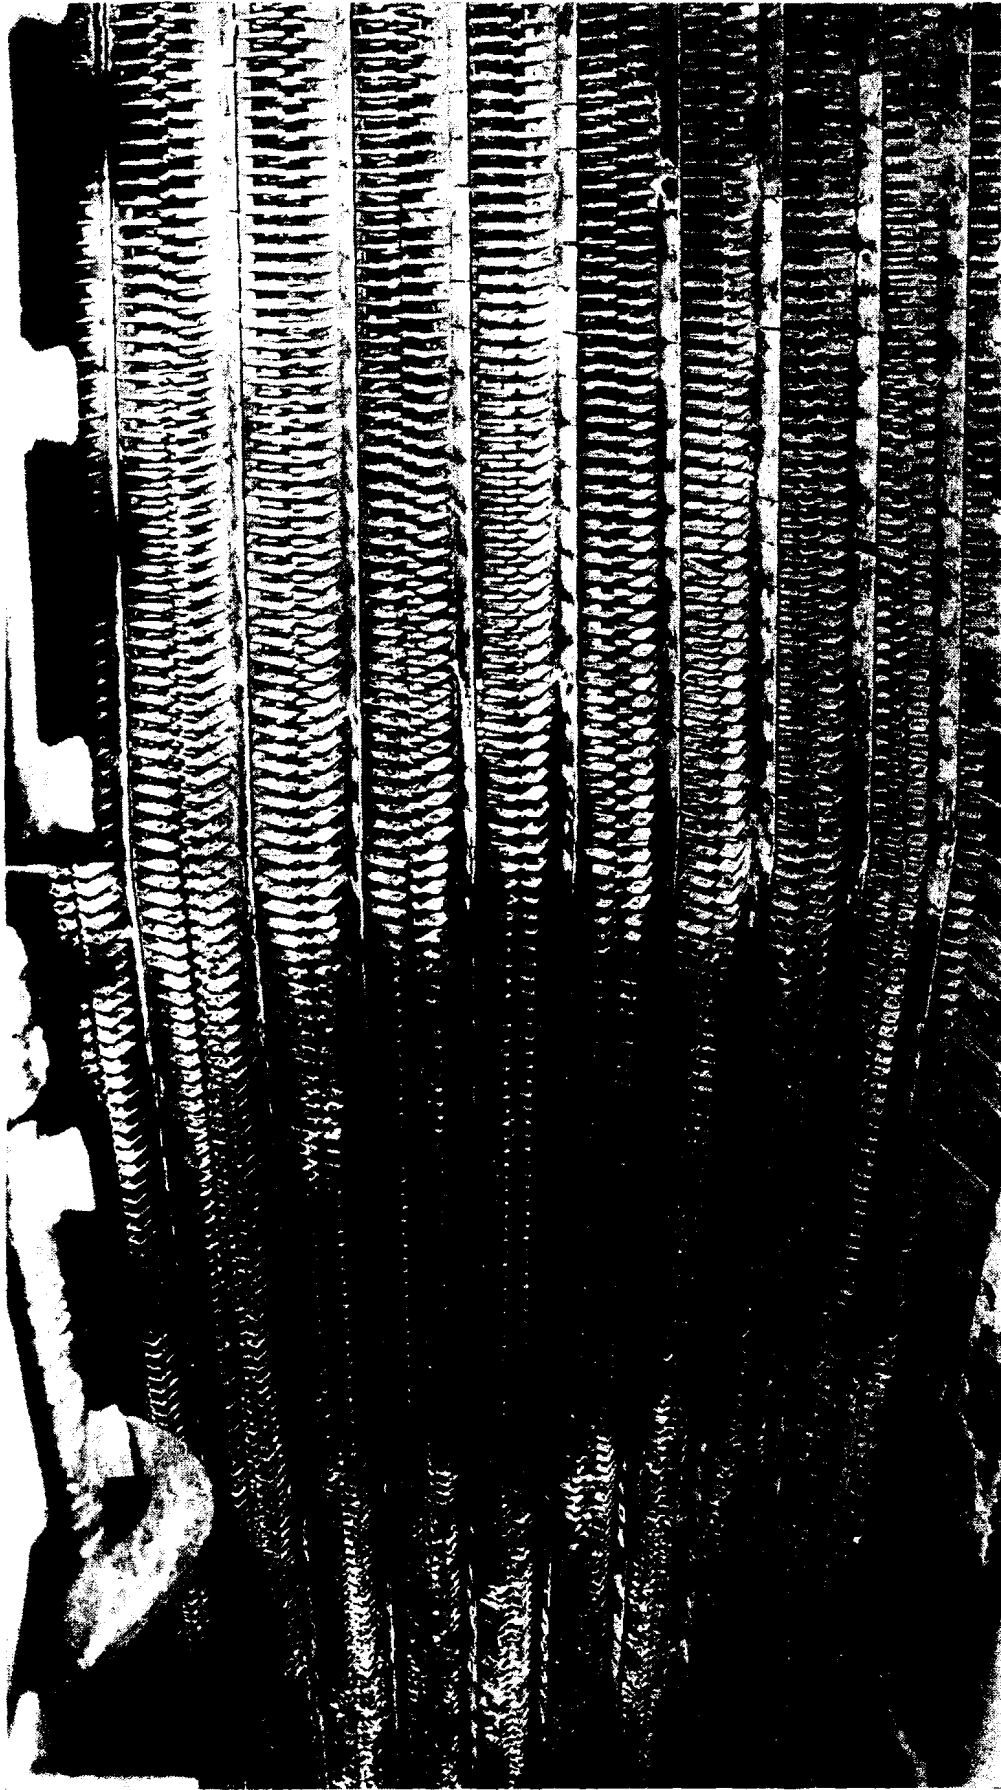
The outsides were examined from below when it was noted that there was an area immediately above the superheater pass which had a distinct darker appearance. This is clearly shown in FIG. 12. Closer examination showed that this area had been stripped of all the aluminium protective paint and was coated with a light brown rust. Surrounding this area was a white deposit which suggested that boiler compound from escaped boiler water had dried out on the tubes.

It was also noted that the steam-iron reaction had only taken place on the bore where the thickness of metal was least. No scale was found on the bore in positions corresponding with fins and studs on the outside of the tube.

FIG. 12—VIEW OF ECONOMIZERS FROM BELOW SHOWING HEAT AFFECTED ZONE ABOVE THE SUPERHEATED PASS

From the above evidence, it was decided to replace the economizers.
