# 'WITHDRAW BEARING USING TAPPED HOLES PROVIDED'

LIEUTENANT V. HENSON, R.N.

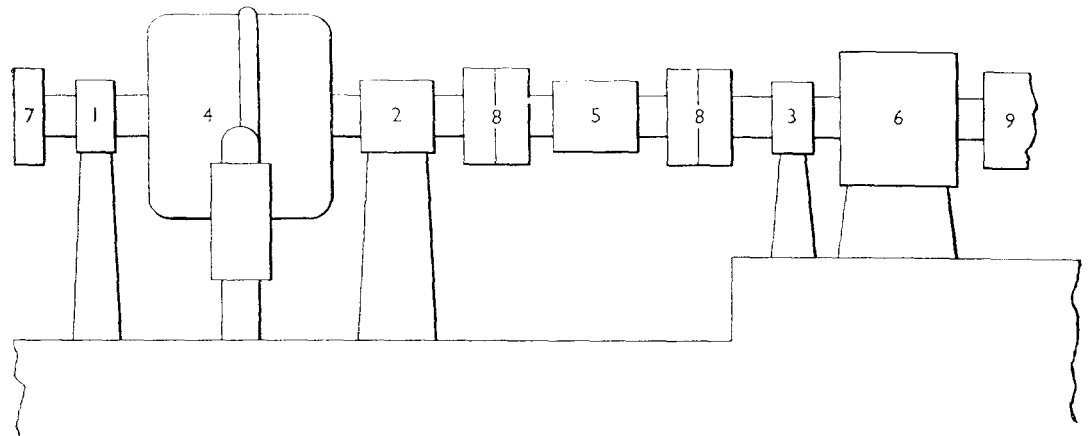
FIG. 1—THE GENERAL ARRANGEMENT

Removal of the bearing cover revealed severe damage to the ball thrust bearing. The race had split radially and allowed the balls to crunch together. This bearing failure was considered to have affected the adjacent journal bearing. Spare roller and thrust bearings were available and preparations to remove the old ones were therefore commenced.

Examination of the relevant dynamometer and propeller shaft drawings revealed an unexpected difficulty. The stub shaft between the thrust block and the dynamometer coupling was seen to be spigotted at each end. Male spigots,  $\frac{3}{8}$ in. at one end and  $\frac{1}{4}$ in. at the other, meant that  $\frac{3}{4}$ in. play had to be found in the shaft assembly before this shaft could be removed and the bearing drawn off the dynamometer shaft. The general arrangement is shown in FIG. 1.

From examination of the dynamometer drawings it was evident that the axial clearance required would have to be found elsewhere. In the most favourable position only  $\frac{1}{2}$ in. could be obtained by moving the dynamometer.

Various observers took up their positions and the shaft was slowly eased forward exactly  $\frac{3}{4}$  in., using the hydraulic jacks. Despite some anxieties the movement was well controlled and, as a result, the stub shaft was then lifted clear.

The two new bearings were carefully fitted and the dynamometer alignment re-checked. The stub shaft spigots were machined back to facilitate replacement work and the coupling bolts checked for size and soundness. The dynamometer position was as recommended by the makers, the axial clearance being divided equally fore and aft and the bearing heights correct.
