SOME NAVAL ENGINEERING CALAMITIES

COMMANDER A. J. H. GOODWIN, O.B.E., R.N., M.I.MAR.E.

The following paper was presented to the Scottish Branch of the Institute of Marine Engineers in October, 1964, by the author who is now the Senior Manager of the Yarrow-Admiralty Research Department. The naval calamities he describes are those with which he has had personal contact and the events are associated with the ship in which he was serving at the time. Many of these events provide some lessons in engineering both on the technical side and even more on the administrative side.

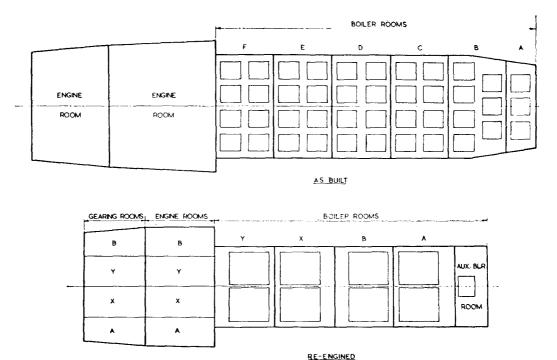
FIG 3—ARRANGEMENT OF MACHINERY SPACES—H.M.S. RENOWN

The upper part of FIG. 3 shows the arrangement of the machinery compartments at that time, and the lower part the re-arrangement when she was reengined, completing in 1939. It will be seen that at the time there were 42 boilers arranged in six boiler rooms—A containing three, B seven and C, D, E. and F eight each. The fire broke out early in the afternoon watch in D boiler room, while the ship was steaming on C and D boilers. It subsequently transpired that the cause of the fire was oil fuel that was being transferred from forward to one of the double bottom tanks in D boiler room. The filling arrangements were a stand pipe with an open-ended funnel and a filling valve above. The stoker who was tending this valve made the cardinal error of sounding the wrong tank, so that as he could see no rise of level, he kept opening the valve wider and wider until the tank and its stand pipe were completely full and the oil overflowed, some of it striking the hot boiler front and catching fire.

The stoker then completely lost his head and as he described later, 'Some of the oil came over me and I thought I was on fire, so I rushed up on to the upper deck to put it out'.

No one else in the boiler room was aware what was happening, so the oil continued flowing at full bore into the boiler room so that the whole of the bilges were soon alight, and the steaming crew were driven out of the boiler room. Unfortunately, the boiler fans were still running and providing all the air necessary to keep the fire raging. Very soon news of the calamity spread round the ship and officers and men off watch came rushing to help. The Officer-of-the-Watch at the time (he subsequently became Engineer-in-Chief of the Royal Canadian Navy) concentrated on keeping the forward four boilers in C boiler room alight and this was no mean task as the after bulkhead was red hot and desultory fires kept breaking out in the bilges there.

As a result of the Board of Inquiry that was held, alterations and additions were carried out and new construction modified so that:

- (1) Open ended funnels for tank filling were barred from boiler rooms
- (2) External shut-off arrangements were made for steam to boiler room fans, steam to oil fuel pumps and heaters, and the oil fuel supply to each boiler.

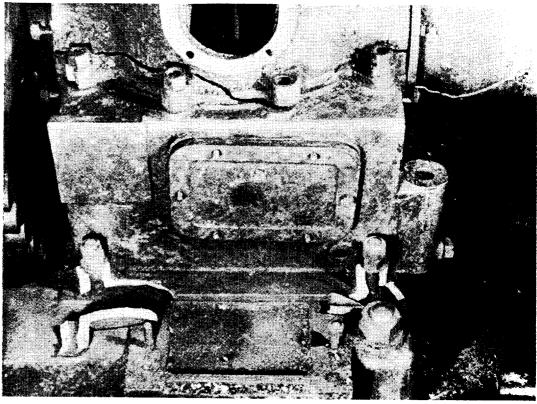
Fig. 7

This was the first and best known case of crippling of the machinery due to shock although the hull remained watertight, but it was followed by innumerable casualties due to this cause either from magnetic or acoustic mines or near-miss bomb explosions. Typical examples of such failures are shown in FIGS. 7, 8 and 9.

Referring back to the photographs of damage, it can be seen in FIG. 7 that fractures have been caused by the bending moments set up in the cast iron crankcase by the pull of the holding-down studs during the decelerating phase. I cannot remember whether the fourth stud had been missing or was itself fractured, thus saving the crankcase in that vicinity. FIG. 9 illustrates a failure in the accelerating phase, and again, bending moments have played a large part in increasing the maximum tensile stresses in the cast iron to above its U.T.S.

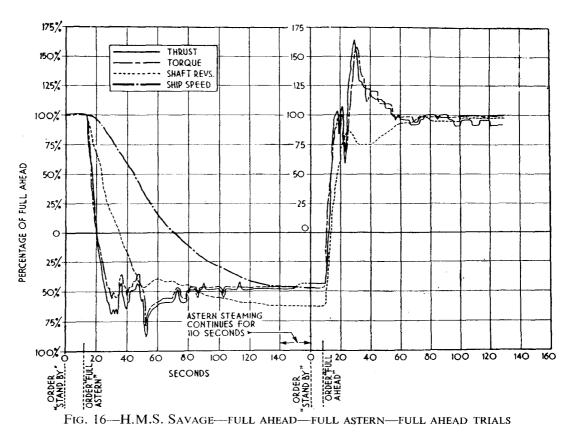
Some readers may remember a set of curves I produced in Vol. 6, No. 2 of the *Journal of Naval Engineering* in April, 1953, showing the transient torque and thrusts that occur when manœuvring from ahead to astern and *vice versa* (FIG.

16). From these it can be seen that some of the highest stresses are liable to be caused in the propeller during these transient conditions, and since one of the objects of the trials was to establish whether propulsive efficiency could be improved by thinning the propeller blades, it was necessary to establish that such thinned blades would retain sufficient strength. We did, in fact, continue thinning until a point was reached where the bronze propeller blades were bent by fierce manœuvring. With a well trained crew we were able to go from one to eight sprayers in 12 seconds; present day automatic boiler control systems can just beat this speed.

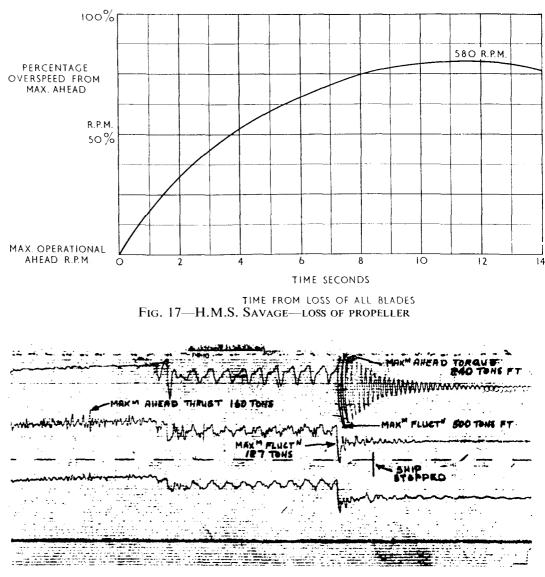
The propeller from which the blades fell off (FIG. 17) was an 11 per cent chrome, 0.15 per cent nickel stainless steel propeller thinned 20 per cent below that normally used for bronze propellers. The real trouble, however, was that the casting technique had not been properly mastered and, in fact, one propeller of this type was left overnight seemingly intact in the factory and was found next morning with one of the blades fallen off. The fact that the blades fell off the propeller in question while manœuvring should not be regarded as a black mark for stainless steel propellers, but only for our particular technique at that time. Analysis of the pen recorder traces of this propeller shown in FIG. 18 produces the following results:
