‘BRITISH FRIGATE GOES BACKWARDS’

**FAILURE AND REPAIR OF A CONTROLLABLE-PITCH PROPELLER
IN H.M.S. ‘LINCOLN’**

LIEUTENANT R. W. TURNER, R.N.

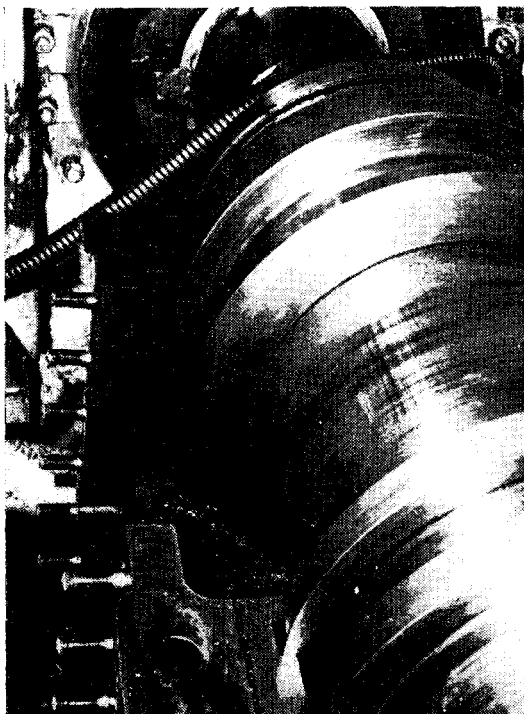
FIG. 2—SEIZED SLIDING RING

Both shafts were stopped, but further attempts to proceed resulted in the port blades swinging astern when a speed of 10 knots, or 100 r.p.m., was exceeded, but there was no further movement on the ECR pitch indicator. The C-P propeller control was tried from the secondary for'd engine position and then on local control on the oil distribution box, but it was found that the operating arm of the yoke was jammed in the full-ahead position. Unsuccessful attempts were made to move this operating arm aft, first by servo-motor control alone and then by backing up with chain blocks. The link pins between the operating arm and servo motor were disconnected to ensure correct operation of the latter. This was satisfactory, indicating that the sliding ring in the oil distribution box was seized or jammed on to the propeller shaft. The high-

An endeavour was made to move the sliding ring aft on the shaft by levering against the box, but to no avail. The key between the sliding ring and valve rod pin was removed, but further attempts to move the ring with screw jacks were also unsuccessful. The key, when checked on a face plate, was bowed 0.064 in. indicating that the valve rod and pin had forced the sliding ring hard against the oil distribution box casing.

After thorough cleaning, heat was applied to the sliding ring and, as anticipated, the whitemetal bond melted and the ring then moved easily along its full operating distance along the shaft. The whitemetal was cleaned off and the shaft and ring oiled, allowing free movement.

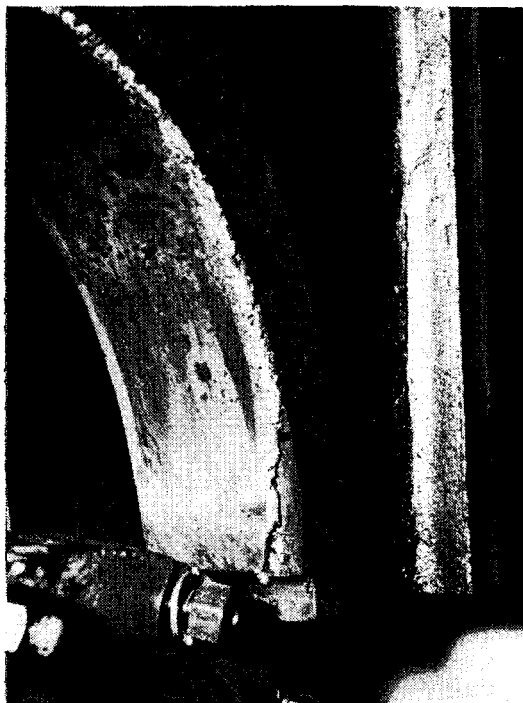
FIG. 3—OIL DISTRIBUTION BOX CASING

Not having freed the ring, the next step was to split the oil distribution box at its horizontal joint. The bottom half was supported on blocks and the top half lifted after all control and top gear had been removed. It was then seen that the forward, after and location bearings were partially wiped (FIG. 3) and whitemetal had apparently run from the forward bearing to bond the sliding ring on to the shaft. Further attempts were made to move the ring by jacking, but only $\frac{3}{16}$ -inch movement could be obtained.

The Hong Kong and Whampoa Dock Company had by then been called in for assistance, so both halves of the oil distribution box were removed from the C-P space to the dockyard for remetalling and machining of the bearings. This necessitated partial removal of the deck hatch coaming, the box being approximately $3\frac{1}{2}$ feet long and $2\frac{1}{2}$ feet square and weighing a total of $1\frac{1}{2}$ tons. While this was being done the port thrust block cover was removed for examination of the thrust collar and pads but only 0.002 in. additional clearance was found above the last readings taken.

By this time the oil distribution box had been returned from the dockyard. The forward and after casing journals had been machined to give clearances of 0.010 in. as also were the location bearing faces. The top and bottom halves of the box were then bedded on to the shaft separately. Difficulty was experienced when the two halves were bolted together. Slight distortion of the box while remetalling caused the horns of the after end of the casing to bear on the shaft, and these necessitated scraping to give clearance. The box was finally rejointed and the bolts hardened up, and when tried on the shaft it swung freely by hand.

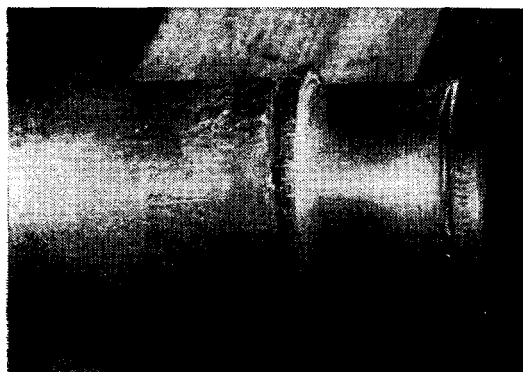
FIG. 4—AFTER SECTION OF FAILED OPERATING ROD

The cause of the defect was now apparent and due to the failure of the after welded joint on the valve rod coupling. This permitted the high-pressure oil in the valve rod to pass directly into the low-pressure area in the propeller shaft, so releasing the oil pressure on the hub servomotor piston. The speed of the ship at the time overcame the spring pressure in the hub, causing the blades to move astern, and this action withdrew the after section of the valve

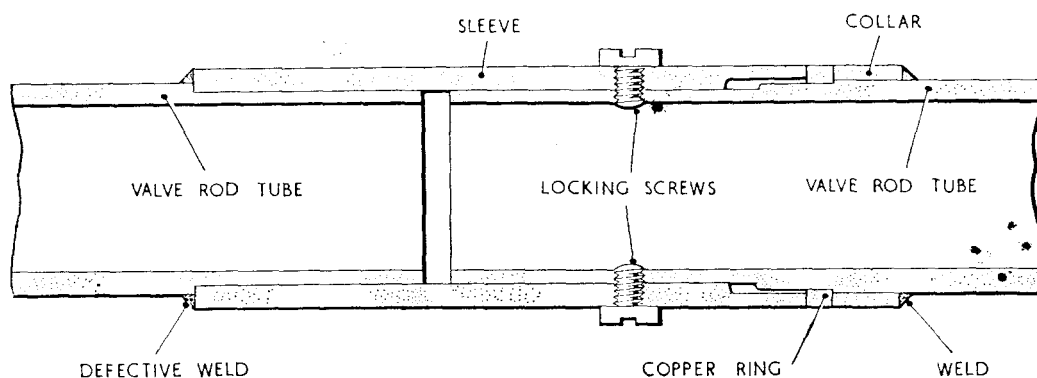
FIG. 5—VALVE ROD COUPLING

As soon as it was freed, the valve liner and pin in the hob were withdrawn, together with the valve rod. It was then found that the latter had fractured on the weld of a joining coupling, approximately ten feet from the forward end (FIG. 5). The forward face of the withdrawn valve rod was found hammered and belled where it had been bearing against the remainder of the rod in the

propeller shaft (FIG. 5).

rod from the sleeve. After speed was reduced the hub unit springs moved the blades, piston and valve rod forward, but the latter failed to re-engage in the sleeve. The sliding ring was forced forward by the operating key, fouled the casing and bowed the key, causing the damage in the oil distribution box as described above.

The whole valve rod was unscrewed into sections and taken to Whampoa Dockyard for repair and X-ray of all welds. The damaged section of the rod and coupling were faired and the valve rod sections immediately forward and aft of the failure checked for alignment. This was satisfactory.

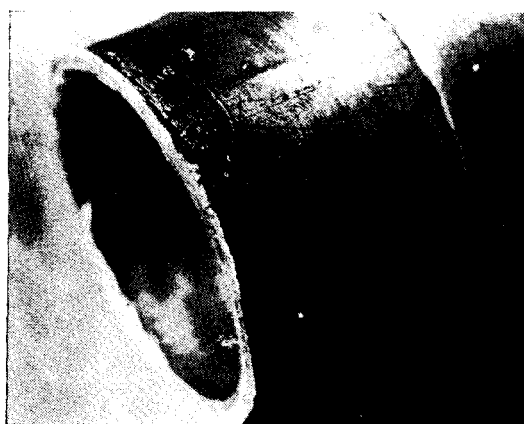
FIG. 6—SLEEVE OF FAILED OPERATING ROD JOINT

The next problem to arise was how to remove the remainder of the valve rod, some 60 feet inside the propeller shaft. First thoughts were to break the Admiralty coupling just aft of the oil distribution box, withdraw the propeller shaft sufficiently aft to enable the broken valve rod to be grasped, slide it aft and eventually push it through the shaft with bamboo canes or searchers. This was decided against. A better suggestion was to remove a section of the intermediate propeller shaft between the thrust block and the forward end of the oil distribution box shaft. This only entailed moving the propeller shaft aft a couple of inches to free the spigots on the coupling, and would leave the forward valve rod, pin and liner free to be withdrawn forward. This was done, but it was found necessary to jack the propeller hub before the shaft could be moved at all. On drawing out the remaining valve rod it was seen that the after end of the coupling, where it was welded, was also hammered. Examination of the weld showed poor penetration on the vertical face, and it was surprising that the C-P gear had operated so long before failing.
