NOTES FROM THE SEA

Steam Strainers—Daring Class

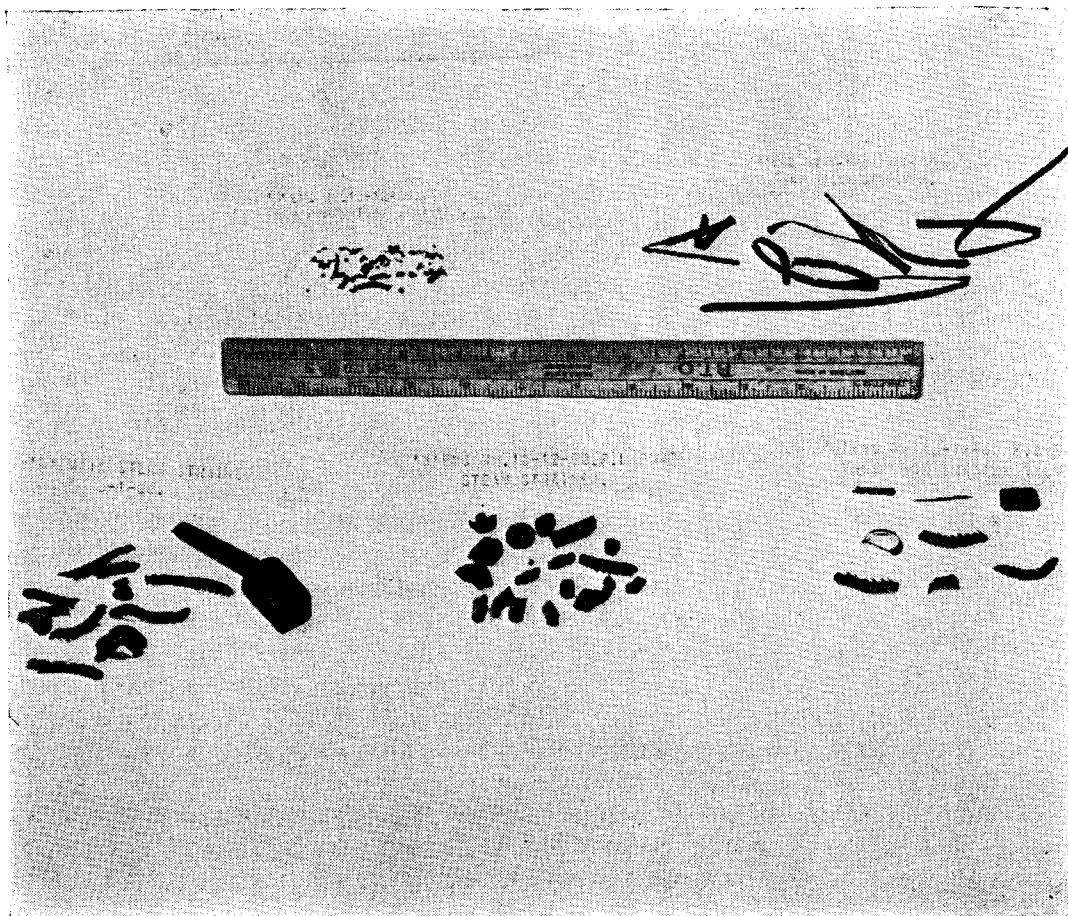
FIG. 1—IS IT A WASTE OF TIME?

The result of the examination of the steam strainers is shown graphically in FIG. 1 and needs no elaboration. The bits and pieces, some of which are almost recognizable, were found as follows:

- Top left—'A' engine room main feed pump steam strainer (13-12-66)
- Top right—'A' engine room main feed pump steam strainer (4-1-67)
- Bottom left—'A' main steam strainer (3-1-67)
- Bottom centre—'B' engine room F.L. pump steam strainer (13-12-66)
- Bottom right—'B' engine room F.L. pump valve box (master valve) (13-12-66)
