REPAIRS TO AN F.L. PUMP

H.M.S. PROTECTOR

LIEUTENANT D. P. HARRIS, R.N., A.I.MAR.E.

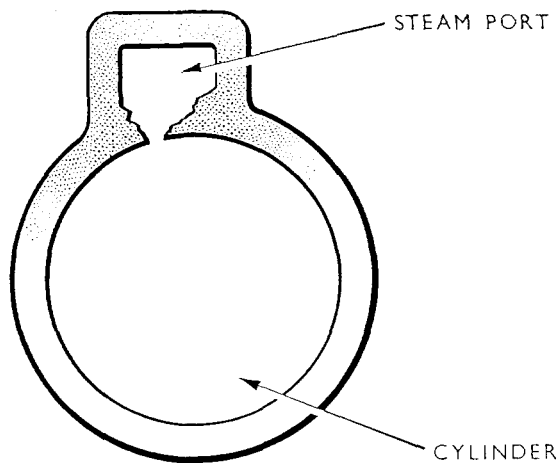
FIG. 1

On investigation it was found that a hole had appeared between the steam cylinder and steam port of the port F.L. Pump (see FIG. 1), thus breaking down the flow of steam to, and exhaust from, the top of the cylinder. The metal between the cylinder and steam port was found to be paper thin over a large area, due to a defect in the original casting. Initially, attempts were made to repair the defect with epoxy resin, but the araldite held on board was not sufficiently temperature resistant and these attempts were unsuccessful.
