THE DEVELOPMENT OF NYLON PROPELLERS

LIEUTENANT-COMMANDER E. W. WARD, R.N.

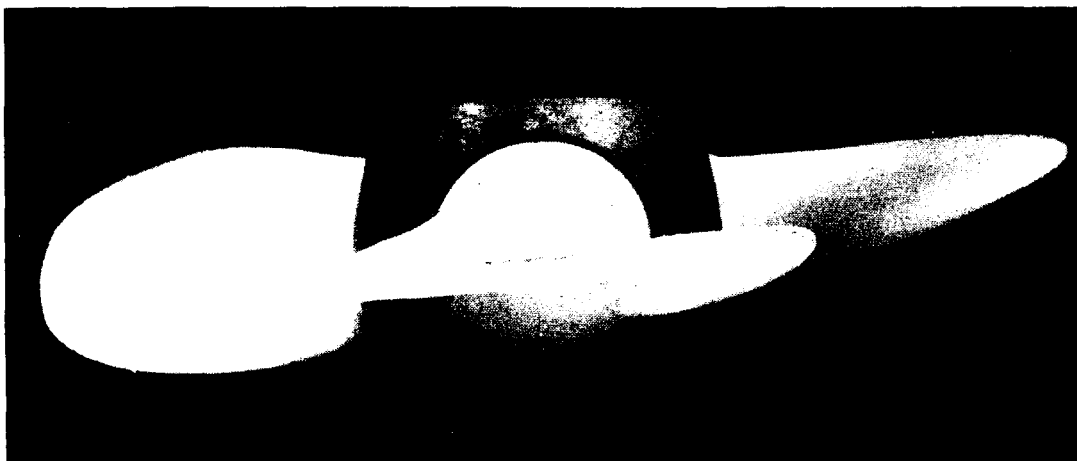
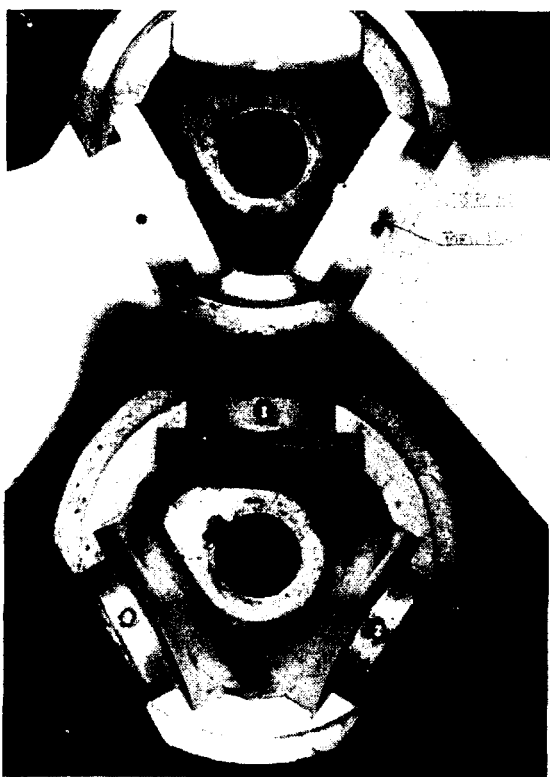
FIG. 8(a)—45-FT POLICE LAUNCH DAMAGE (JUNE, 1960)

FIG. 8(b)—45-FT POLICE LAUNCH DAMAGE
(JUNE, 1960)

In June, 1960, this boat sustained underwater damage through striking a submerged object. The boat was slipped for repair of hull damage but a visual examination of the propellers revealed no apparent damage to them. On being put back into service, however, excessive vibration and loss of power was experienced and the boat had to be re-slipped for a more detailed examination of the propellers. This inspection showed that elongation of the hole in the root of one blade of the starboard propeller in which is fitted the locking pin for setting (and holding) the pitch of the blade, had occurred. The blade had subsequently 'feathered' under the hydrodynamic forces with consequent loss of power. FIGS. 8(a) and (b) show this damage to the locking arrangement and the feathered blade.

The starboard shaft was fitted with a new nylon propeller and evaluation was resumed, the damaged propeller being subsequently repaired by re-drilling the hole and fitting a larger diameter locking pin. Apart from this, the propeller suffered no damage and was held as a spare for further fitting if required.

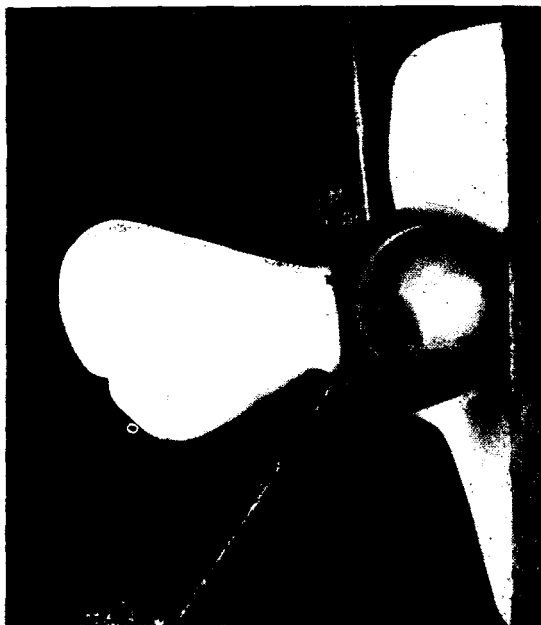
FIG. 9—45-FT POLICE LAUNCH—CUT IN PORT PROPELLER (AUG. 1960)

The next examination was made in August, 1960, after the propellers had completed 1,500 hours' running. On this occasion, it was discovered that the port propeller had fouled a wire at some stage and one blade had a cut on the edge approximately $\frac{3}{8}$ -inch deep. No other damage had been sustained so the damaged blade was faired off and the boat put back into service. FIG. 9 shows the cut in the edge of the damaged propeller blade.

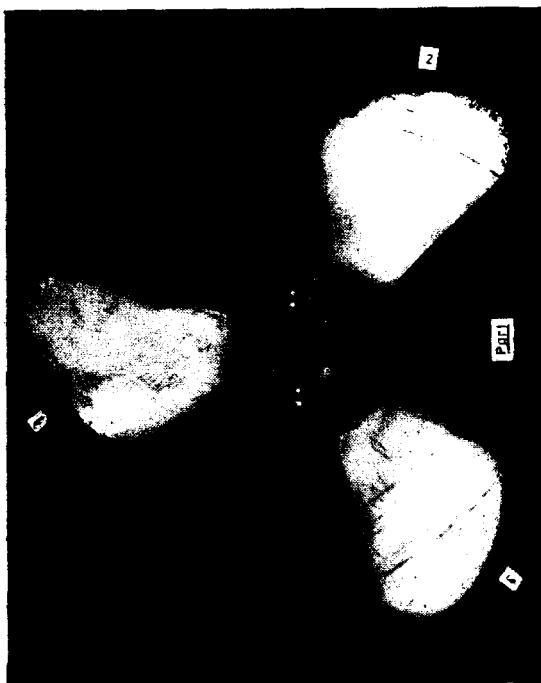
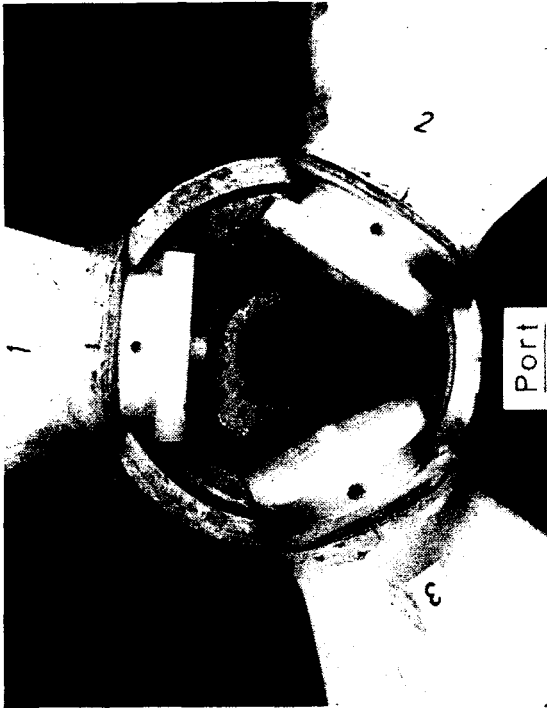
FIG. 10(a)—45-FT POLICE LAUNCH—NYLON PROPELLERS, 2,500 HOURS

After 2,500 hours' running, the boat was again slipped in December, 1960, and the propellers were dismantled for a complete examination. It was found that the damage previously sustained to the edge had not increased but there was evidence, in the form of superficial scratches on the blade surface as well as slight elongation of the pitch locking arrangements, that they had suffered further minor damage through striking underwater obstructions. It was

FIG. 10(b)—45-FT POLICE LAUNCH—NYLON PROPELLERS, 2,500 HOURS

FIG. 10(c)—45-FT POLICE LAUNCH—NYLON PROPELLERS, 2,500 HOURS

encouraging to note that although there was some superficial de-zincification of the bronze hubs, with areas of local pitting adjacent to the trailing edges of the blades, there was a complete absence of any cavitation damage to the blades themselves.

FIGS. 10(a), (b) and (c) show the state of the propellers at this stage, and for comparison FIG. 11 shows a standard H.T. brass propeller removed from another Police launch after 2,500 hours' running.

In view of the slight elongation of the holes of the pitch locking arrangements, the propellers were re-pitched and put back into service, giving very satisfactory service until June, 1961, when it was reported that the port propeller was missing. The reason for this loss was never satisfactorily determined, but a report from Portsmouth at the time indicated that, on slipping the boat, it was found that the key of the starboard propeller had corroded and was in two pieces such that there was no mechanical connection between the boss and the shaft. It was therefore concluded that this had also happened to the port propeller key and that, in this case, relative movement between shaft and propeller had caused the securing nut to unscrew.

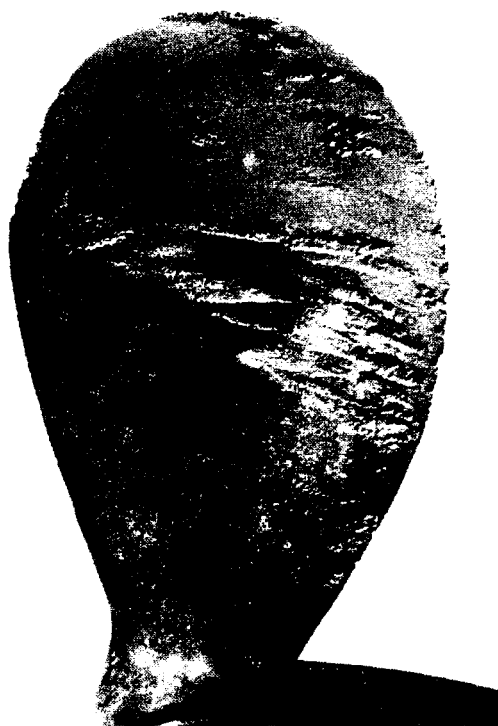
FIG. 11—45-FT POLICE LAUNCH—H.T. BRASS PROPELLER, 2,500 HOURS
