# FAILURE OF A BELLOWS EXPANSION PIECE

—H.M.S. ASHANTI

LIEUTENANT-COMMANDER T. C. DEACON, R.N., A.M.I.MECH.E.,  
A.M.I.MAR.E.

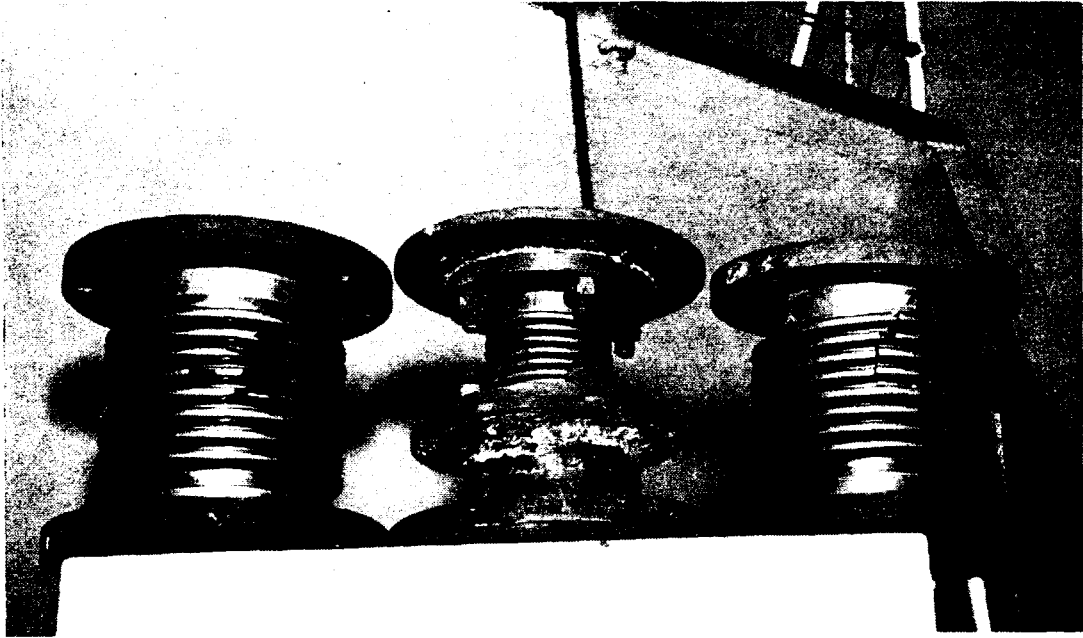
FIG. 1—THE DEFECTIVE BELLOWS PIECES AND THE JURY RIG

Careful measurement showed that the hot length must be  $8\frac{1}{2}$  inches but the cold length  $8\frac{7}{8}$  inches. To give minimum tensile stress on the installation and compressive stress in operation, it was decided to make adaptors to give an overall free length of  $8\frac{11}{16}$  inches. A copper-nickel-iron erosion piece having the correct diameter was used to provide the flanges as it was not wished to destroy the original bellows piece before it had been metallurgically examined. Mild steel blank flanges were sif-bronzed to the erosion piece with 3-inch holes burned out of the centres and four studs welded on to suit the new expansion piece. One flange was offset  $\frac{1}{4}$ -inch to allow for a measured misalignment of the pipes. The final result, ungainly but serviceable, can be seen in FIG. 1.

Ship's opinion inclines to the view that failure was due to high frequency vibrations of the convolutions set up by the steam flow, and the rapid failure of the final two due to the fact that the lagging blanket was not fitted. In the earlier cases lagging would have provided appreciable damping. This view is supported by the fact that the bellows piece whistles when in use but the ships staff jury rig and the expansion gland do not. A design has therefore been proposed with an internal shield to prevent the setting up of eddies in the steam flow.

The most likely cause of the failures would appear to have been a combination of the misalignment of the pipe flanges and the high frequency vibrations mentioned in the article. It is of interest that there are five other similar bellows pieces in a G.P. frigate installation none of which have failed in *Ashanti* so far, nor have any failures occurred in other ships of the Class.

The attention of all shipbuilders has been drawn to the importance of proper alignment of pipe flanges and, as stated, sleeved bellows will be provided in future for similar expansion arrangements.
