## CORROSION-FATIGUE CRACKING IN STEAM ACCUMULATORS

*There has recently been a report from the Brazilian Naval Authorities of a fracture in the water drum of a boiler in Minas Gerais (ex H.M.S. Vengeance) apparently resulting from the seal welding of a riveted circumferential joint.*

*The following article is abstracted from Technical Report Volume IV, March 1962, of the British Engine Boiler and Electrical Insurance Company, Limited, Manchester, and is reproduced by courtesy of the Company. It explains the mechanism of failure arising from seal welding a riveted joint and emphasizes the possible serious consequences of effecting such a repair to a pressure vessel of riveted construction, a number of which are still in service.*

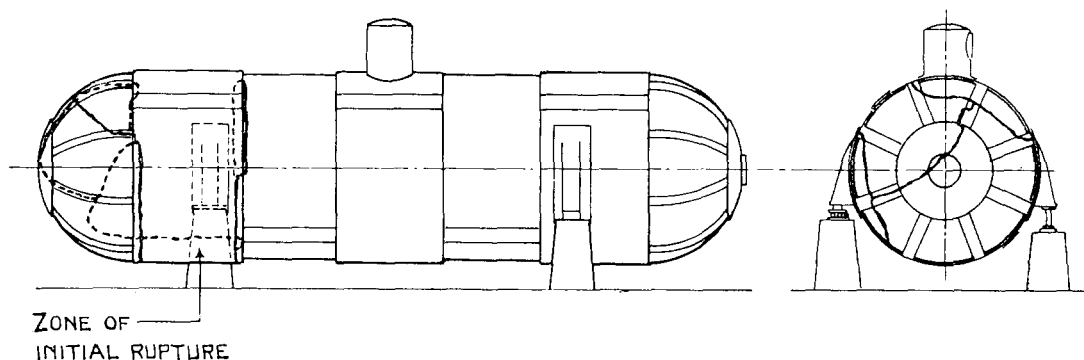
The initial point of rupture at the time of the explosion was located in the first shell ring at the end of the vessel nearest to the boiler house. This ring fractured along the lower lap to the inner butt-strap of the lower longitudinal seam, which was located about 45 degrees below the horizontal centre line. The rupture extended round both adjacent circumferential seams and a section of the ring was more or less flattened out, torn clear and blown upwards, alighting about 300 yards away from the vessel ; the adjacent hemispherical end also

FIG. 2—SKETCH SHOWING PATHS OF RUPTURES

ruptured extensively. The paths of the various ruptures are indicated in FIG. 2. The virtual removal of one end of the vessel enabled the steam and water contents to discharge violently and the reaction thus set up projected the remains of the vessel, in the manner of a rocket, through a considerable part of the factory premises until it finally came to rest in the evaporation plant.

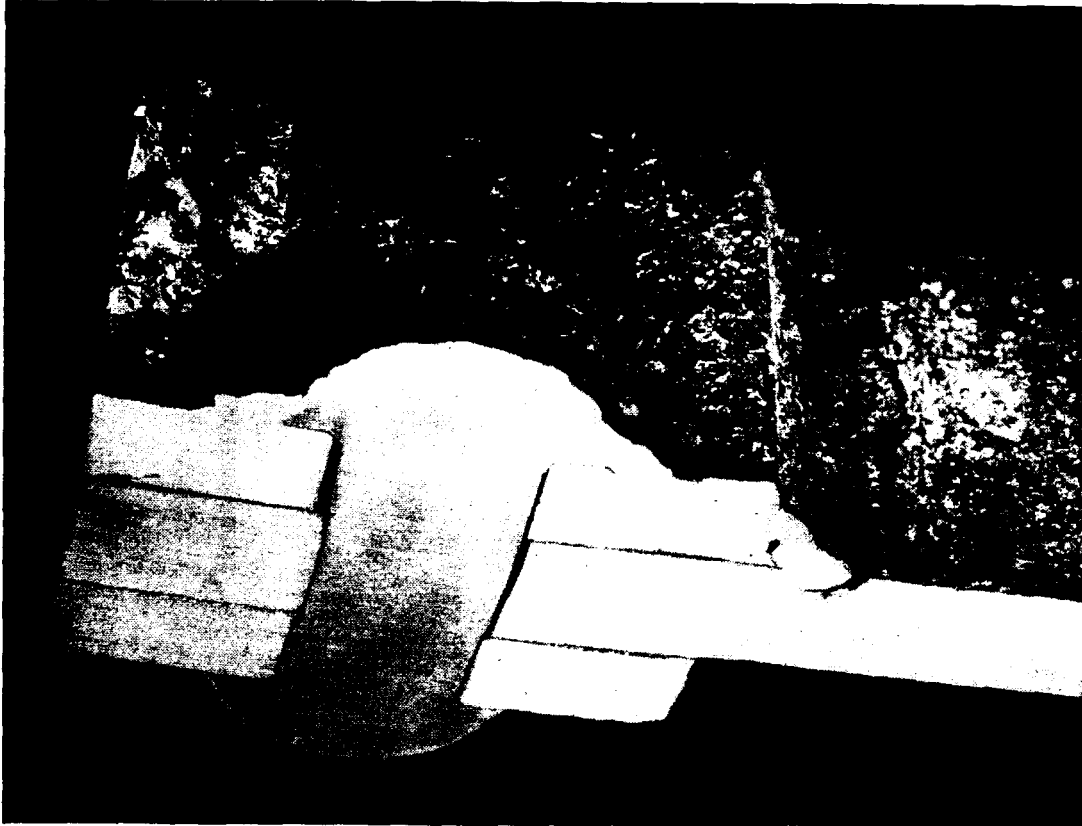
The cause of the rupture that initiated the explosion was found to be the presence of a corrosion-fatigue fissure that had extended practically through the shell plate over almost the full length of the seam at which it occurred. The fissure had developed at the toe of the seal-weld at the lap edge of the butt-strap, and examination of a number of specimens showed that it was a typical example of corrosion-fatigue.

Judging from the many cut-up pieces that were inspected, the internal surfaces of the vessel were singularly free from corrosion, having regard to its age. Below the water level there were isolated, widely separated small corrosion scabs of the type associated with differential aeration corrosion, but over most of the surfaces the original mill scale was still visible beneath a patina of friable rust. In those parts of the vessel where the corrosion-fatigue fissures at the weld toes had not been appreciably disturbed as a result of the explosion, it was noted that they were practically filled with corrosion products that appeared to consist largely of magnetite ( $\text{Fe}_3\text{O}_4$ ). Bearing in mind that the interior of the vessel would be covered with a thin layer of rusty sludge after it had been emptied for examination purposes, the existence of the fissures could easily be overlooked unless their presence was suspected and steps taken to dig away the corrosion products that filled them. A typical example of the fissuring at the toes of the seal-welds is shown in FIG. 3; it should be noted that this fissure had been opened up and the corrosion product broken away as a result of the deforma-

FIG. 3—TYPICAL EXAMPLE OF FISSURE AT TOE OF SEAL WELDING SHOWING WELDING OF RIVET HEAD AND INCOMPLETE FILLING OF HOLE BY RIVET

As it is extremely unlikely that any corrosion-fatigue trouble would have been experienced in the absence of seal-welding of the vessel seams, it is of interest to consider the question as to why such seal-welding was necessary. It will be noted from the transverse section shown in FIG. 3 that the rivet depicted did not fill the hole properly. As the fit of the rivets could have been disturbed in a circumferential direction by the working stresses, and in particular at the time of the explosion, an adjacent section to that depicted in FIG. 3 was cut through longitudinally and this is shown in FIG. 5, from which it will be observed that the fit of the rivets was not substantially different from that shown in FIG. 3. It is evident, therefore, that the rivets did not fill the holes properly when the seam was riveted. This being the case, slight relative movement of the shell and butt-strap plates would be bound to occur when the vessel was pressurized and this would disturb the caulking at the lap edges of the butt-straps and so lead to the development of leakage. There is no reason to doubt that the original leakage from the vessel seams was due primarily to the unsatisfactory fit of the rivets, but a contributory factor was that the pitch of the outermost row of rivets was  $7\frac{1}{2}$  in., which would render adequate caulking

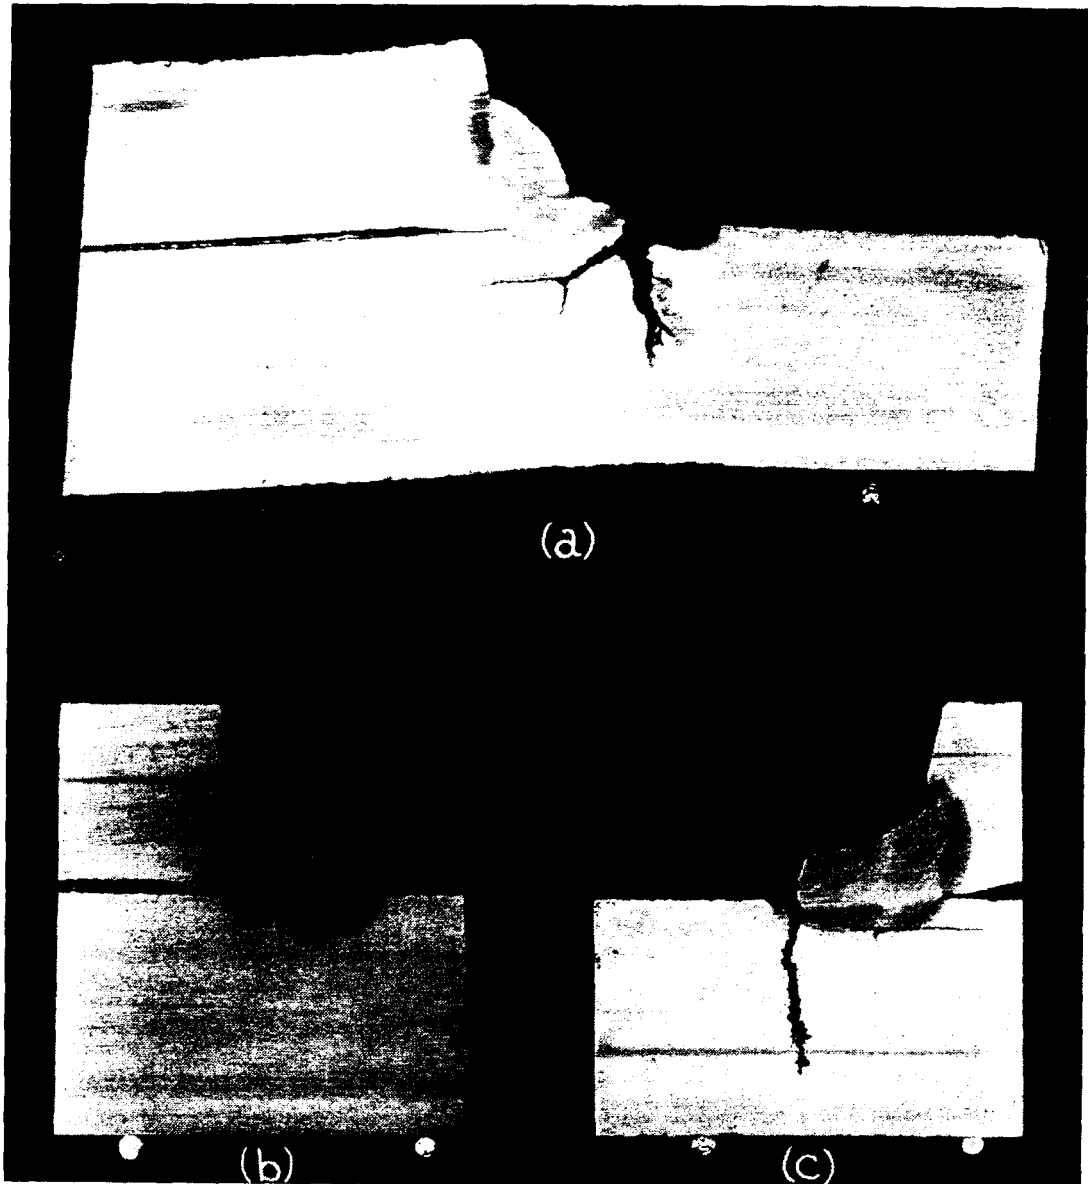
tion that occurred at the time of the explosion. Further examples of the fissuring are shown in FIG. 4, (a) and (c) depicting bare-wire welds and (b) a weld made with a covered electrode.

FIG. 4—TYPICAL EXAMPLES OF FISSURES—(A) AND (C) BARE WIRE (B) COVERED ELECTRODES

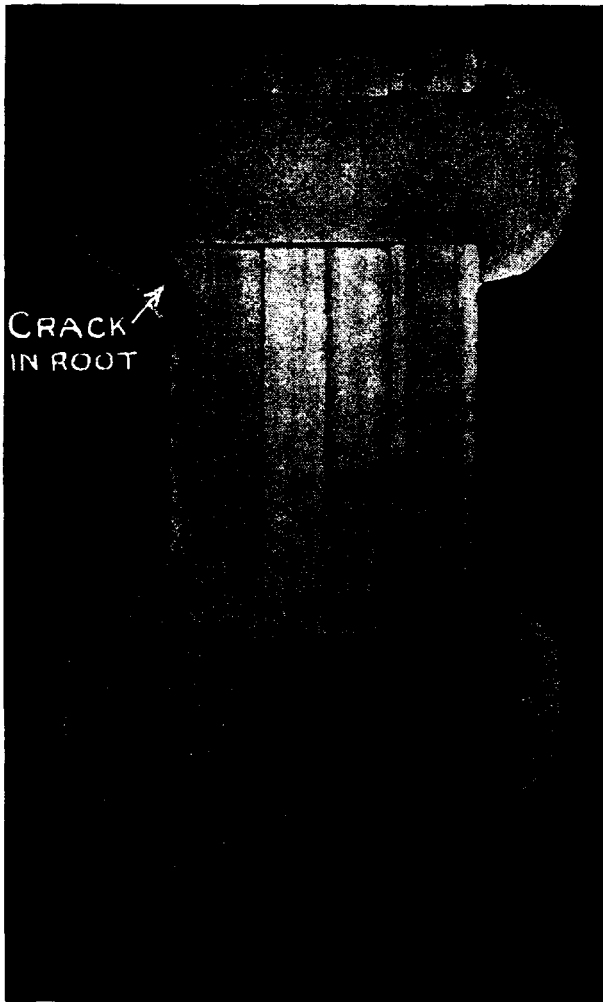
FIG. 5—LONGITUDINAL SECTION THROUGH SEAM ADJACENT TO PART SHOWN IN FIG. 3

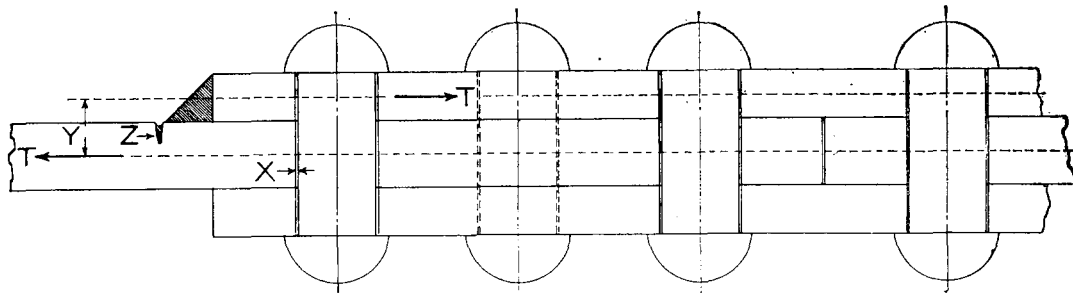
The application of seal-welding to the lap edges of riveted seams is a most undesirable practice because it gives rise to a severe concentration of stress at the toe of the weld. In the sketch, FIG. 6, is shown a section through part of a longitudinal seam in the vessel under consideration. At the time seal-welding was applied the vessel would not, of course, be under pressure, and owing to the slight relaxation that would invariably take place on removal of the pressure, the holes in the plates would not necessarily be in contact with the shanks of the rivets. It follows, therefore, that after the deposition of a seal-weld along the lap edge of a butt-strap there would exist, or be brought about by contraction of the weld-metal, a slight gap between the hole in the butt-strap and the rivet shank, designated X in FIG. 6. When the vessel was subsequently pressurized the shell plate would no longer be free to move relative to the butt-straps so as to take up any gap between the holes and rivet shanks; consequently, the

FIG. 6—TRANSVERSE SECTION THROUGH LONGITUDINAL SEAM

hoop stress arising from the pressure would be imposed largely and in some places probably wholly, on the seal-weld. The effect of this would be to introduce a bending stress at the weld junction between the shell plate and the inner butt-strap, largely concentrated in the shell plate at the toe of the weld; as the neutral axes of the shell plate and butt-strap lie in different planes, the application of a hoop load,  $T$ , would produce a couple,  $Y$ , and the bending moment thus set up would produce a tensile stress at the toe of the weld in the locality designated  $Z$ . A simple calculation shows that at the designed working pressure of 100 lb/sq in. the maximum nominal skin stress thus developed would be in the region of 10.0 tons/sq in. To arrive at an approximation of the true stress

it is necessary to apply a stress concentration factor to take into account the abrupt change of section at the weld toe and the undercutting that was present in the vicinity. Assuming a modest factor of 1.5, the maximum skin stress would be in the region of 15.0 tons/sq in., i.e. in excess of the yield point of the material. It is known that the vessel was tested hydraulically to 1.5 times the working pressure on several occasions and this would cause the formation of a wedge of plastically deformed metal in the locality indicated by Z, the depth of the wedge depending largely on the extent to which the shell plate moved relative to the butt-strap before the rivet shanks began to take up the load. There is every reason to believe, therefore, that the plate material at the toes of the seal-welds at the longitudinal seams was strained plastically to an appreciable degree when the vessel was put back into service after the welding had been applied.

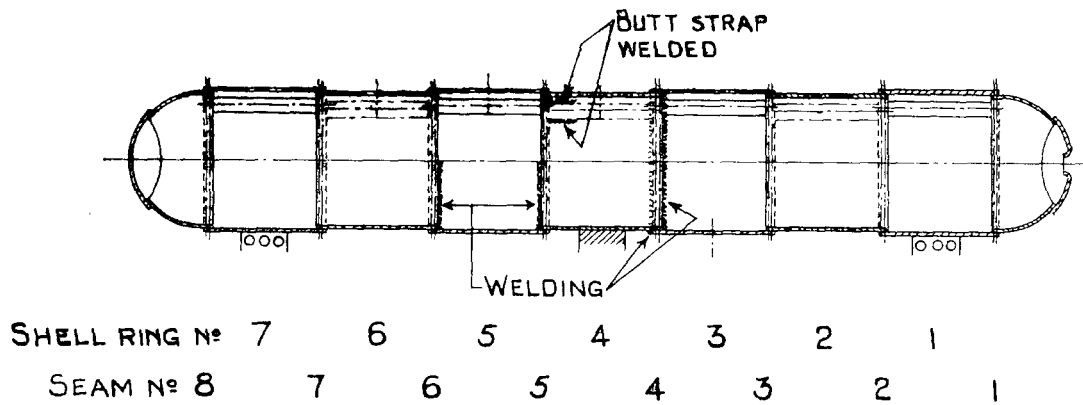
FIG. 7.—DISTRIBUTION OF WELDING IN FIRST ACCUMULATOR

In the case of the first accumulator the welding had been applied along the full length of the lap edges, both internally and externally, at the (hand riveted) No. 4 circumferential seam and, internally, over only the bottom halves of Nos. 5 and 7 seams, as indicated in FIG. 7. The butt-straps of the No. 4 shell ring longitudinal seam had also been welded, internally and externally, at the top and bottom edges for approximately 18 in. extending from the No. 5 seam.

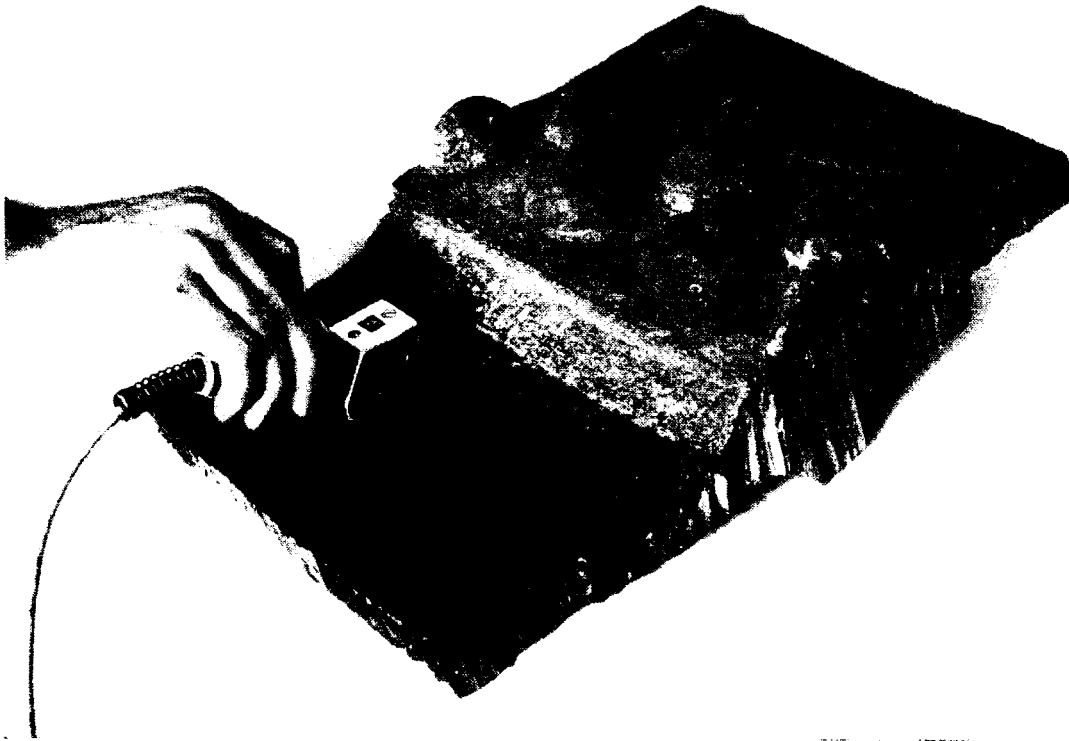
FIG. 8—LOCATION OF PROBE WHEN ULTRASONICALLY TESTING FOR FISSURES AT TOE OF SEAL WELD

In order to determine the extent of the afore-mentioned defects it was decided to examine the vessels ultrasonically. The examination was carried out by means of Kräutkramer Type U.S.I.P. 9 Ultrasonic Flaw Detectors, employing 2 Mc/s 70 degrees and 45 degrees barium titanate angle probes and medium grade machine oil as the couplant. When the angle probes were placed in a position similar to that shown in FIG. 8, the screen indication obtained was as is depicted in FIG. 9 and this confirmed the presence of a crack at the toe of the fillet weld. The length of a crack was traceable by moving the probe parallel to the seam until the crack indication disappeared from the screen. In places, the cracks were found to extend into the plate material to a depth sufficient to prevent any ultrasonic waves passing through to the rivets, and subsequent sectioning of such localities showed that the cracks were approximately 1 in. deep and slightly angled to the place surface. At every location where welding had been resorted to, cracks had developed along the toes of the welds for their full length, and, in most cases, they extended past the ends of the welds for approximately 2 in. During the examination of the fillet welds there were some indications of small cracks radiating from a number of rivet holes.

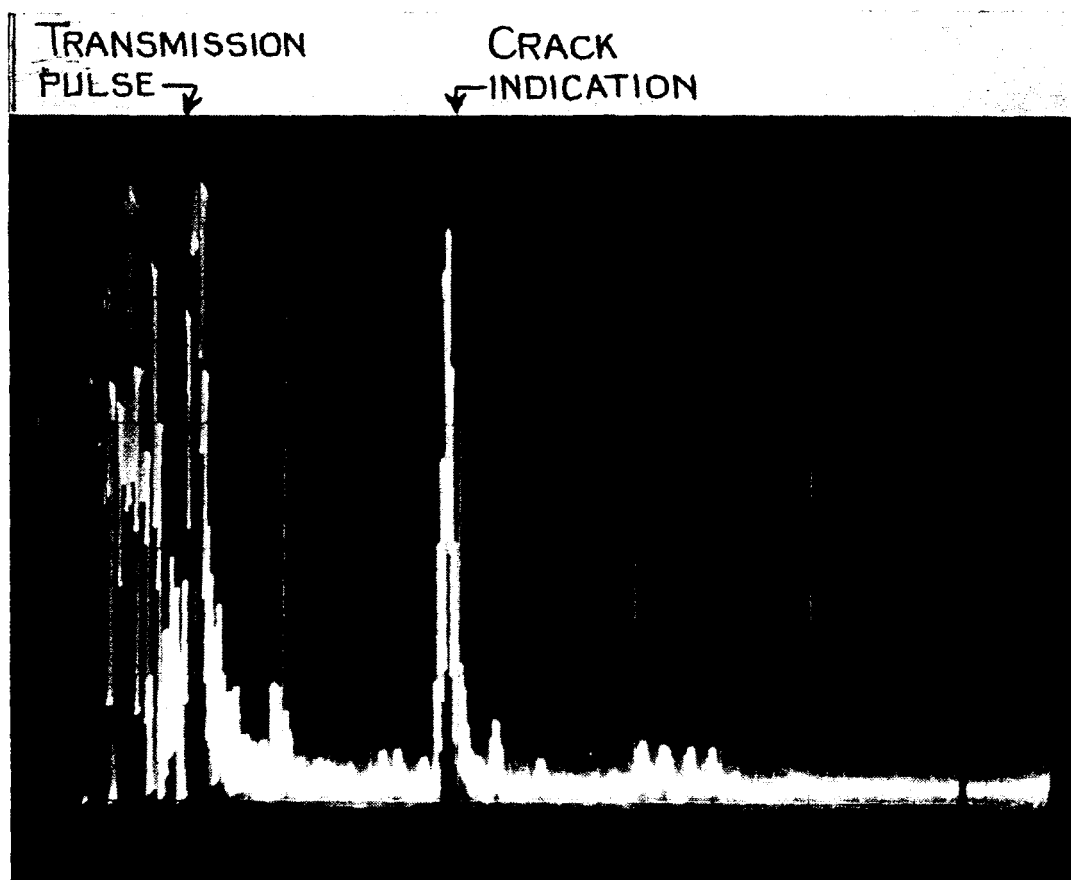
FIG. 9—TRACE ON CATHODE RAY TUBE OF ULTRASONIC TEST INSTRUMENT

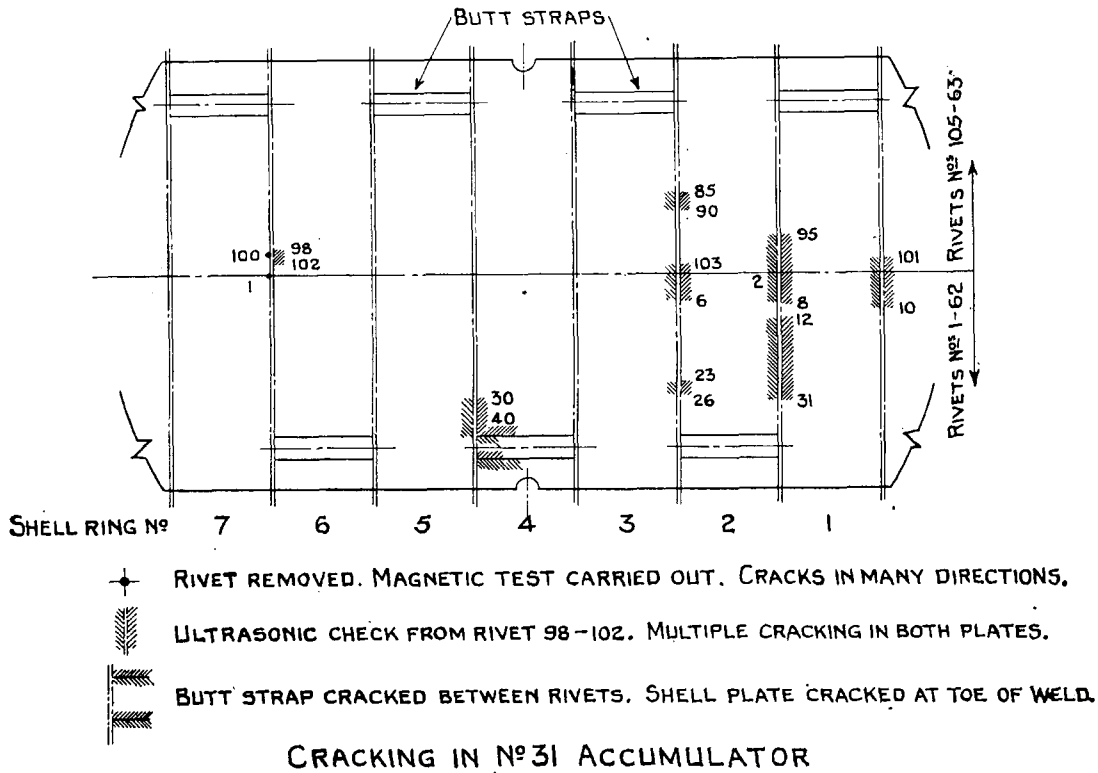
The results obtained from this examination indicated that the circumferential seams of Nos. 1, 2 and 6 shell rings, as well as one end plate, were seriously cracked at nearly every rivet hole. Confirmation of the ultrasonic indications was obtained by removing several rivets and then magnetically testing the holes ; in each case several cracks were detected, radiating in all directions. Further ultrasonic testing was carried out over localised areas in other seams and

FIG. 10—DEVELOPED PLAN OF SECOND ACCUMULATOR SHOWING NON-DESTRUCTIVE TESTS APPLIED

similar results were obtained, which were also confirmed by the removal of rivets and magnetic testing on the holes. The areas tested are delineated on the accompanying sketch, FIG. 10, which is a developed plan of the accumulator as if opened up longitudinally along the top of the vessel. The severity and extent of the defects revealed at the rivet holes was such that it was decided that repair of this accumulator was impracticable and it was taken out of service and replaced. When the two vessels were cut up prior to removal from site, samples became available for laboratory examination, the more interesting features revealed being as follows :—

Due to the extent and severity of the defects revealed by the ultrasonic examination it was decided that the first accumulator should be taken out of service permanently and replaced, and that the ultrasonic examination of the other vessel, which was not affected so seriously, should be extended to ascertain if it was in a condition that would justify repair.

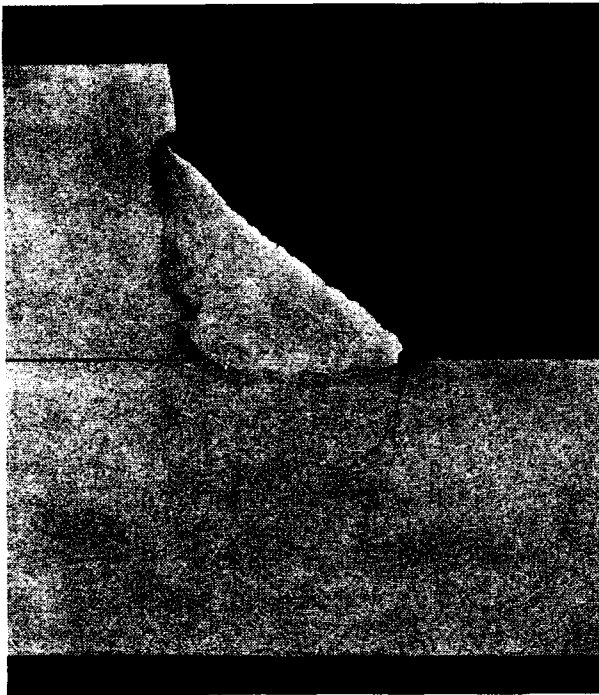
FIG. 11—SECTION AT 6TH CIRCULAR SEAM OF FIRST ACCUMULATOR SHOWING SEAL WELD AND FISSURES

FIG. 11 shows an axial section cut from the bottom of the sixth circular seam from the

manhole end of the first vessel, and the development of a duplex crack system from the slight undercut present at the toe of the fillet weld to the outer plate will be noted. A similar section farther round the same seam is illustrated in FIG. 12, this intersecting the excavation made at the toe of the weld at the time of the visual examination in order to facilitate magnetic

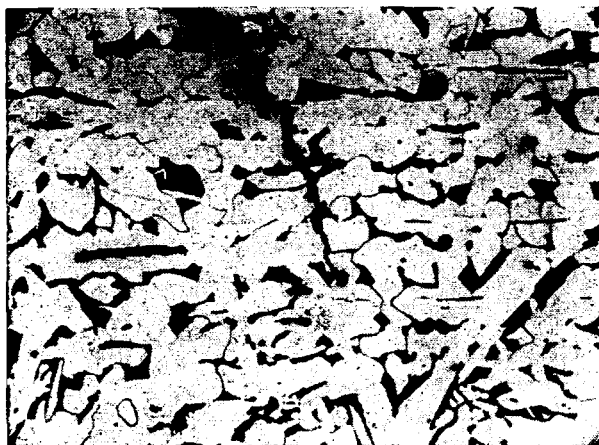
FIG. 13—TERMINATION OF FISSURE IN FIRST ACCUMULATOR

Microscopical examination of several specimens cut to intersect the crack showed it to be typical of corrosion-fatigue; it was in the form of a broad fissure, contained oxide deposits, and the termination was blunt-ended, as shown in FIG. 13. The crack origin at the junction of the weld metal with the plate material showed a modified plate structure resulting from the heat input during welding, depicted in FIG. 14. At this location two separate cracks were present, most likely due to the fact that the section intersected two separate cracks which had broken out at different locations round the seam and during their subsequent development in the circumferential direction overlapped at their ends by a small amount.

The plate material showed a normal structure and its Brinell hardness of 143 is indicative of a tensile strength of approximately 32 tons per sq in.

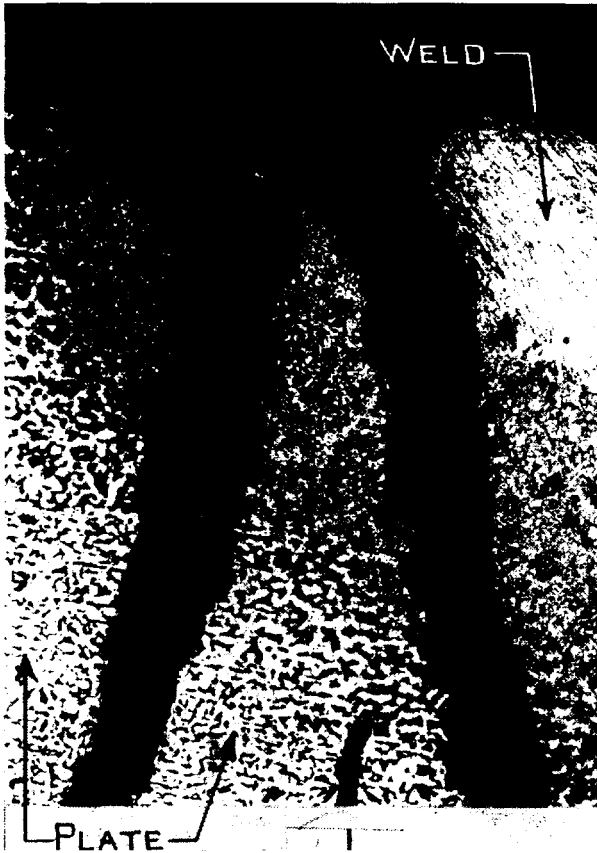
FIG. 14—ORIGIN OF FISSURE SHOWN IN FIG. 13

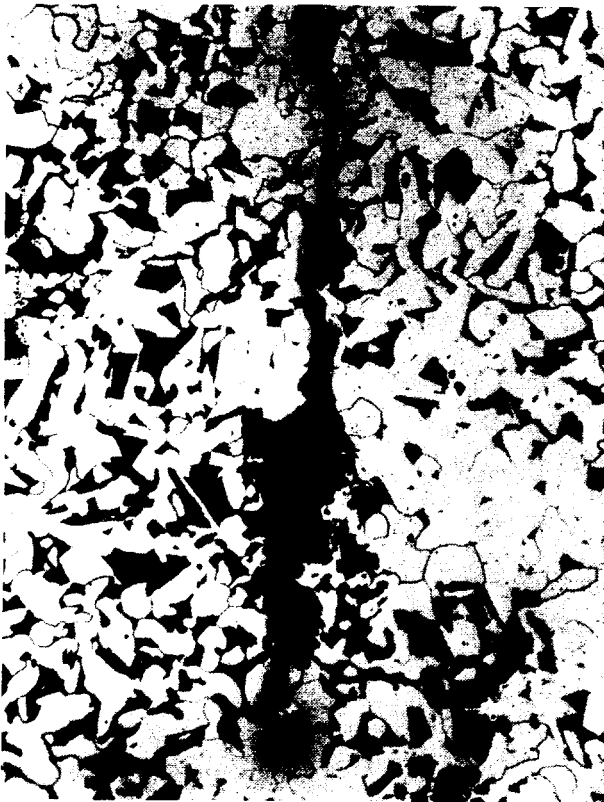
be present. A specimen embracing a typical crack was subsequently prepared for microscopical examination, which revealed it to be of the corrosion-fatigue type, the blunt-ended termination of the oxide-filled fissure being shown in FIG. 15. No structural abnormalities were observed in the plate material, which had a Brinell hardness of 170, equivalent to a tensile strength of 37 tons/sq in.

A macroscopical examination was also made of a sample from the second vessel, cut so as to include a crack at a rivet hole, this being taken from the lower portion of the second circumferential seam from the manhole end. Magnetic crack detection showed several radial cracks up to  $\frac{3}{8}$  in. long to

FIG. 15—TERMINATION OF FISSURE IN SECOND ACCUMULATOR
